BAT SURVEY

**HODDER VIEW
CHAIGLEY
CLITHEROE**

REFERENCE NO. 4585

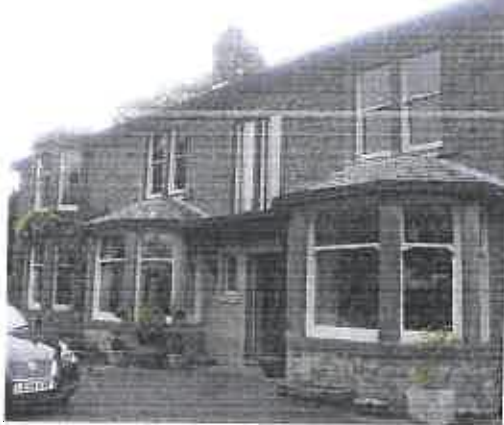
Front elevation

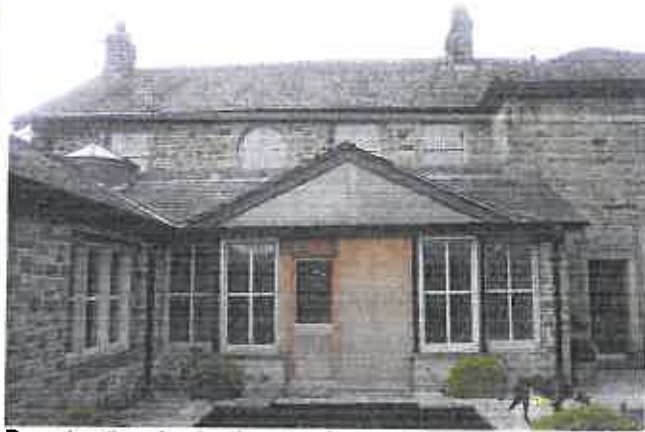
Rear elevation showing the extension

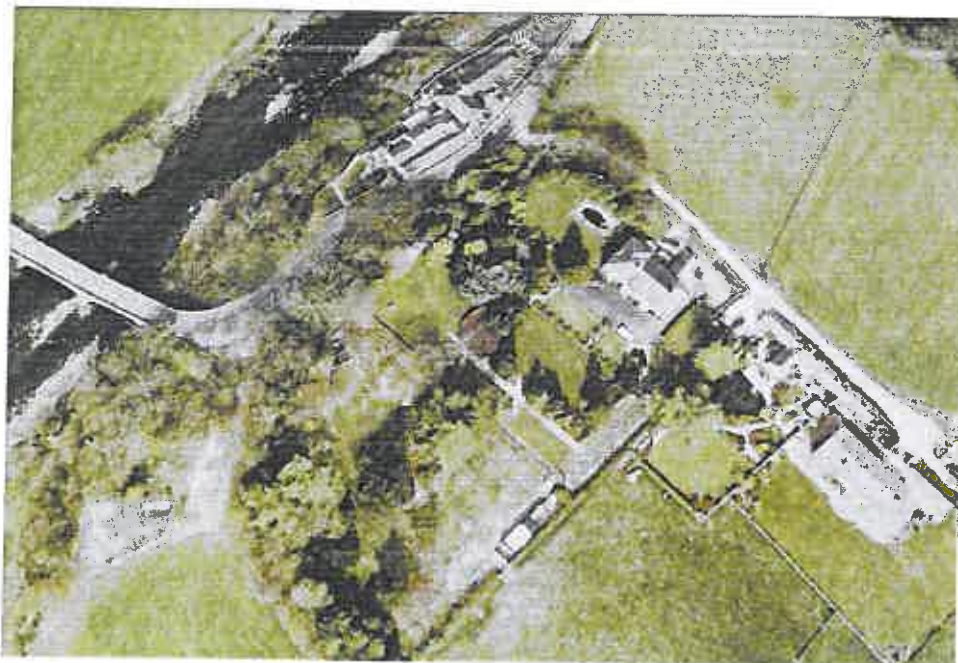
The house is located in an extensive well established garden containing mature shrubbery conifers and broad leaf trees. Pasture land abuts the garden to the rear and front, two further properties are located to the south east of Hodder view, and the former public house The Hodder Bridge (now dwellings) is adjacent to Chipping road which forms the North west boundary of the garden. The river Hodder runs approx 70m from the north west of the house. Wooded areas line the river. The site and the nearby area provides high value foraging potential for bats.

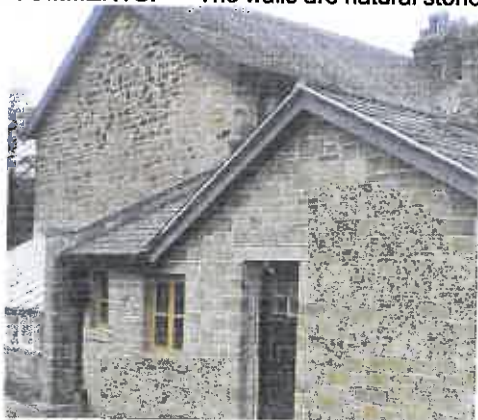
COMMENTS: The walls are natural stone.

Original house gable wall and extension stonework

COMMENTS: The walls are in excellent condition with no access points.

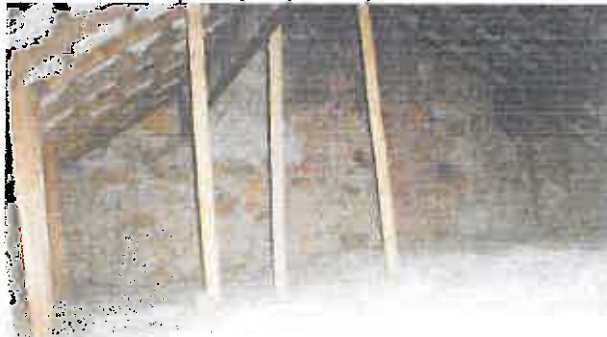
COMMENTS: It was not considered safe to access the roof space, examination was limited to viewing from the access panel with the aid of a torch. The timbers were in reasonable condition with no cracks or crevices the abutments of battens/ rafters were rendered. Insulation quilt was laid over ceiling joists. As far as it was possible to see the gable where bats had emerged from, signs that they were present internally were not evident the detector did not pick up any activity.

Internal south east gable

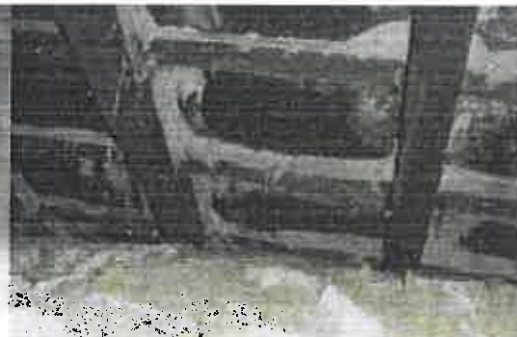
Rafters and battens

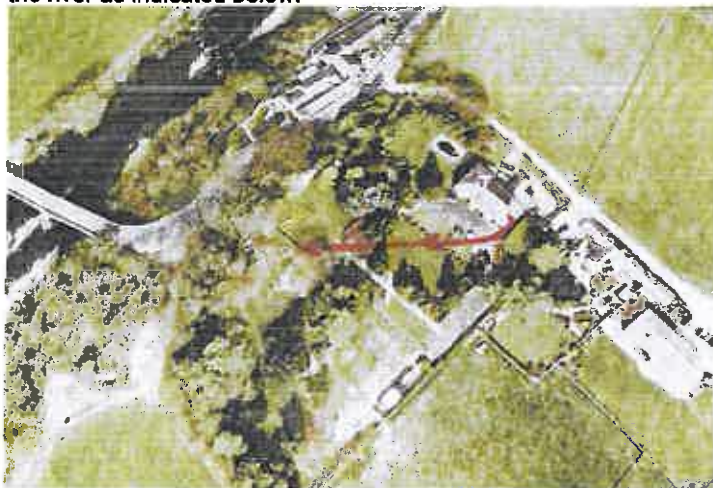
The evening survey recorded emergence from the soffit of the main roof gable barge boards commencing at 9.40pm this emergence activity continued until 10.20 pm approx 30no bats (pipistrelle) having emerged. The commute to forage from the house was a south westerly direction towards the dense wooded areas adjacent to the river as indicated below.
