## WOLFEN HALL, CHIPPING, LANCASHIRE, PR3 2NZ:

# HERITAGE STATEMENT IN SUPPORT OF PROPOSED FRONT PORCH

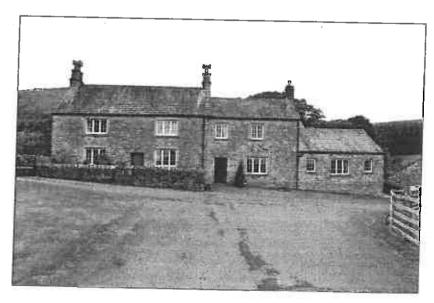
Photo 1: the present Wolfen Hall

2.1 Wolfen Hall Farm comprises a group of various buildings occupying an outlying location 2km north-west of Chipping village, at the foot of Parlick and Wolf Fell, the southern end of the Bowland fells, and in the Forest of Bowland AONB. The Hall itself comprises a single dwelling, created from the amalgamation of the farmhouse with other adjoining buildings, and stands at the south-west end of the farm group.

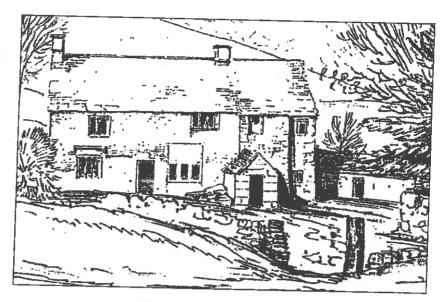
Figure 1: John Weld's sketch of Wolfen Hall, 1841<sup>2</sup>

Figure 1 shows the main house with an irregular arrangement of windows, at least one of which has a hood mould, with an approximately central doorway. Beyond a straight joint or set-back to the right of this part of the building are two further narrow bays, apparently unheated, with a small stone, gabled porch positioned at the junction between these and the main house. The separate illustration of the doorway, set within the porch, shows an ogee arch and large moulded jambs of medieval character (figure 2). The first edition Ordnance

- 3.3 Two illustrations of Wolfen Hall made before the 1860s alterations, by John Weld of Leagram Hall in 1841, are useful in showing how much the exterior has been altered since then (figures 1 & 2 below).

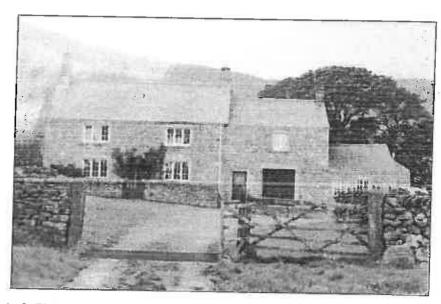
Photo 2: Photograph of 1980s/1990s, showing garage occupying north-east end

- 3.6 Also during the twentieth century, the front of the farm buildings which adjoined the north-east end of the house was altered to create a wide opening in order to serve as a garage, the appearance of which is shown in photograph 2 below, taken in the 1980s or 1990s.
- 3.7 Episodes of extensions and alterations to the Hall were given listed building and planning consent in 1995, 1999, and 2000, the aspects of which relevant here were the replacement of the garage doorway by a window, and the insertion of a new window opening at first floor level, over the adjacent entrance.

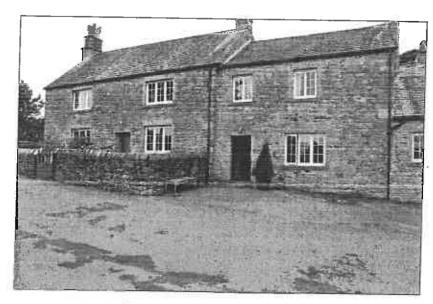
Photo 3: Present appearance of the site for the proposed porch

- The north-east end of the house appears to have been entirely rebuilt in the 1860s, as no architectural features demonstrably earlier than that date were observed within it. The doorway used as the main entrance into the dwelling has tie-stone jambs and must have replaced the ogee arched doorway observed by Weld in 1841, but its size and proportions are agricultural rather than domestic so it was clearly intended as the entrance to a shippon or stable, rather than part of the dwelling. The three windows in this elevation are all post-1999 in their present forms, the ground floor window having been created to replace the garage doorway noted above, though all have been treated so as to resemble nineteenth century openings. The interior of this part of the range now forms the kitchen and other domestic areas. Further to the north-east, the single storey end of the range is equally very modern in character.
