Introduction

Bowland Ecology Ltd was commissioned by Cass Associates to undertake an extended Phase 1 habitat survey of a site off Whiteacre Lane, Barrow, Lancashire (NGR: SD 74082 437821). This report addendum is required to provide additional information regarding the ecological value of ditches at the site. This addendum has been prepared in response to Environment Agency concerns regarding the aquatic ecological value of ditches at the site. This addendum should be read in conjunction with the Ecological Appraisal Survey report for the site (Preliminary Ecological Appraisal, Whiteacre Lane, Barrow – Bowland Ecology Ltd, August 2014).

Appendix A – Ditch location plan

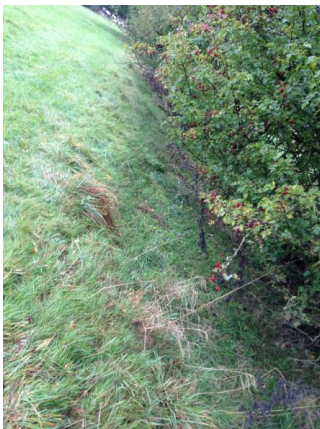
Description	Aquatic species	Inundation/ moisture dependent species	Legally protected species	Photos
D1	Shallow ditch colonized by terrestrial species, Yorkshire fog (<i>Holcus lanatus</i>), creeping bent (<i>Agrostis stolonifera</i>) and cock's-foot (<i>Dactylis glomerata</i>). No deep channel, lacking aquatic species.	None present	At the north-eastern corner where D1 and D2 meet there is a small area of opposite leaved golden saxifrage (<i>Chrysosplenium oppositifolium</i>), indicating that this area is slightly damper. This species is typical of damp woodland soils in western Britain. Creeping bent grass and small amounts of creeping buttercup (<i>Ranunculus repens</i>) also present in adjacent terrestrial habitats.	Nesting bird habitat only.

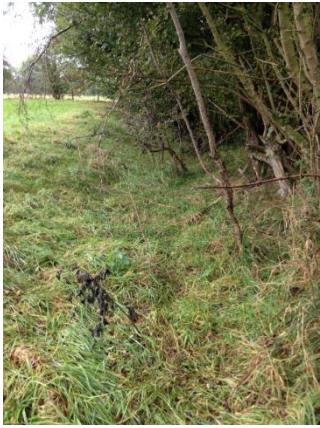
D2	Shallow ditch colonized by terrestrial species, Yorkshire fog (<i>Holcus lanatus</i>), creeping bent (<i>Agrostis stolonifera</i>) and cock's-foot (<i>Dactylis glomerata</i>). Appears to have filled with earth/silt and become colonized by terrestrial vegetation. No deep channel, lacking aquatic species.	None present	None present - creeping bent grass and small amounts of creeping buttercup (<i>Ranunculus repens</i>) also present in adjacent terrestrial habitats.	Nesting bird habitat only.

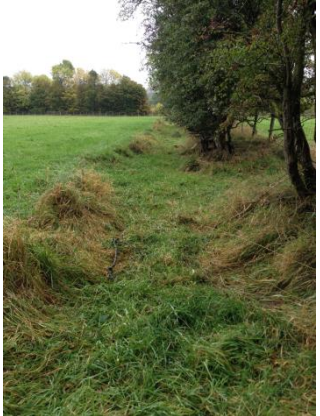
D3	Shallow ditch colonized by terrestrial species, Yorkshire fog (<i>Holcus lanatus</i>) and creeping bent (<i>Agrostis stolonifera</i>). Appears to have filled with earth/silt and become colonized by terrestrial vegetation. No deep channel, lacking aquatic species.	None present	None present - creeping bent grass and small amounts of creeping buttercup (<i>Ranunculus repens</i>) also present in adjacent terrestrial habitats.	Nesting bird habitat only.

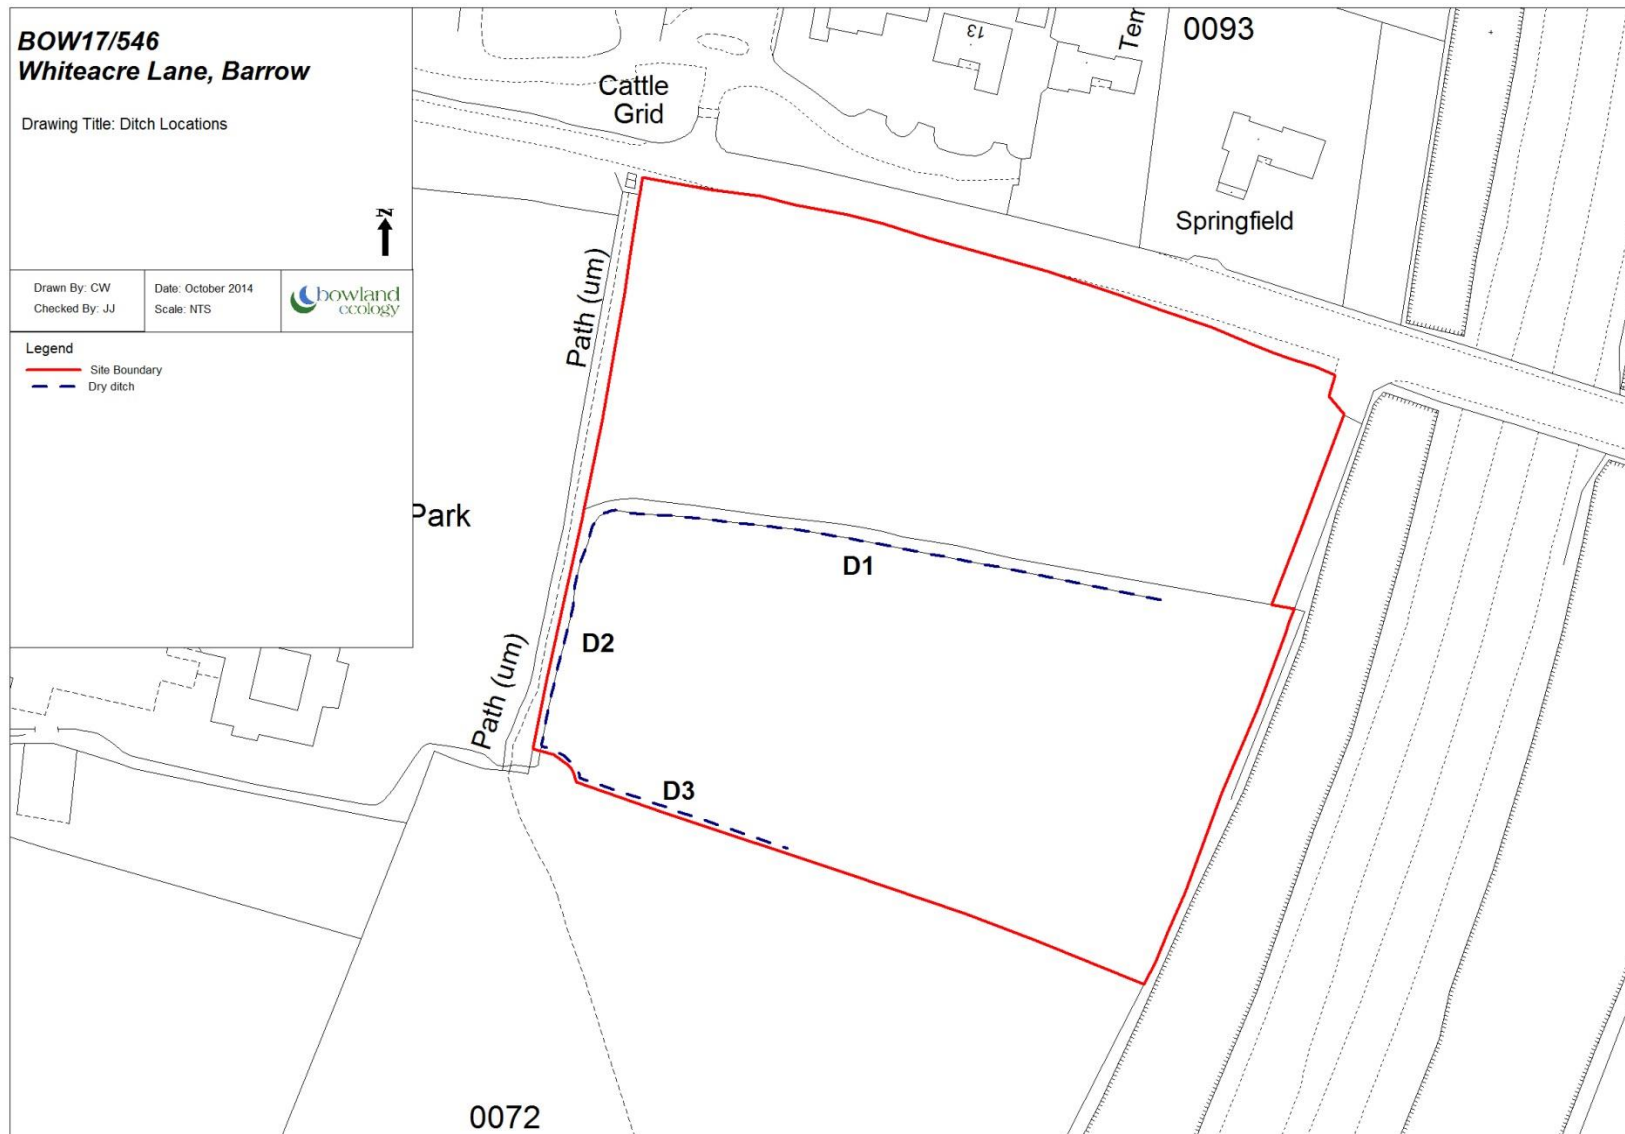
The three ditches were surveyed after a period of heavy rainfall, and were found to be dry and densely vegetated with Yorkshire fog (*Holcus lanatus*), creeping bent (*Agrostis stolonifera*) and cock’s-foot (*Dactylis glomerata*) (see Appendix A for locations of the three ditches).
