1232 Whiteacre Lane
Barrow, Clitheroe
Tree Survey Report

Document Control		
Client: Redrow Homes Lancashire	Drawing title: Whiteacre Lane Tree Survey	
Drawn by: James Davison, JD	Checked by: Kate Da Cruz, KC	
Project No: 1232	Project: Whiteacre Lane, Barrow	Date: August 2014

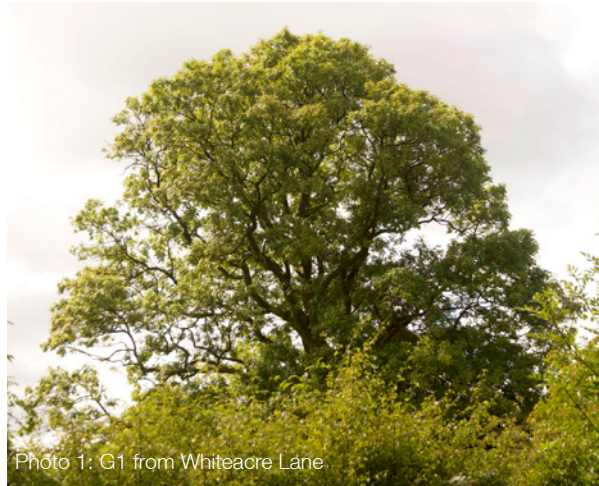
Photo 1: G1 from Whiteacre Lane.

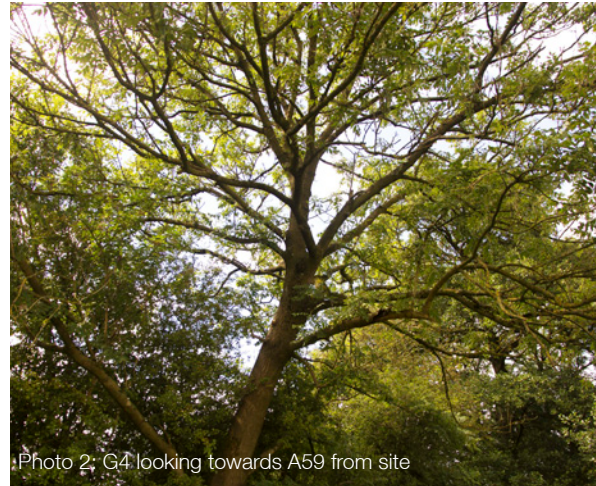
Photo 2: G4 looking towards A59 from site

- a large area of young to semi-mature trees containing Field Male, Ash and Hawthorn (G5);
- a small but relatively tall group of Grey Poplar (G4);
- a group of young, widely spaced, deciduous trees dominated by Ash (G6).

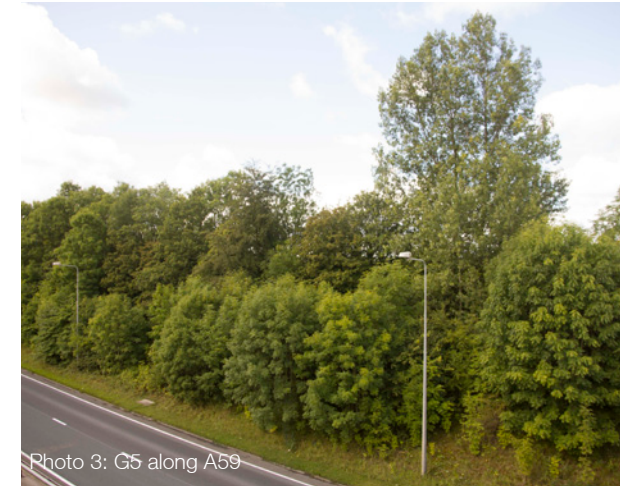
Photo 3: G5 along A59

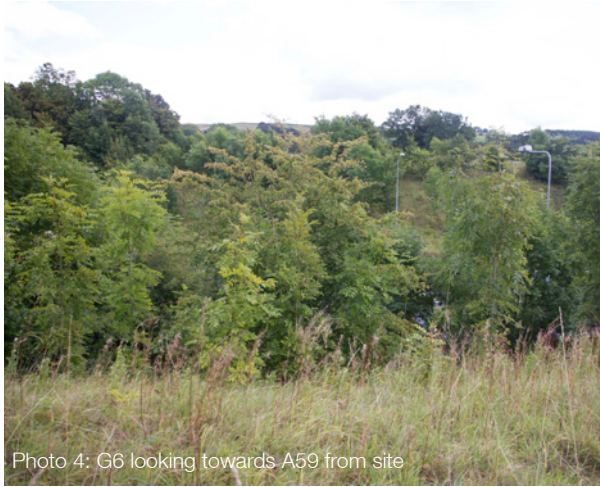
Photo 4: G6 looking towards A59 from site

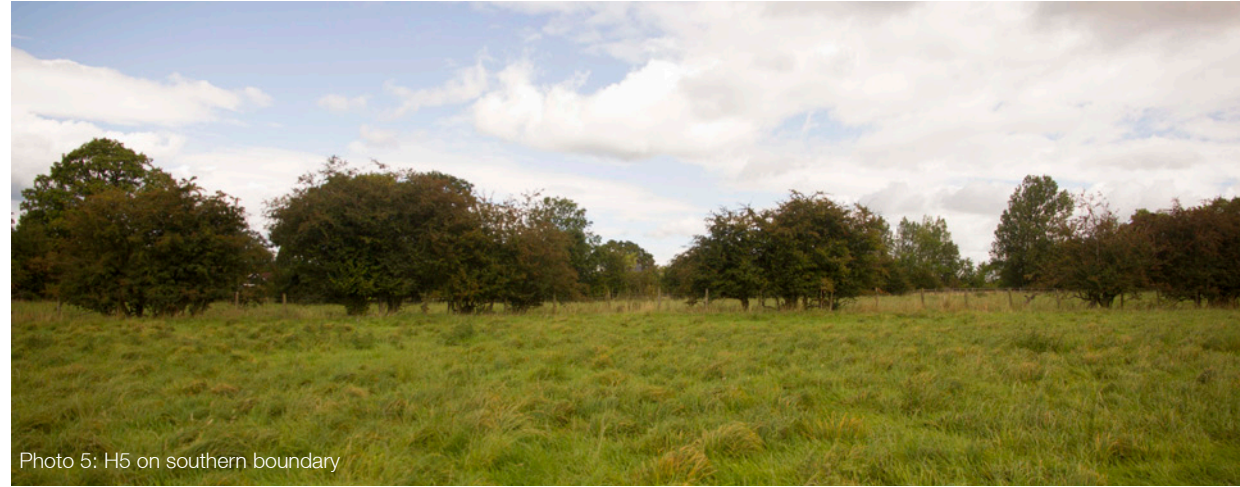
Photo 5: H5 on southern boundary

Along the southern edge of the site is a predominantly Hawthorn hedgerow with occasional Hazel and Elder (H5). This hedgerow is approximately six metres high and contains large gaps.

Hedgerows which are retained and contain gaps will be augmented by the planting up of gaps using a mix of locally native species.

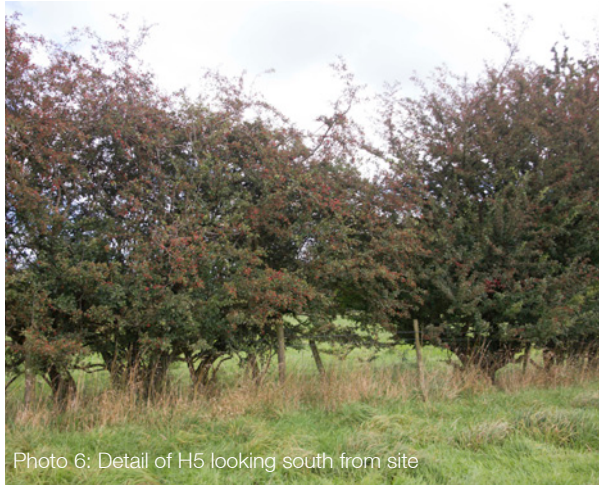
Photo 6: Detail of H5 looking south from site

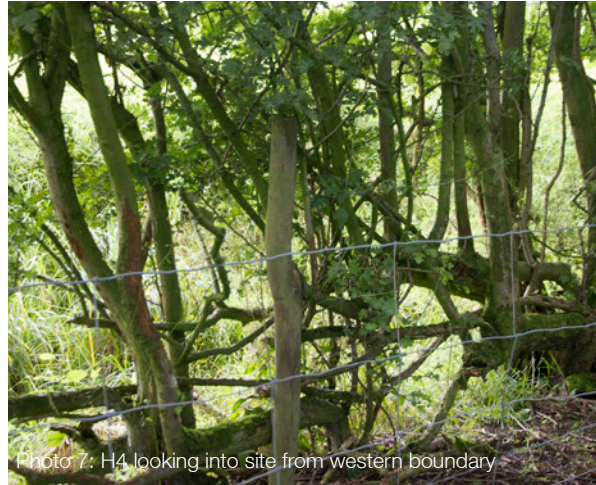
Hedgerows define the western edge of the site. The northern section of this boundary (H3) is gappy, about four metres high and contains Hawthorn, Elder and Hazel. The southern section of the western boundary (H4) is Hawthorn and approximately five metres high.

Photo 7: H4 looking into site from western boundary

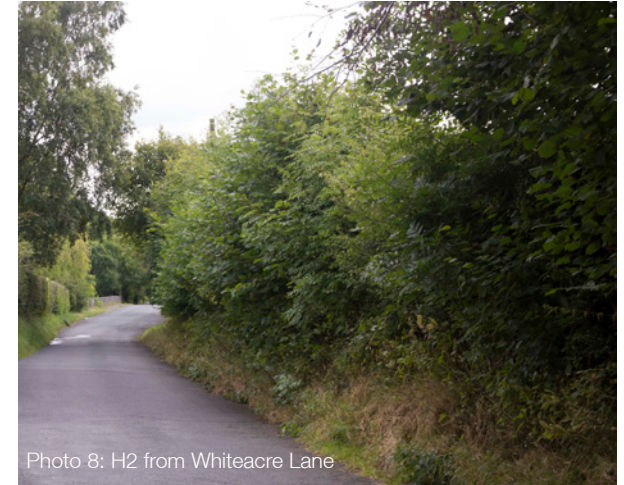
A hedgerow along Whiteacre Lane provides a boundary along the northern edge of the site (H2). This hedge is approximately five metres high and is predominantly Hawthorn with Hazel, Ash, Holly and Elder.

Photo 8: H2 from Whiteacre Lane

The proposed access arrangements will result in the need to remove trees and hedgerow along the northern boundary in order to create sufficient visibility for the new access point and to accommodate a footpath. The trees/hedgerows affected by the proposed access are low quality, category C (H2, G2 and G3).

A new hedge will be planted along Whiteacre Lane. It will be set back from the road beyond the sight lines for the new access. The new hedgerow will comprise of a mix of locally native species and contain native hedgerow trees.
