BAT SURVEY

**HIGH HOUSE FARM BARN 2
DILWORTH
LONRIDGE**

**DATE AND TIME OF VISIT
22nd Oct 2014 10.30 am**

REFERENCE NO. 4344

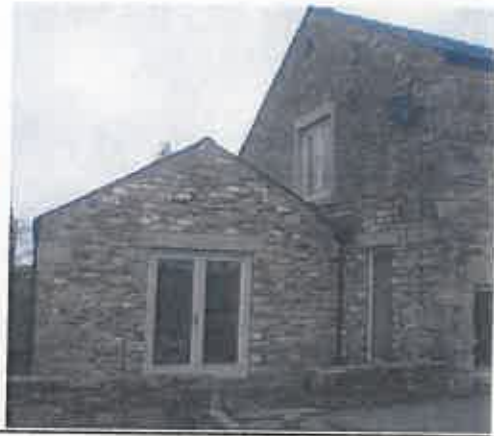
Garden room east elevation

The building is a barn building dating from 1871 which has been recently converted to a private dwelling the main barn is two storey and the garden room is a single storey section on the south elevation. Work on the garden room is not totally completed.

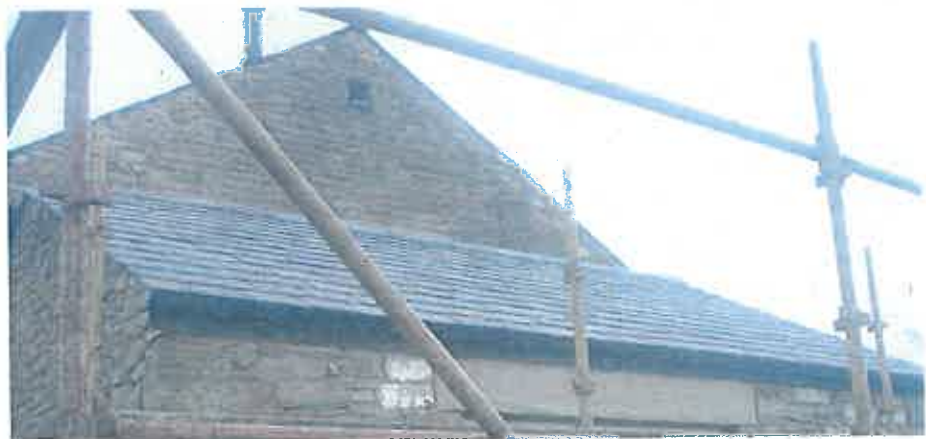
COMMENTS: The roof on the garden room which is being affected by the alteration is a pitched construction with a valley gutter at the abutment with the main barn wall. The finish is blue slate.

COMMENTS: There is a loose slate adjacent to the east gable, it was possible to inspect this area closely and to determine that bats do not use the crevice. The remainder of the roof is in good condition being relatively new with no access points.

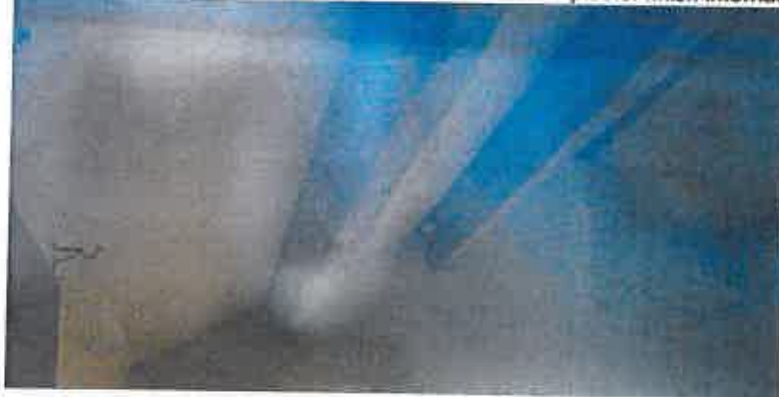
COMMENTS: There is no enclosed roof space in the garden room the ceiling is lined to the underside with plasterboard, the roof has not been finished off with a plaster finish internally.
