EUROPEAN PROTECTED SPECIES (EPS)

Far Laithe Barn, Hill House Farm, Grindleton. (NGR: SD 764 465)

Survey date: 27 May 2014

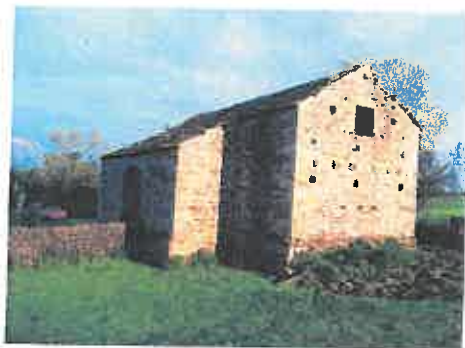
Figure 2: north-west elevation

Internally, the building has an earth floor and all areas are compacted, damp and heavily manured. The main wagon entrance (figure 2) is cobbled and the wagon door is absent. On the north-west gable end is an unglazed window; there is a single timber door on the west elevation. The building is cool and very well-ventilated /draughty and there is considerable natural light inside the building (figure 7); there are no enclosed voids or areas without natural light.

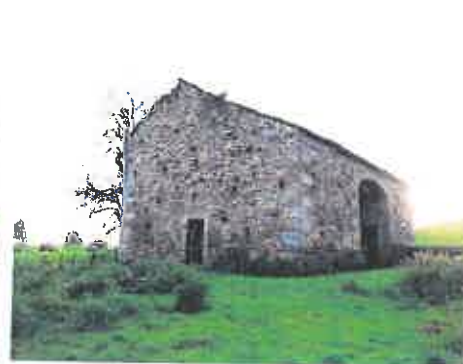
Figure 4: south-east elevation

Stonework inside and outside the barn is mortar-pointed although lack of maintenance has resulted in many obvious gaps in the stonework. Ventilation holes are also present throughout the building (figure 4).

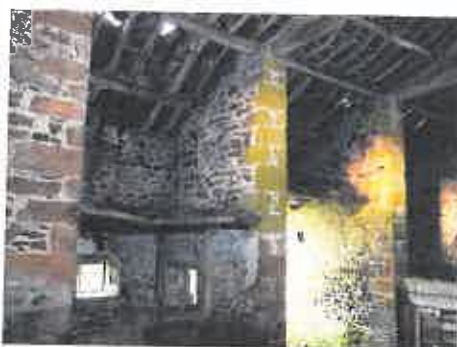
Figure 6:

Approx. 15% of the stone slates are absent or displaced (figures 7 to 10). The roof has many gaps and significant ingress of water has caused damage to the timber haylofts inside (figures 6 and 7). Three lofts are present: (1) a small hay loft is situated above the entrance porch, (2) another small loft is located beside the wagon entrance, (3) a larger loft is located on the south-east gable, this forms an under-croft with cubicles beneath (figure 8).

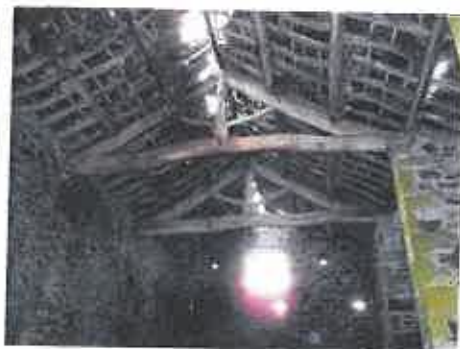
Figure: 7

This is a 4-bay detached stone barn (figure 7) with traditional rubble-infill wall construction and duo-pitched stone slate roof. The timber post-and-truss frame supports a rafter-with-purlin roof. The stone slate roof is unlined and there is considerable damage to the roof particularly along the line of the ridge.
