# **HERITAGE STATEMENT**

**IN SUPPORT OF A PLANNING APPLICATION TO  
CONVERT TWO BARNs TO TWO DWELLINGS**

**LITTLE DUDLANDS FARM,  
RIMINGTON LANE,  
RIMINGTON,  
LANCS, BB7 4EA**

**Janet Dixon Town Planners Ltd.  
144 Woone Lne  
Clitheroe  
Lancashire  
BB7 1BN**

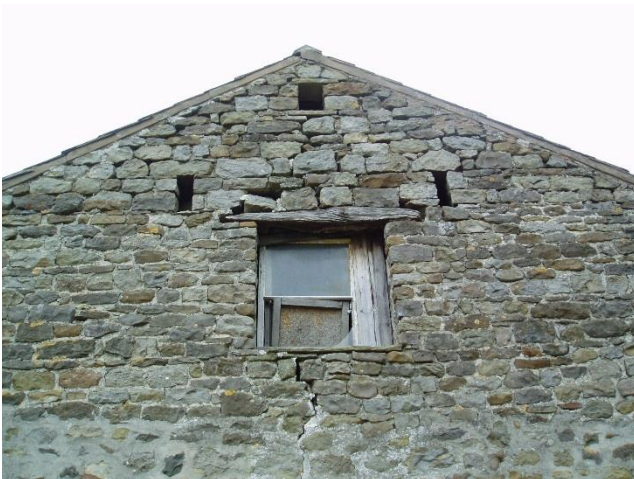
Eastern gable north barn

The barns are constructed out of random stone with stone detailing around the openings with evidence of breathing holes in the north barn. Both barns have wagon entrances from

the farm yard into the barn. The north barn has a plan square head wagon opening in to a full height storage area. The western gable has breathing holes and an owl hole above a forking hole beneath the ridge. This barn appears to have been constructed in two sections because the ridge lines do not run through. The left hand end has the wagon entrance and the right hand end appears to have been designed and using for animal housing. At the right hand end of the barn there is a door in the southern elevation which leads into stables. The detailing around the door is chamfered and is similar to the detailing around the farmhouse door opposite. To the right of the stable door are two breathing holes one which has been modified to create small windows. The right hand end of the barn has a first floor over the stable and stalls and a lean-to shippon at the rear with concrete stalls. The shippon has two entrance doors in the gable and three windows in the northern elevation. An internal door leads from the shippon into the main barn area against the north side of which is another small lean-to providing a small pen.

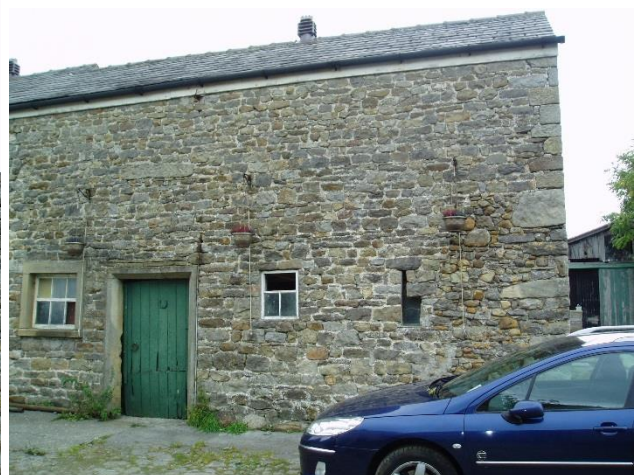
South elevation north barn

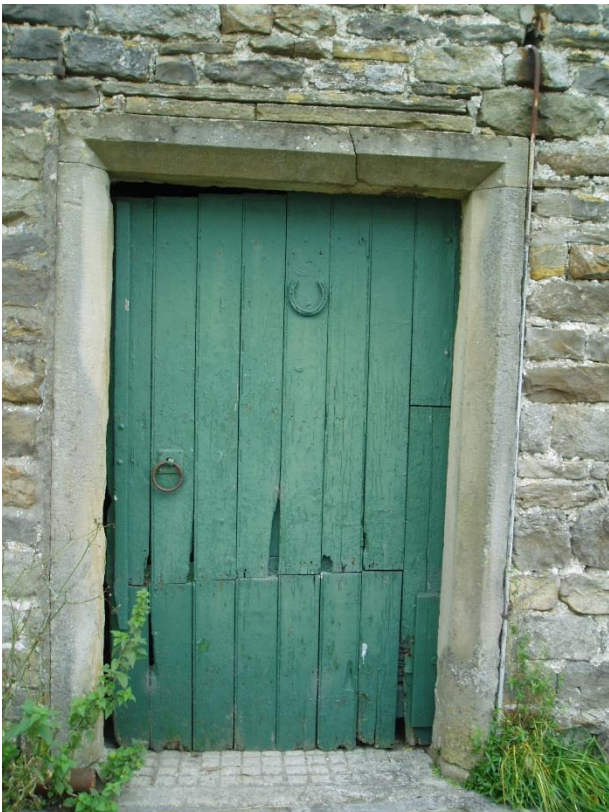
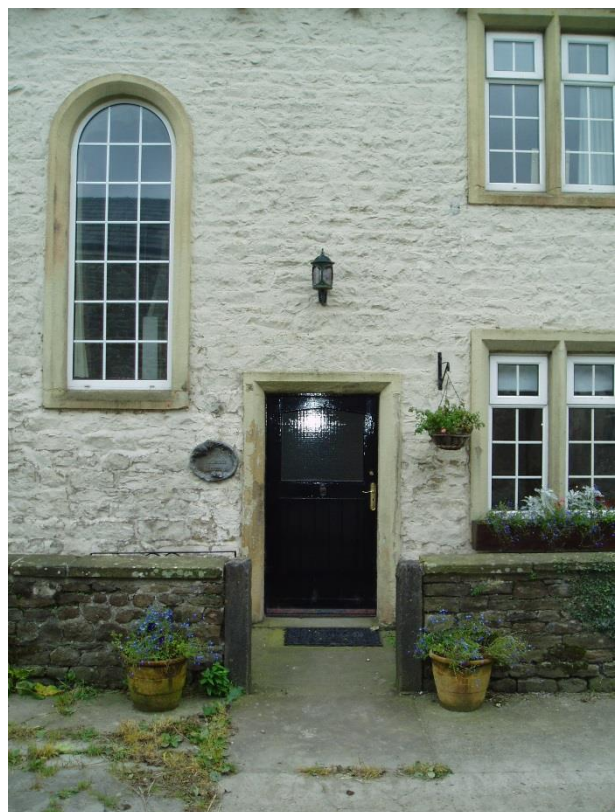
Stable door north barn surround detailing similar to farmhouse door opposite

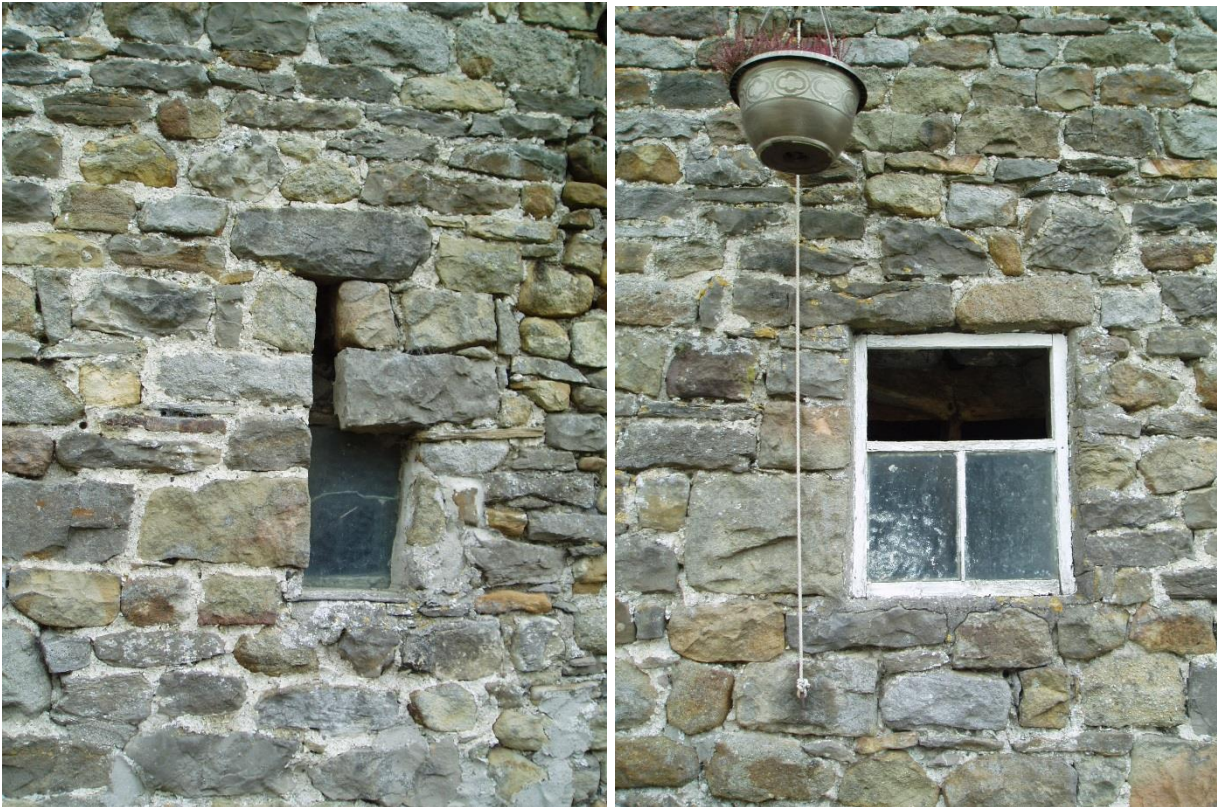
Breathing holes modified to create small windows.

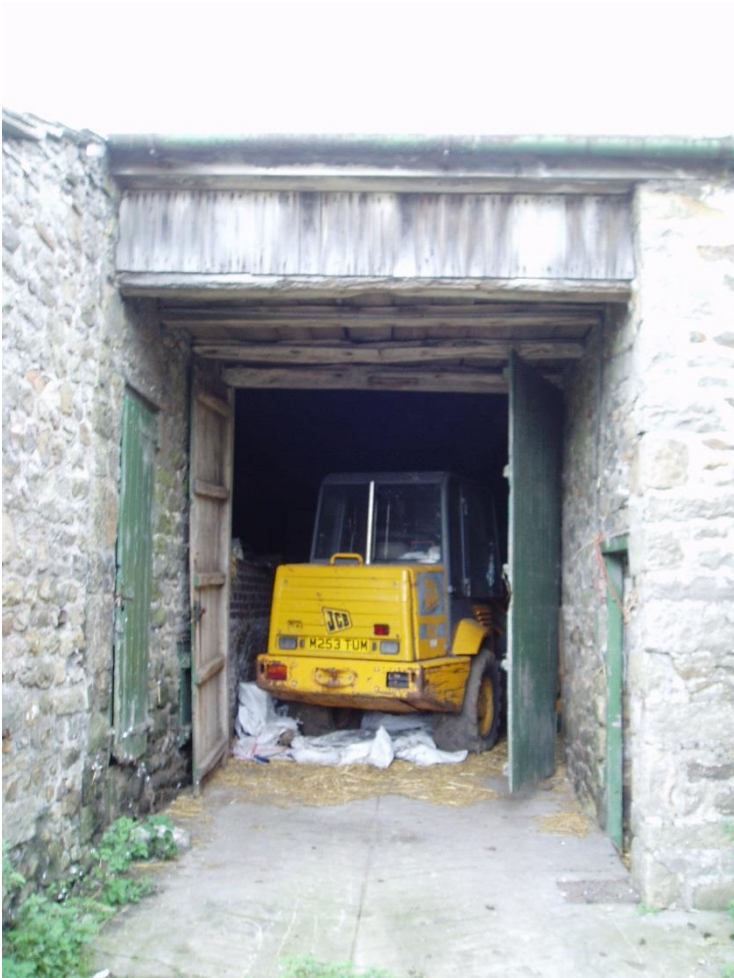
West barn wagon entrance

The west barn has wagon entrance in the east elevation into the farm yard with a corresponding door on the western elevation. The east wagon entrance has the barn doors set back beneath a canopy to the right of this entrance is a stable with loft over. To the right is a raised doorway with internal stairs to a harness room and workshop.

The covered wagon entrance opens into the main barn which is two storeys high. The roof is carried on three king post trusses. The right hand side of the barn is open storage the lower left hand side would have originally had cattle stalls with a central isle which is now used for stabling with a loft above. This area of stalls is lit from two ground floor windows in the gable and a single window in the rear elevation. The area beneath the harness room has access from the gable end and is lit by two small windows facing the farm yard. In the northern gable of the building there is a single owl hole. The roof of the barn is covered in stone flags laid in diminishing courses. Attached to the northern gable of the barn is a single storey is a brick built lean to shippon. The OS maps suggest that this was built after 1911. Looking at the condition of this part of the building it is likely that it was constructed in the early twentieth century.

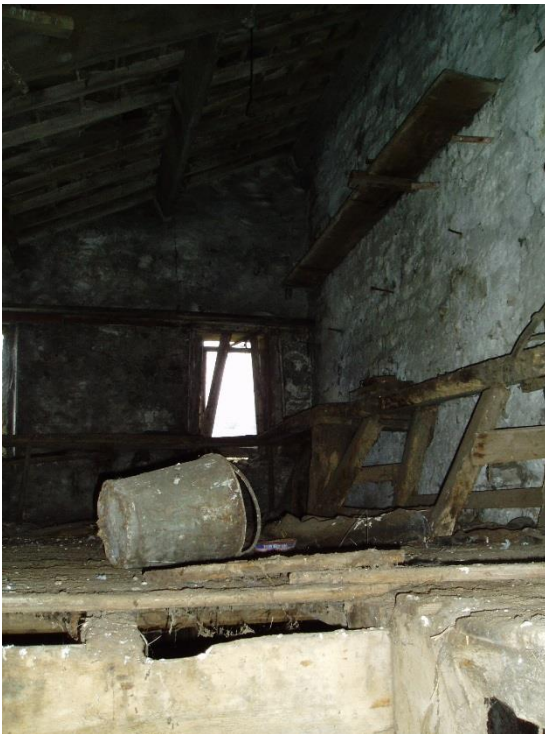
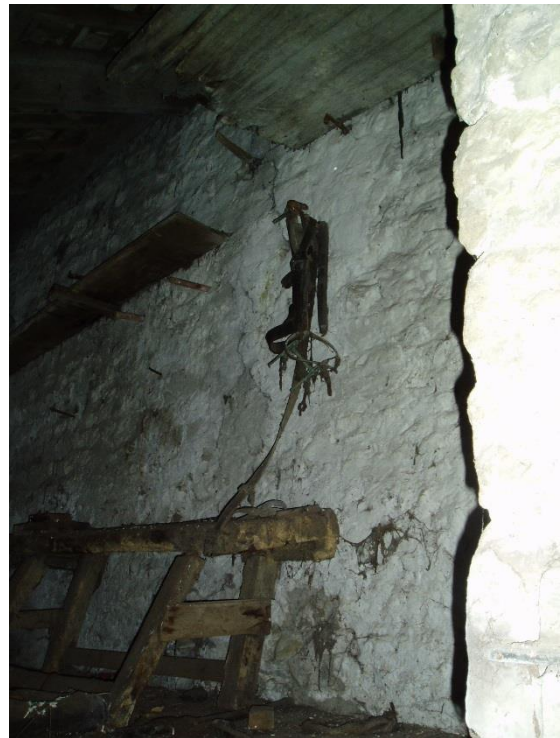
Harness room and workshop

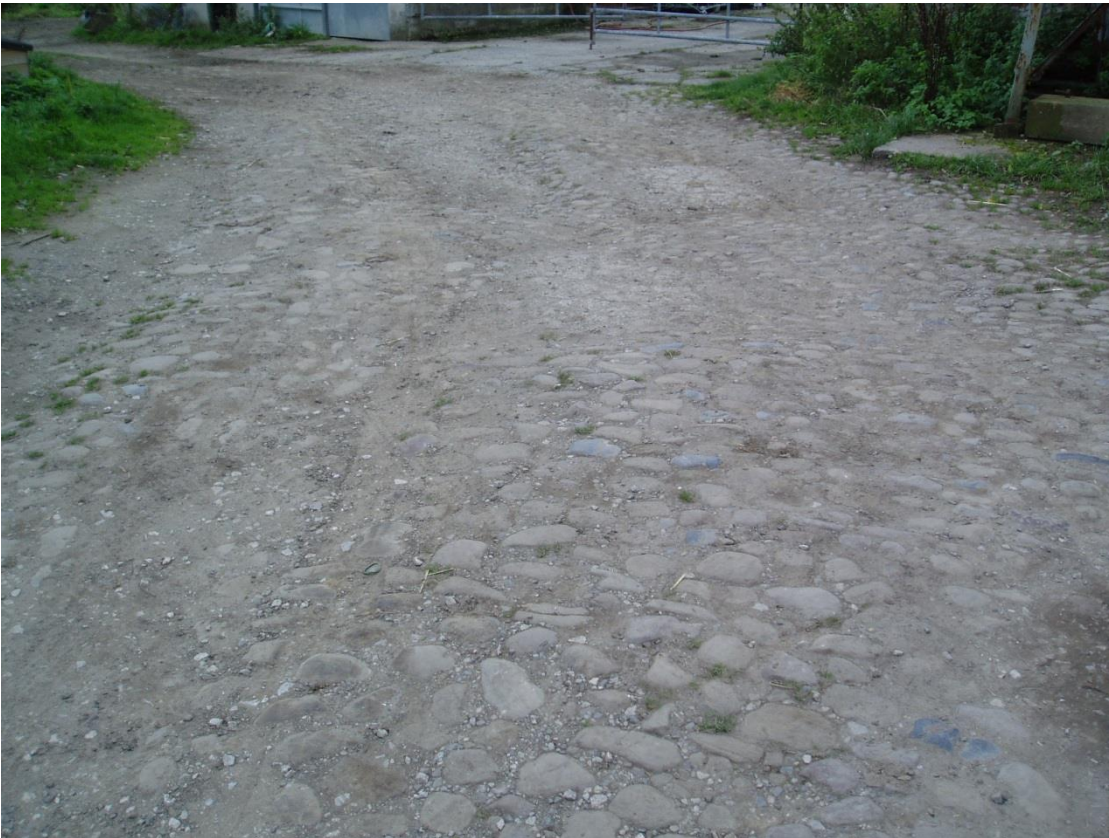
Cobbled surface of the farm yard

The two barns and the farmhouse stand round a farmyard. This appears to have been originally covered in cobbles. The farmhouse has particularly good stone walls around the garden. At the rear is a low stone wall with flat topped copings. At the front of the farmhouse there is a low stone wall with round coping which dramatically sweeps up at the corners to meet the high stone wall along the gable side garden walls which also forms the back of the domestic outbuildings.

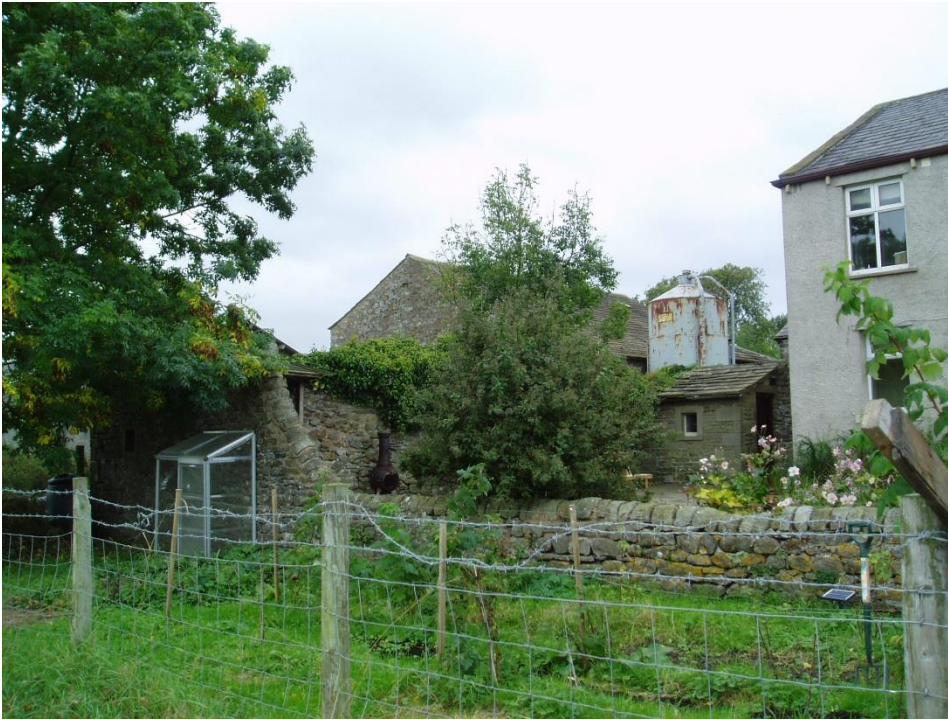
Unusual boundary wall to garden with swept ends.
