Protected Species Survey at 1, Beech Grove, Chatburn BB7 4AR 19th February 2015

Undertaken by Joyce Gillies

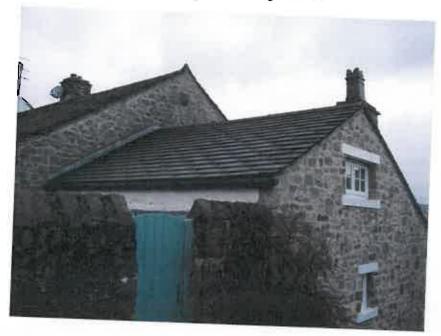
Figure 1 - The Easter gable.

The end terrace cottage has a single storey part at the northern end.(Fig 1Eastern elevation and Fig 2 Northern elevation)

The outside roofline, gutters, gaps in the structure were inspected using a powerful torch and binoculars, as it was just above head height.(see fig 1)

No signs of bats were seen anywhere on the gable end, at the front or the rear roof or guttering (fig. 1).

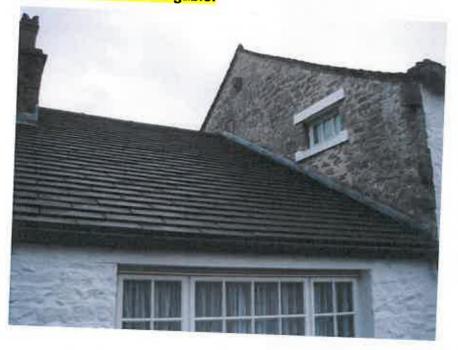
Figure 2 - The Northern Elevation.

No bats were seen or heard anywhere around the property at emergence time. A chimney emerged through the roof on the northern aspect(fig2), this had lead flashing round the base. It was not possible to inspect under the lead. Care must be taken to LIFT THIS CAREFULLY to look closely under it for small bats, during any work.

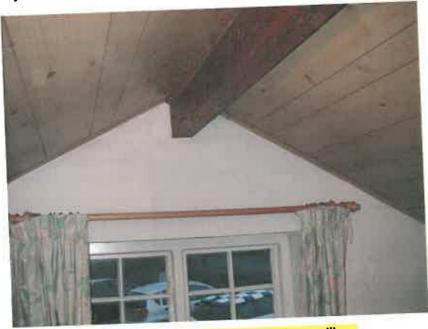
Fig 3 Inside the bedroom with lined sloping ceiling.

The inside of the bedroom ceiling was sloping and directly below the roof slates. It was lined with 'boards' which fitted directly up to the eaves.(fig 3) This join was intact and gave no access into the main bedroom.

No evidence of bat use was found on the bedroom walls (fig3). Nor the breeze block/roof junction or on objects stored under the eaves (fig 4).

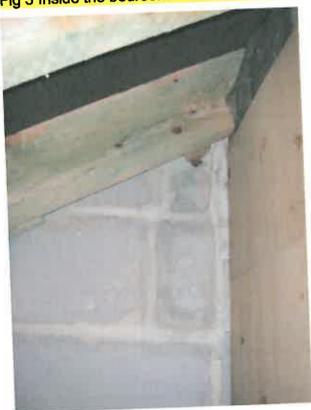
Fig 4 Storage area

To the left, under the eaves, was a separate boarded off section accessed through a small door. At the far end was a breeze block lining to the gable end wall(fig 4)

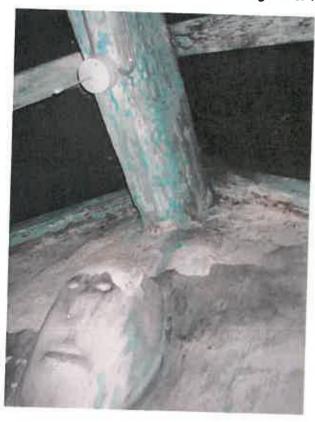
Fig 5 Inside the main loft.

To raise the roof of the Eastern end of the property, to make a bigger bedroom etc. . It will not quite reach the existing roof line of the main part of the house, but the inside of the loft in the adjoining gable was surveyed(fig 5), as the new roof will have to link into this wall.

The newly raised roof will come just below this gable, on the other side of this wall.
