**BAT SURVEY**

**DUNSOP BRIDGE TROUT FARM WORKSHOP  
WHITWELL ROAD  
DUNSOP BRIDGE  
CLITHEROE**

**DATE AND TIME OF VISIT  
28<sup>TH</sup> NOV 2014 10.00am**

**REFERENCE NO. 4603**

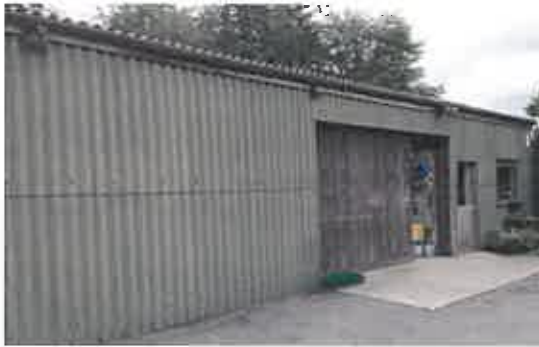
South elevation

The building is a portal frame, corrugated steel clad building with a small block built office section within, to the east end. The building built in 1992 is a functioning workshop used during working hours by the Trout farm business.

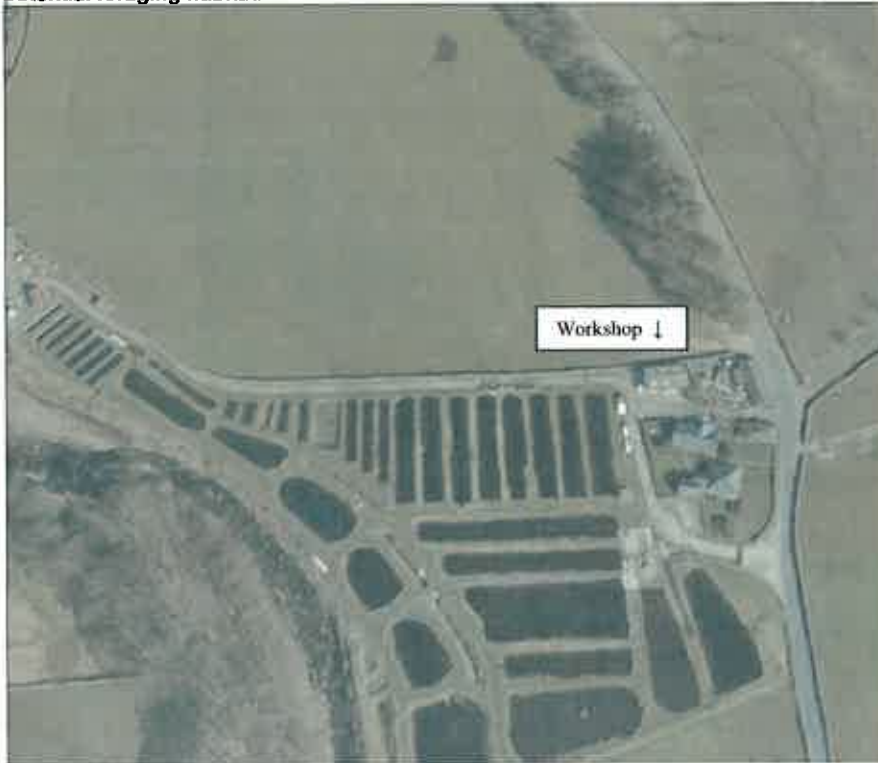
**COMMENTS:** Steel portal frame with corrugated steel cladding.

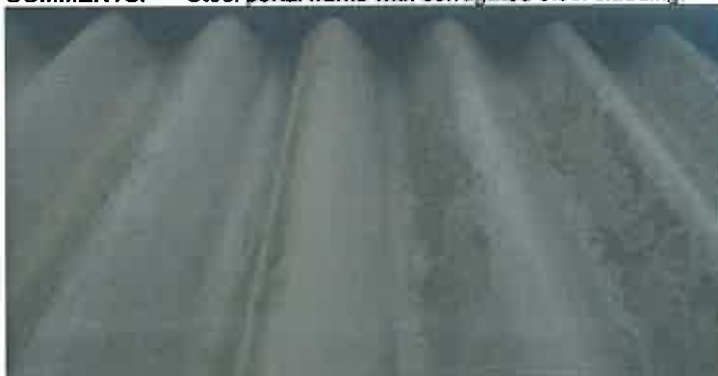
**COMMENTS:** There are no access points in the walls. During working hours the doors are open.

**COMMENTS:** The roof is corrugated fibre cement fixed to timber purlins and steel portal.

COMMENTS: The sheets are in good condition with no access points.

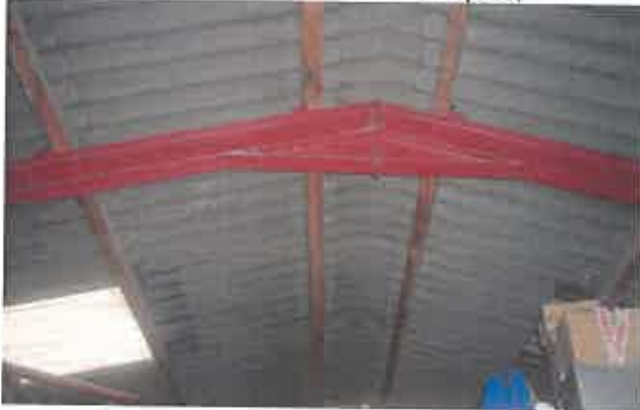
COMMENTS: There is no enclosed roof space.

COMMENTS: The ground surrounding the building and the external walls were examined for signs of bat entry ie. droppings or grease marks / urine staining. No signs where found

COMMENTS: The building being a functioning workshop subject to regular cleaning had no dropping or insect feeding evidence.
