**BAT SURVEY**

**AT  
COUNTY HOUSE  
SIMONSTONE LANE  
SIMONSTONE  
BB12 7NX**

**DATE AND TIME OF VISIT  
21<sup>st</sup> April 2015 3.30 pm**

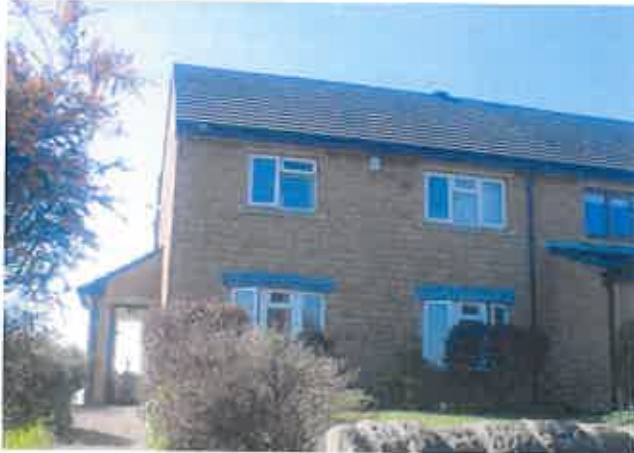
The property is a semi detached house built in 1996. It has a lean-to porch to the side and a single storey lean to across the rear elevation of the property. Part of the rear lean- to is a garden room with a plastic roof.

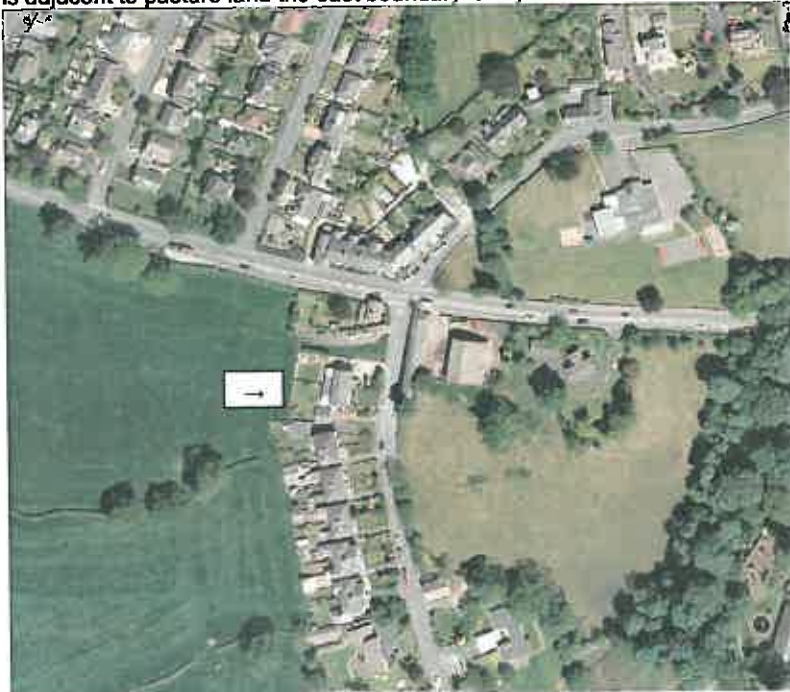
COMMENTS: The property is located on the outskirts of the settlement area of Simonstone. The west boundary is adjacent to pasture land the east boundary is adjacent to Simonstone lane with pasture land beyond.

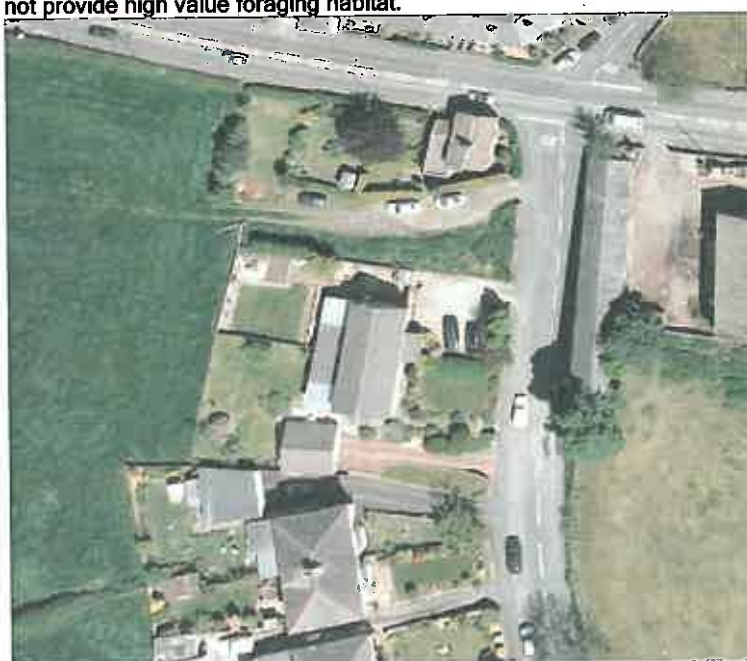
COMMENTS: The house is located in a garden laid to lawns to the front, rear and side. There is some domestic shrubbery in the front (east) garden between the path/ drive, it provides low value foraging habitat. There are a couple of mature trees to the East on the opposite side of Simonstone lane. There is extensive mature woodland located approx 100m to the east of the house running from north to south. The immediate locality generally does not provide high value foraging habitat.

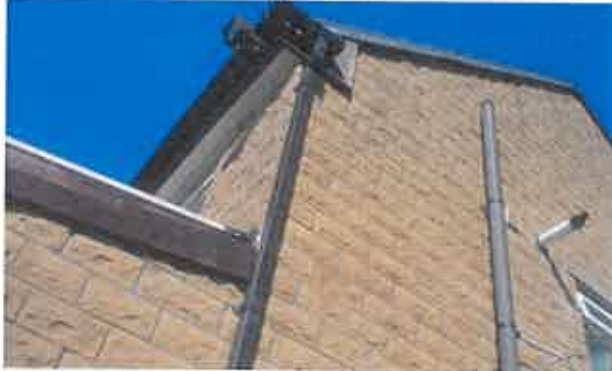
The walls are coursed natural stone.

The stone and pointing are in perfect condition with no access points for bats.

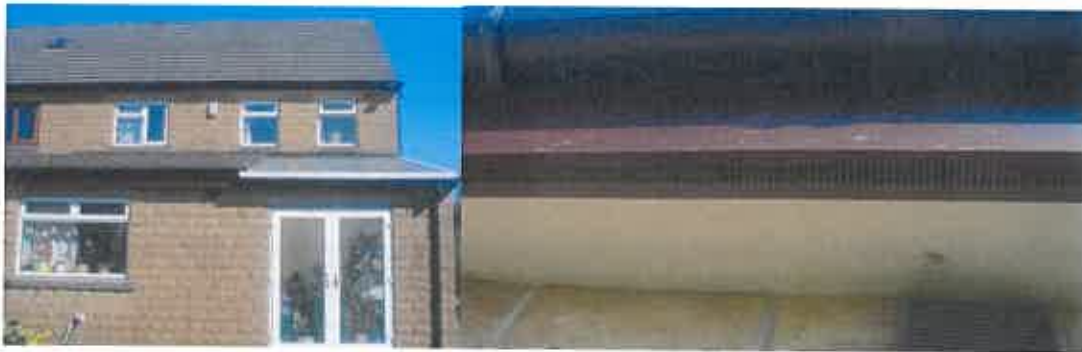
**COMMENTS:** The main roof is a tiled pitched construction with ventilated eaves overhang and boarded soffits. The single storey rear lean-to has a tiled finish over the kitchen section and clear plastic finish over the garden room.

The tiled roof is in perfect condition with no slipped or loose tiles. The soffits are very good condition and tight fitting as illustrated. The plastic roof covering and associated flashings have no gaps or access points.

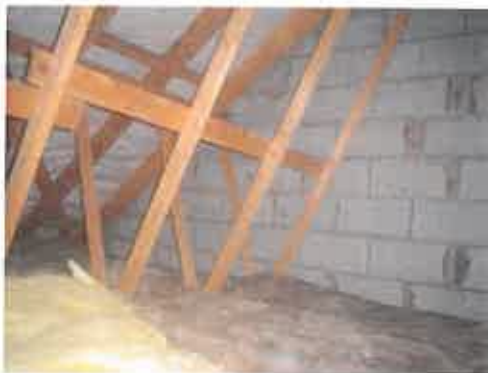
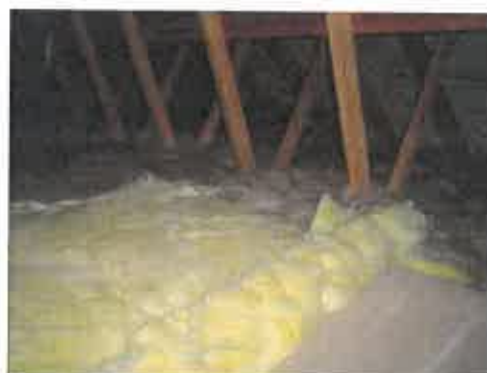
The roof is trussed rafter with felt over the ceiling joists. The space is very clean dust and debris free there was no sign of any droppings or feeding evidence on the insulation quilt. The timbers and felt are in perfect condition.

COMMENTS: The roof space was thoroughly examined for all the above listed signs. The quilt was inspected for dropping or feeding evidence, nothing was recorded.
