Protected Species Survey at 27, Caulder Ave, Billington, Nr Whalley

11th June 2015

Undertaken by Joyce Gillies

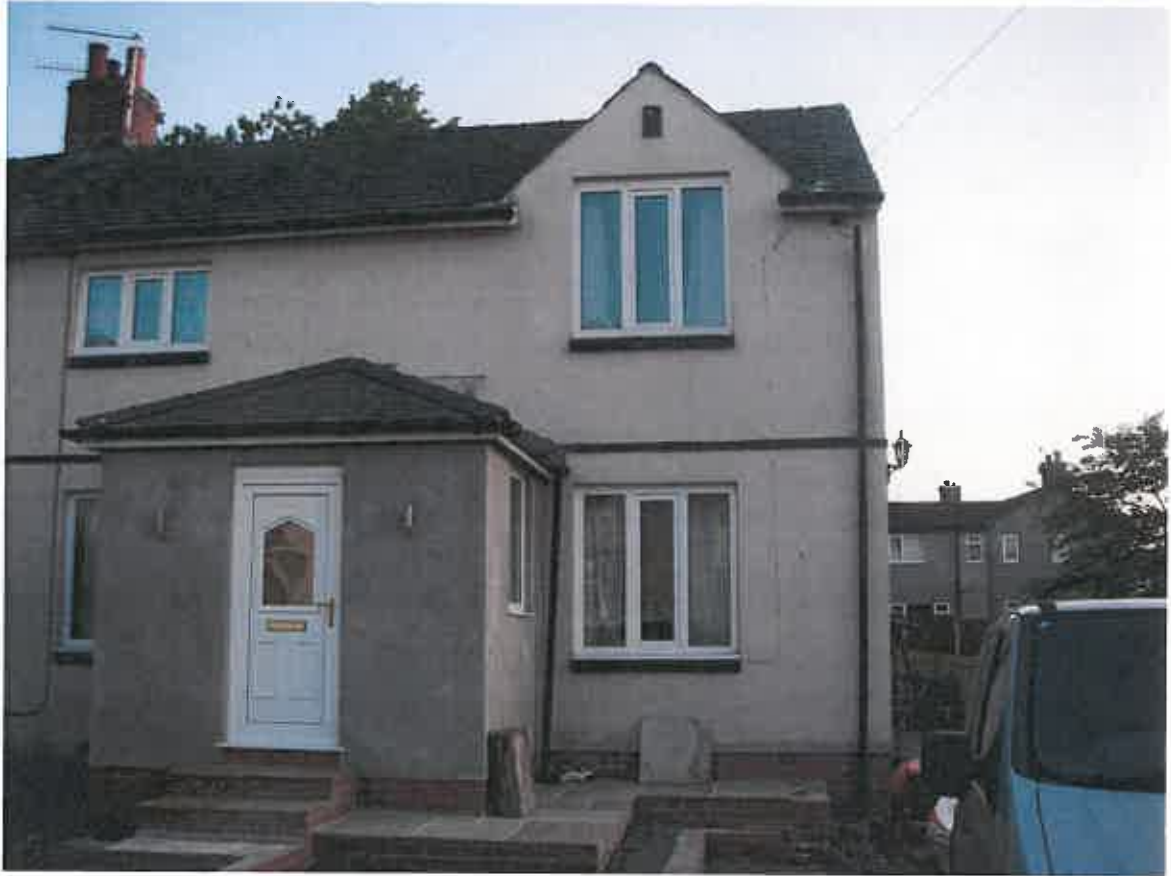
Figure 1 – Front View

The outside roofline, gutters, gaps in the structure were inspected using binoculars, from the front, side and back.(fig 1,2+3)

No signs of bats were seen emerging from anywhere on the house, at the front (fig 1), back (fig 3) or the gable wall (fig 2).

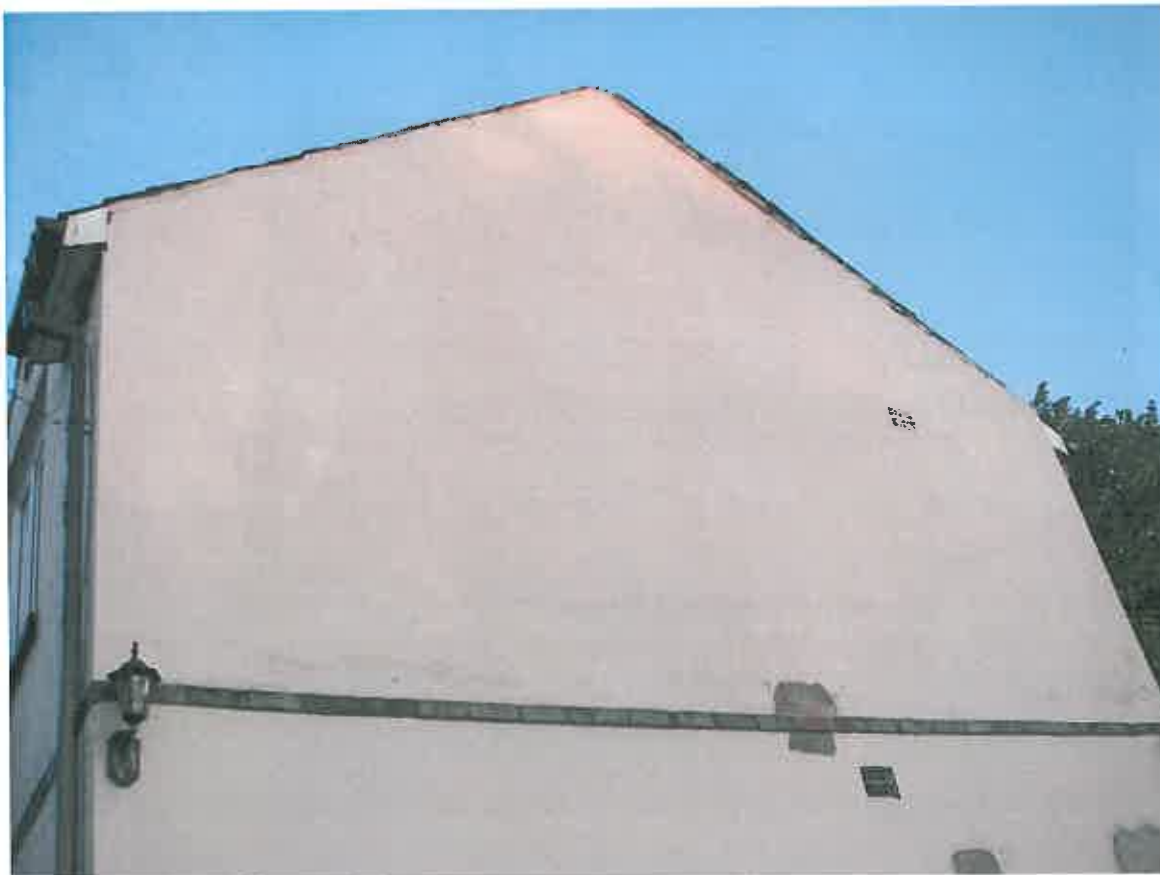
Figure 2– Side View Gable End.

The existing , two storey house is rendered from the ground to the gutter and all the gable end wall. It has a pitched, tile/slate roof to which the render joins with no barge board below, on the gable end.

The gable end wall was catching the prevailing wind and therefore would not be first choice as a maternity roost.

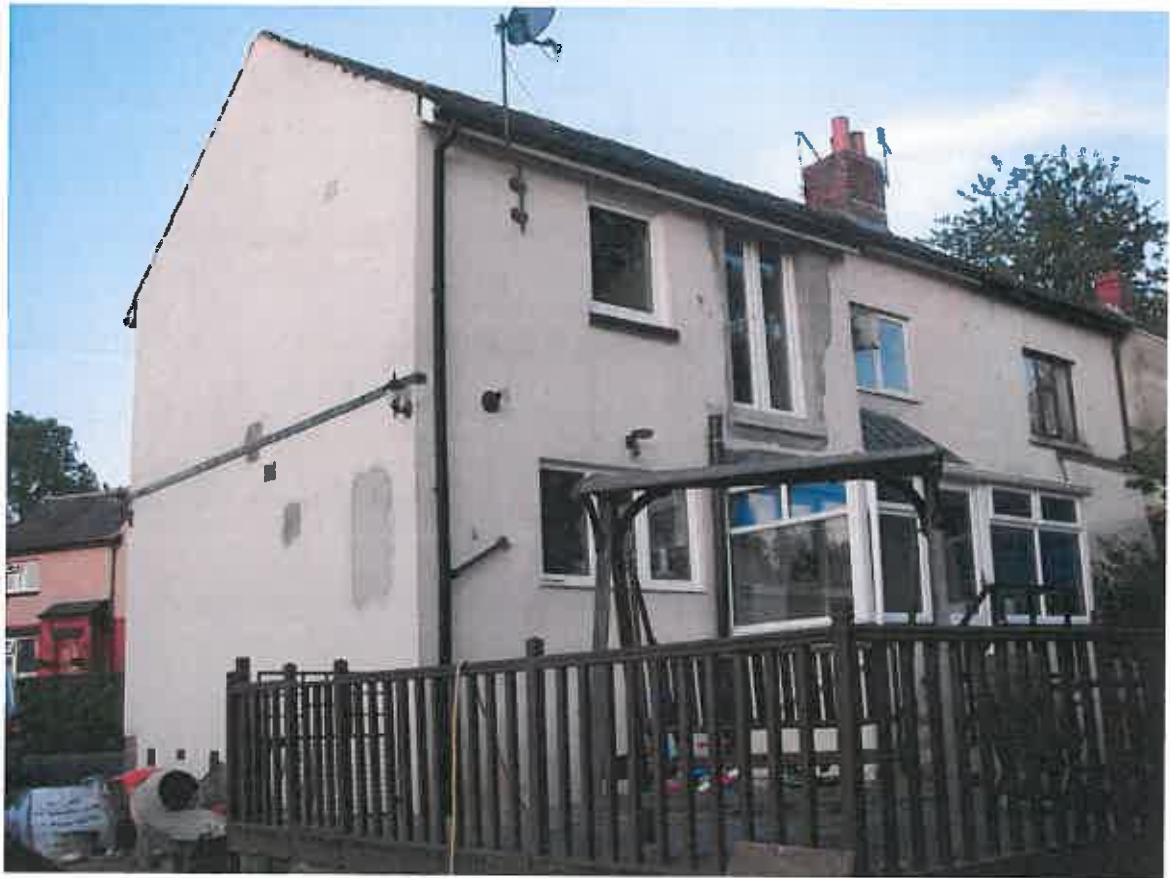
Figure 3 : Rear View

This bat was observed feeding in the shelter of the new fence at the rear of No27, one other bat was seen and heard as the evening cooled.

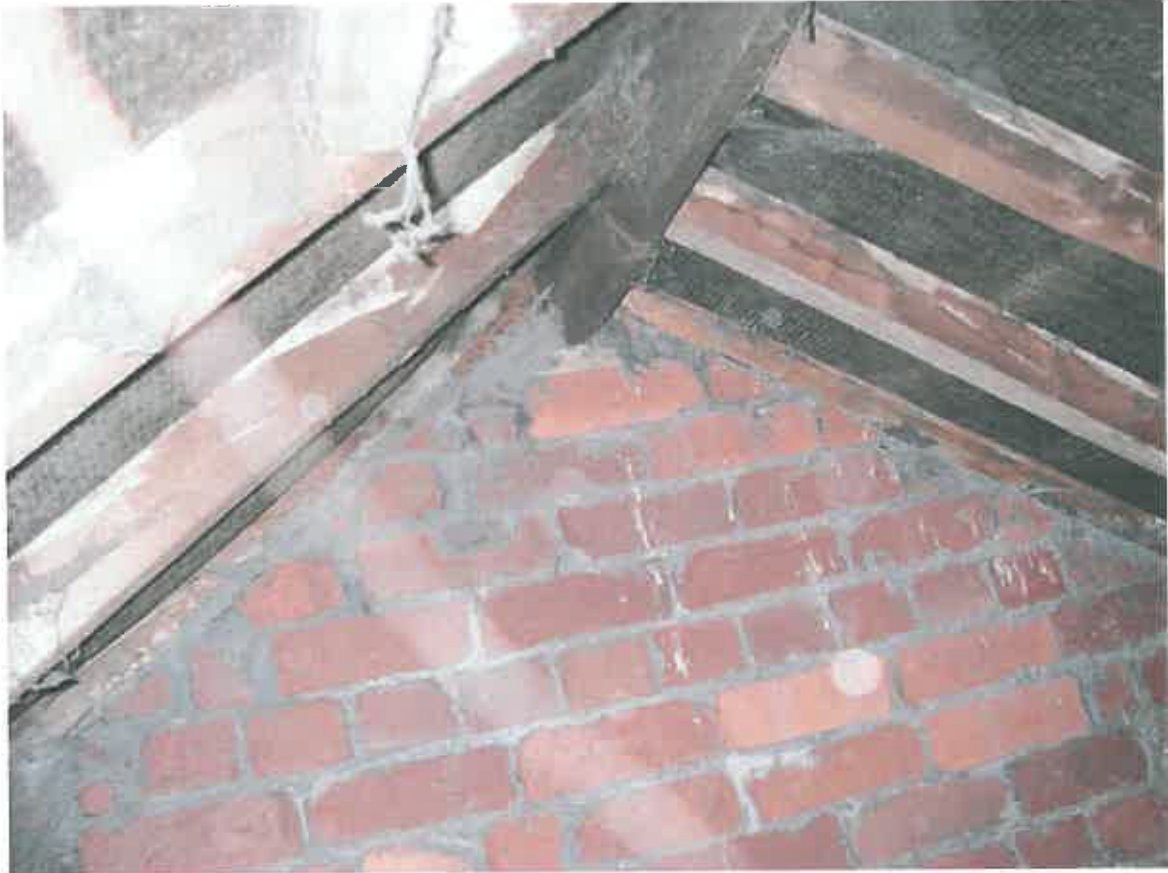
Figure 4: Interior Gable End

The brick work on the internal gable end wall was clean, apart from many, heavy spiders webs.(fig 4)

No evidence of bat use was found on the brick wall or the objects stored in the loft.
(fig 4)

This would have been droppings on the insulation or bricks or on the hanging spider's webs, snapped- off moth wings or odour of bats.

Clean, complete, roofing felt lined the tile/slate roof.
