320150453P

## HERITAGE STATEMENT

### PROPOSED CONVERSION OF A REDUNDANT FIELD BARN (BROOK WOOD) INTO A SINGLE RESIDENTIAL DWELLING.

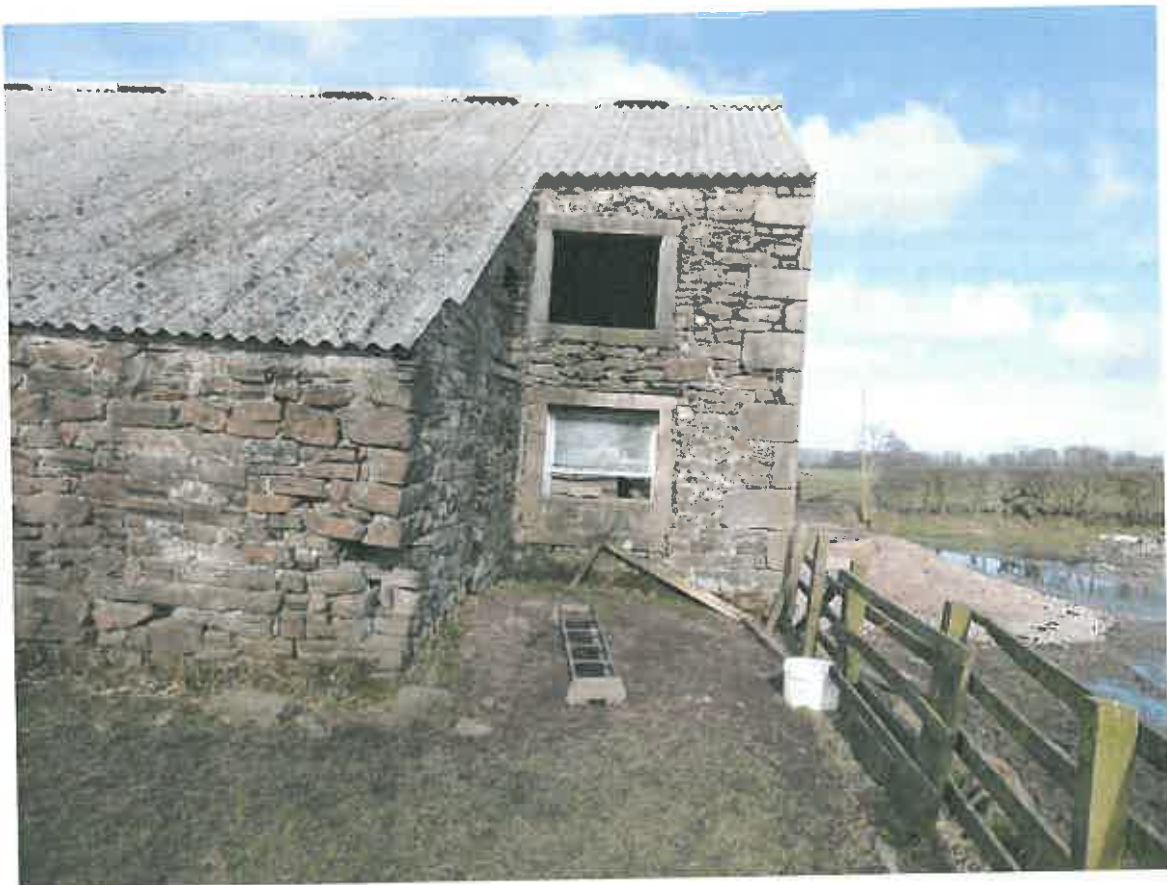
The windows illustrate the two storey living accommodation.

The living area is at the east end of the building and offered two storey accommodation. The barn has a central area which is currently the full height of the building and then a cow byre to the western end with stalls where animals would be tied up through the winter with a loft above where hay would be stored.

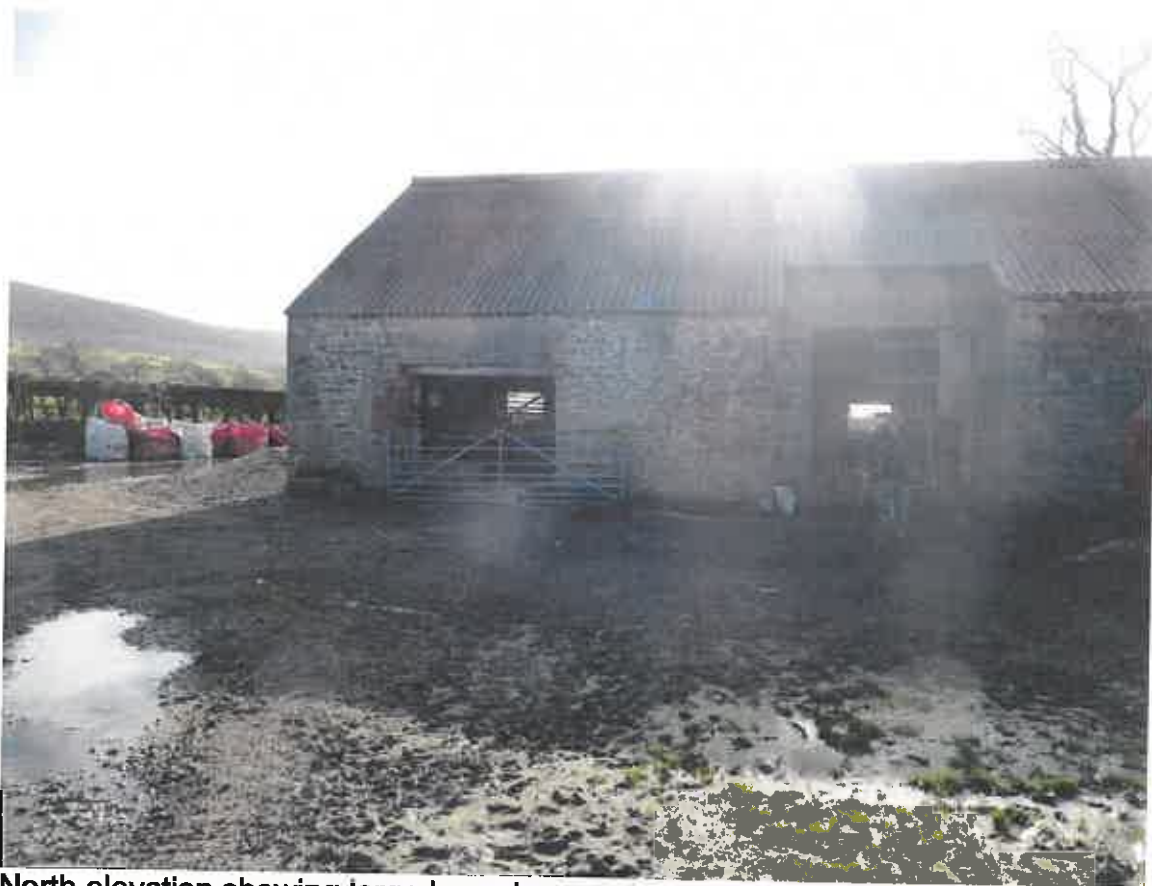
North elevation showing large barn door.

The large central area is accessed by a large barn door through which a hay cart could be backed into the building for unloading. There is an additional lean to on the south elevation which also would have been used to house cattle. There is a small door to the rear of the barn which opens to the outside adjacent to the entrance to this byre. There are a number of ground floor windows around the areas where cattle would have been housed as well as a small door on the north elevation to give access to the byre for both livestock and the farmer.

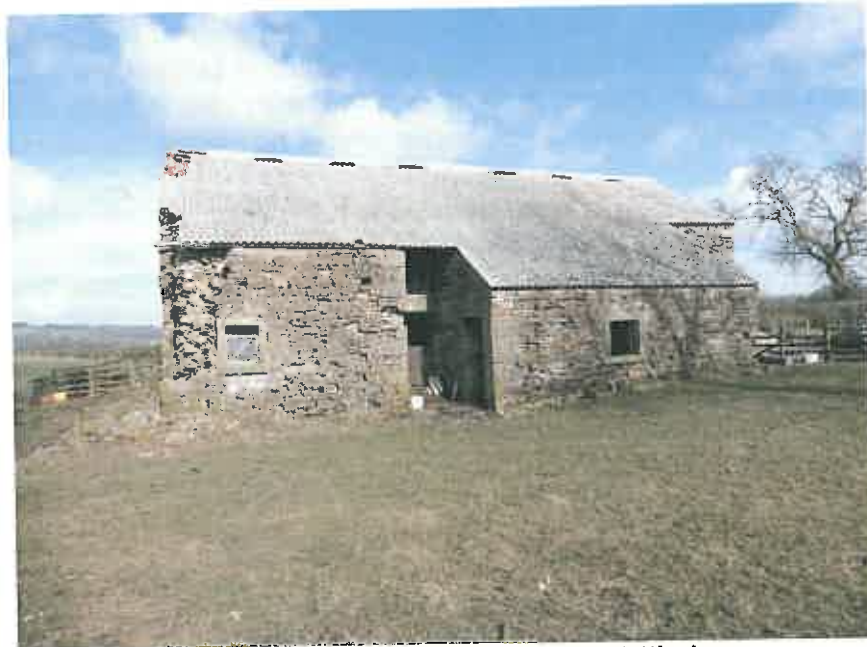
South elevation showing lean to cattle byre

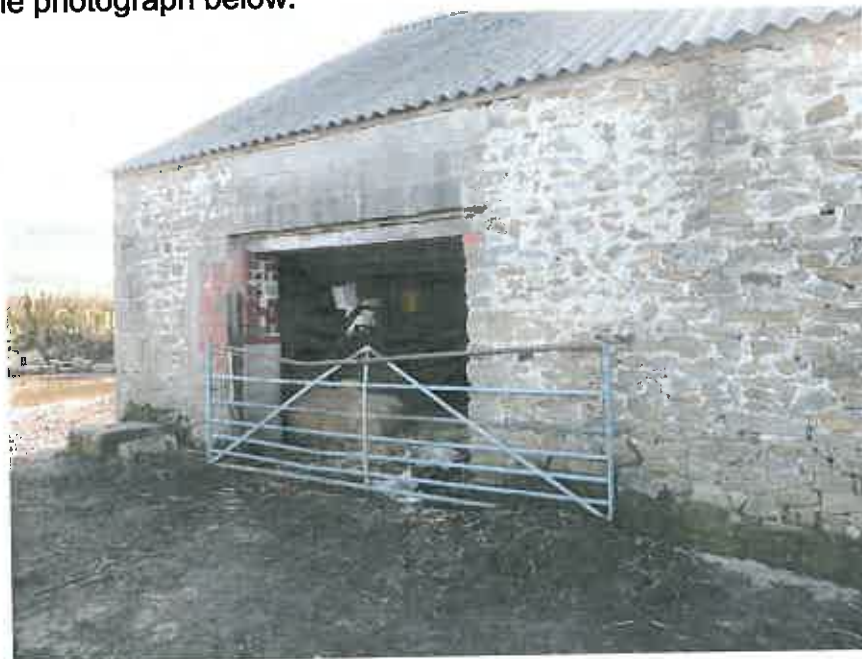
The only major structural alteration has been on the north elevation on the ground floor of the living area where a large opening has been made to allow easier access when the barn was still used to house livestock. The entrance has a timber lintel with some of the supporting wall being replaced with bricks and cement blocks above the lintel. See the photograph below:

As discussed above the barn is in good structural condition with the exception of part of the east gable. The structural survey provides more detail. The stone work is roughly squared rubble with the small area of brick and blocks around the new entrance.
