BAT SURVEY

**REAR OF
17, 19, and 21 KING STREET
WHALLEY**

**DATE AND TIME OF VISIT
14TH May 2015 8.45 - 9.40 pm**

REFERENCE NO. 3980

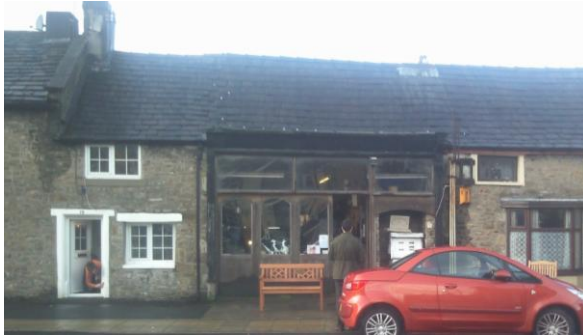
Shop elevation to King street

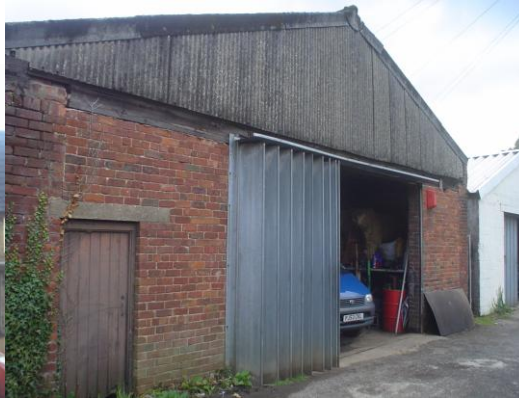
Rear elevation of portal buildings

COMMENTS: The largest building is brick built with corrugated fibre cement gables. The smaller building is constructed in blockwork.

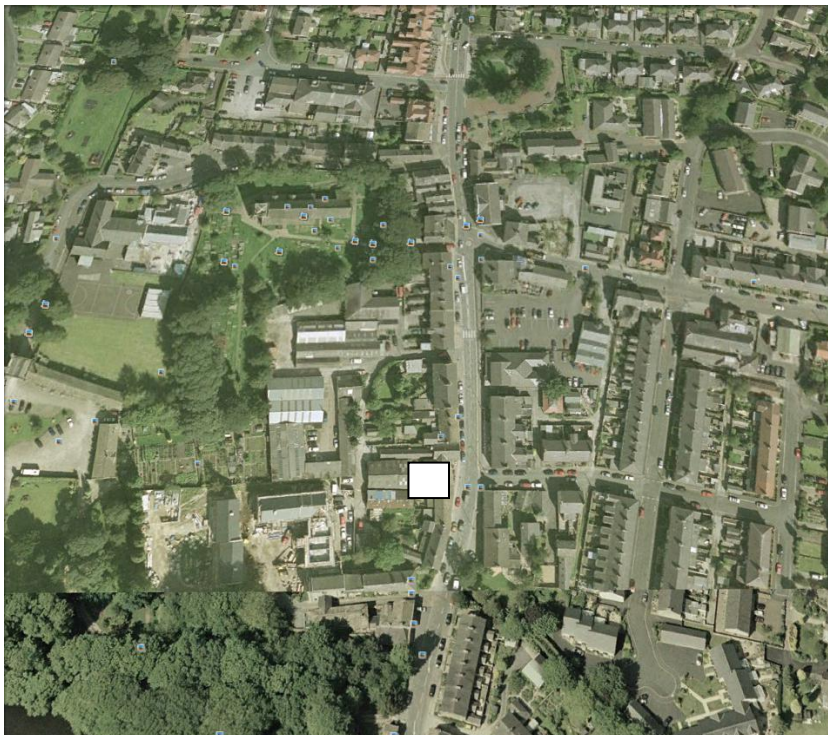
COMMENTS: The buildings are located to the rear of a retail unit which is located on the main street in the centre of the town Whalley. The buildings have sliding shutter doors on to the back street.

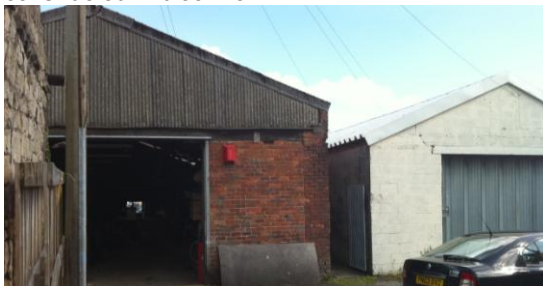
COMMENTS: The brick building has a pitched corrugated fibre cement roof over steel portal frame. The block building has an insulated composite profile sheet roof. There is no enclosed roof void.

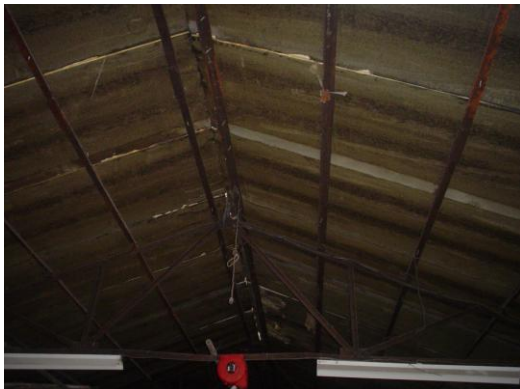
COMMENTS: There are no ceilings in either roof, the underside of the roof sheets are exposed. The buildings do not provide a suitable habitat for bats.

Internal view of garage/workshop roof.

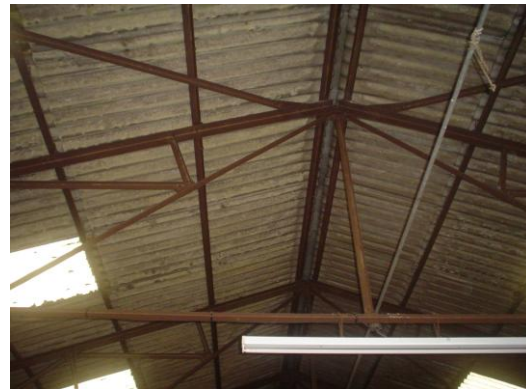
Internal view of brick shop/store/workshop roof.
