## BAT, BARN OWL & NESTING BIRD SURVEY AT SOUTHPORT HOUSE, SAWLEY

Author	Chris Arthur	Date	24 <sup>th</sup> April 2015
Checked by	Andrew Gardner	Date	24 <sup>th</sup> April 2015
Report Version	1		
Field data entered	<input checked="" type="checkbox"/>		
Report Reference	2674

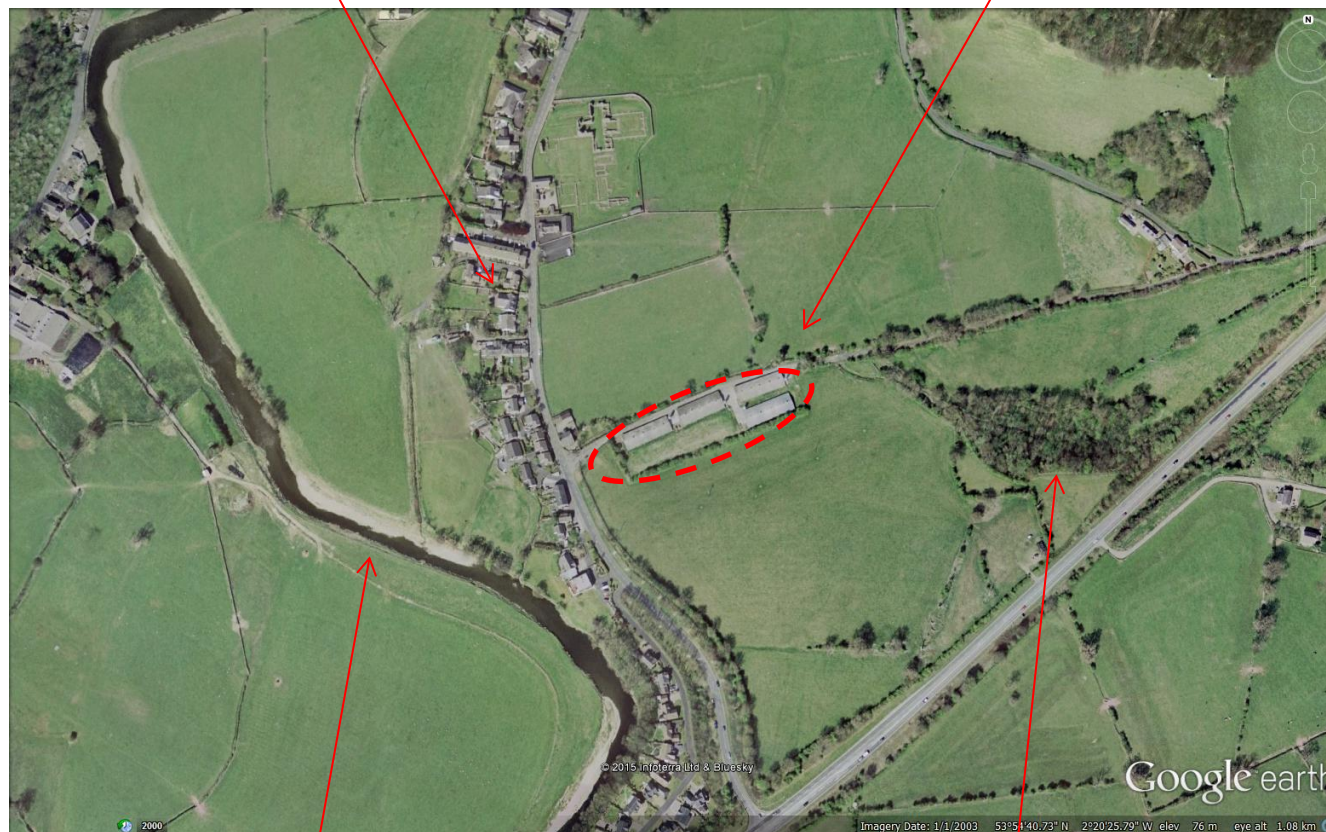
Residential dwellings offer numerous potential roost sites in the local area

The site is encompassed by poor semi-improved grassland of low value to bats

The nearby River Ribble offers high quality foraging habitat and a strong commuting route

Fragmented woodland offers pockets of foraging habitat

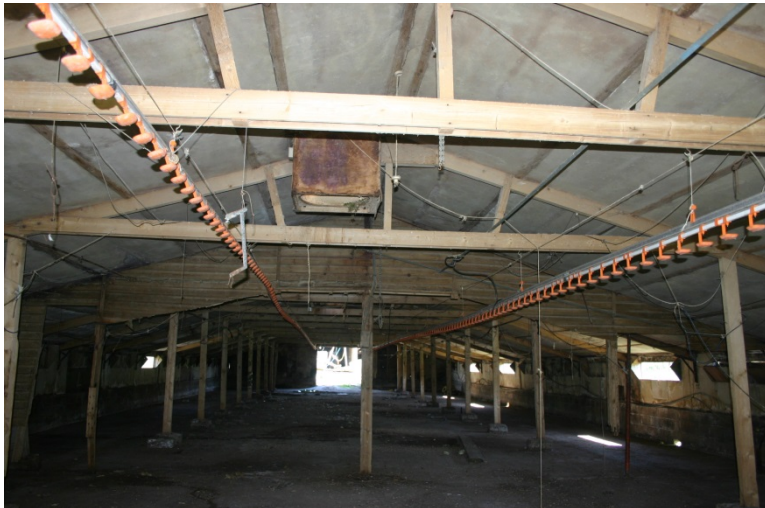
Photograph	Notes
 	<p>There are four buildings on site. These are a complex of derelict chicken sheds and are of similar construction, though in varying states of disrepair.</p>
 	<p>The lower sections of the walls of the sheds are made from concrete block, with the upper sections constructed on timber.</p> <p>The walls are well sealed and do not offer any potential roosting sites.</p>
 	<p>The buildings are under cement fibre or metal corrugate roofs. These materials are inherently unsuitable for use by bats.</p>

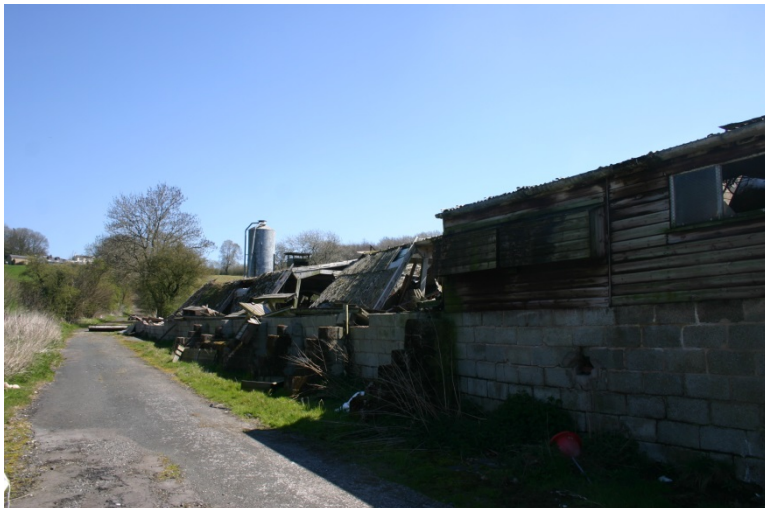
Internally there are no enclosed voids, but the roof structure is entirely exposed. They are lined with fibre board panels, some of which have detached and offer low quality potential roost sites.

The degraded nature of the buildings means that conditions internally are light and draughty.

No indications of use by bats were found in these areas.

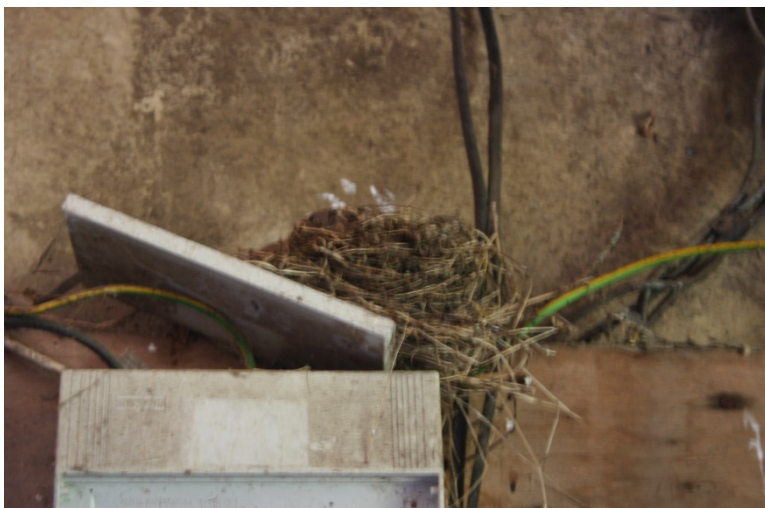
The sheds are in varying states of disrepair. The North-east shed has collapsed for much of its length, though the remaining three are in comparatively good condition.

Old bird nests were found within the sheds, though these were all unoccupied at the time of the survey.
