**White Lodge, Pendleton  
Clitheroe  
BB7 1PT**

**Bats: Building Survey**

**Simply Ecology Limited  
Written by: Jason Reynolds MSc MCIEEM**

**July 2015**

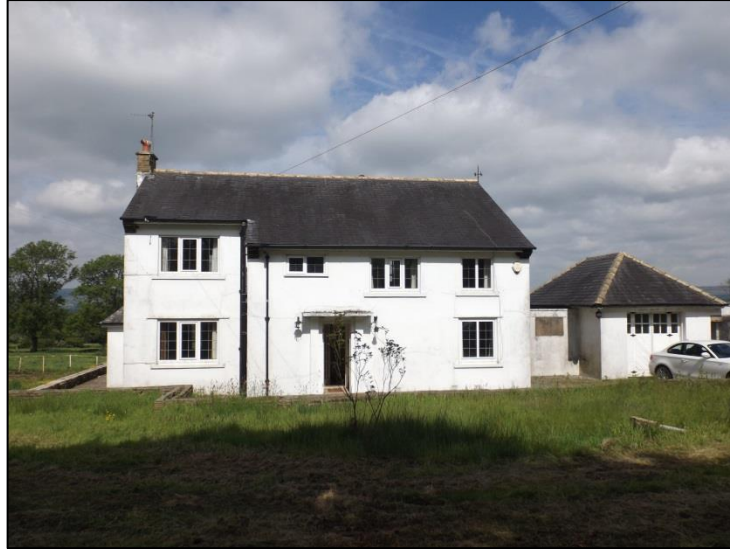
Plate 1: A view of the eastern aspect of the property.

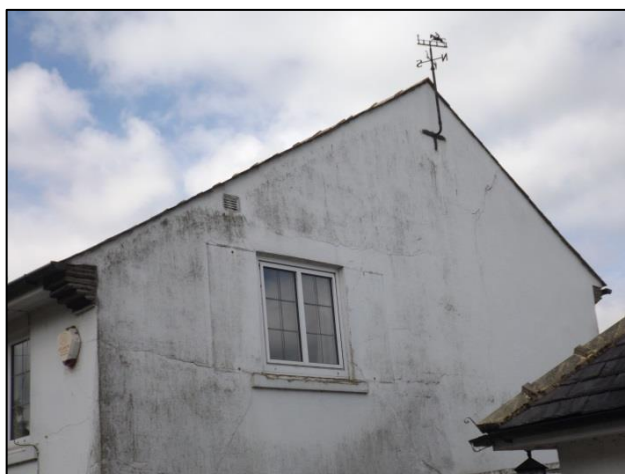
- 3.1.1 The building for the most part was in good state of repair. Whilst the rendering was slightly cracked in places, there were no suitable gaps or crevices suitable for bats to gain access (see Plate 2). There was no noticeable degradation of the bricks or pointing at all. All UPVC windows and doors were tightly fitted and completely sealed (see Plate 3).

*Plate 2: The rendering and structural integrity of the building was sufficient to provide no potential for bats to gain access.*

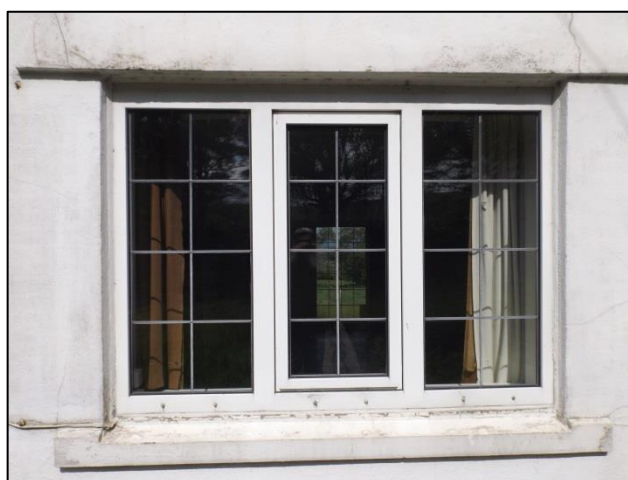
*Plate 3: All windows and doors were fully sealed.*

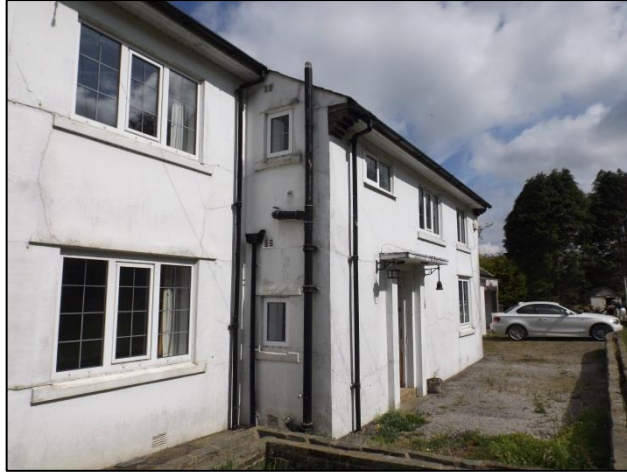
- 3.1.2 A thorough check of all ledges, and walls around the building was completed, as well as the ground near to the building. No signs such as staining, prey remains or droppings were found anywhere around the outside of the building (see Plate 4). The verges at each gable end were sealed with no potential for bat access. Similarly, there was no potential for bat access in the majority of the eaves of the building (see Plate 5). However, at each corner of the building there was a small set of cornice stones in the eaves. The cornice stones on the south west corner had a gap due to missing mortar of suitable dimensions to allow bats access (see Plate 6). Additionally, there were gaps between the soffit and the stones potentially offering access to internal spaces (see Plate 7). Also of interest were nesting house martins (*Delichon urbica*) within the eaves of the property on either side (see Plate 8).

*Plate 4: No staining, droppings or any other signs of bat activity were found*

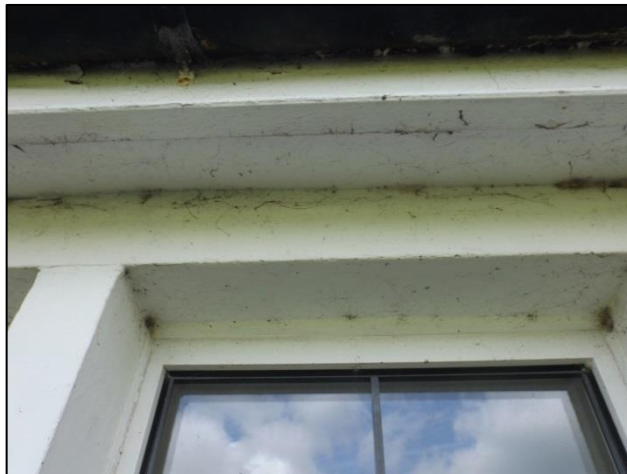
*Plate 5: The eaves were completely sealed up with no potential for bat access.*

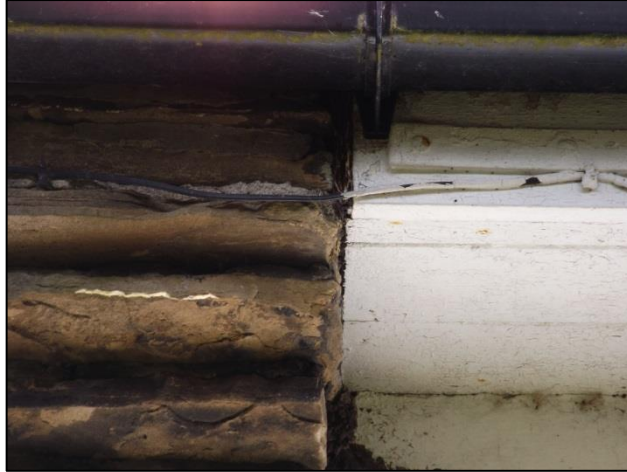
*Plate 7: Between the stones and the soffit it may be possible for bats to gain access.*

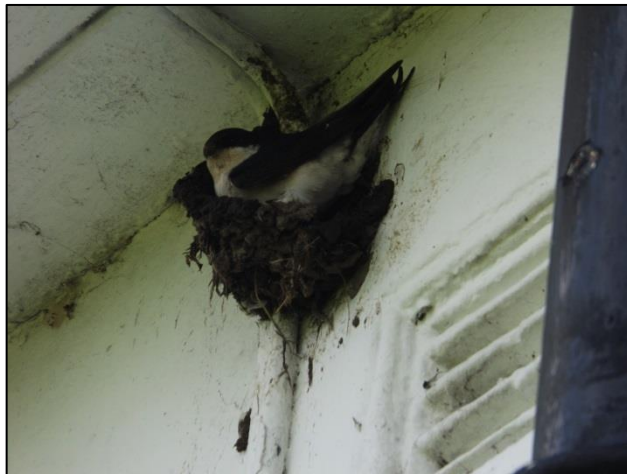
*Plate 8: House Martins were visibly utilising the eaves for nesting.*

- 5.10.2 To mitigate for loss of house martin nesting sites it is recommended that at least 4 house martin nesting bowls should be incorporated under the eaves around new building. These should be located away from windows and at a height no less than 3m above the ground (see Plates 25). House martin nests/bowls can be obtained from a number of sources including <http://www.nhbs.com/title/view/173580>. **Reason:** This will enable the continued use of the site by house martins and will result in no overall negative effect upon biodiversity at the site. This will ensure compliance with the Local Authorities duty under The Natural Environment and Rural Communities Act 2006.

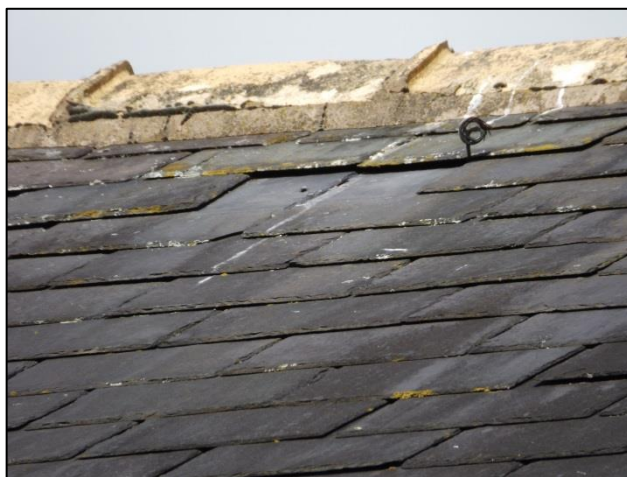
- 3.1.3 The roofing slates were in a relatively good state of repair; although there were some that had slipped/cracked revealing gaps that were suitable to provide access for bats (see Plates 9 and 10). Additionally, the slates on the protruding bay window at the rear of the property (west) showed signs of potential for access (see Plate 11). A thorough inspection of all other aspects of the roof was carried out. However, no potential for bat access was found in the ridge, the lead flashing or around the chimney.

*Plate 9: Missing tiles on the eastern aspect of the pitched roof.*

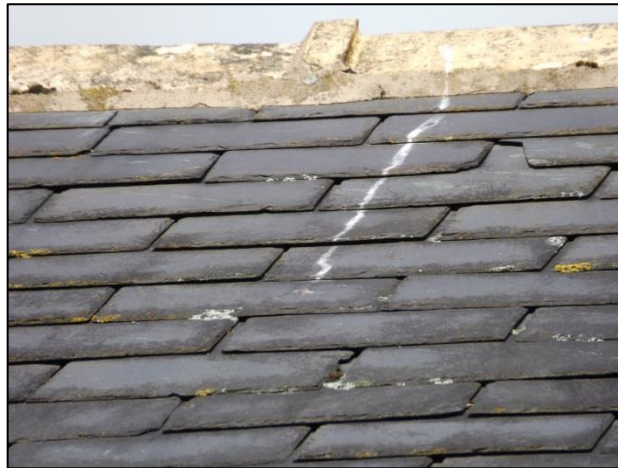
*Plate 10: Cracked tiles also provided access for bats to gain access.*

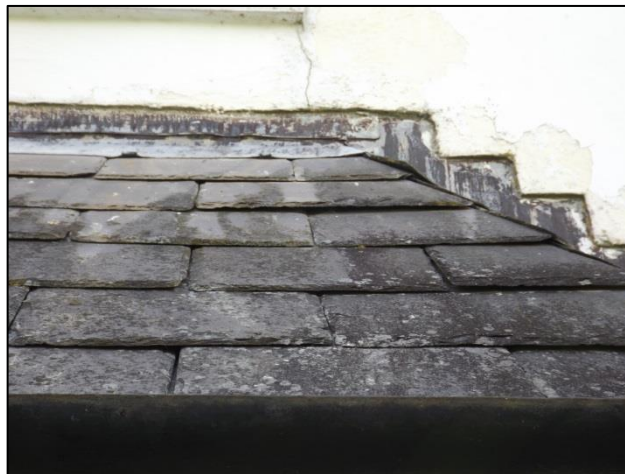
Plate 11: The bay window at the rear also had gaps in the slate tiles.

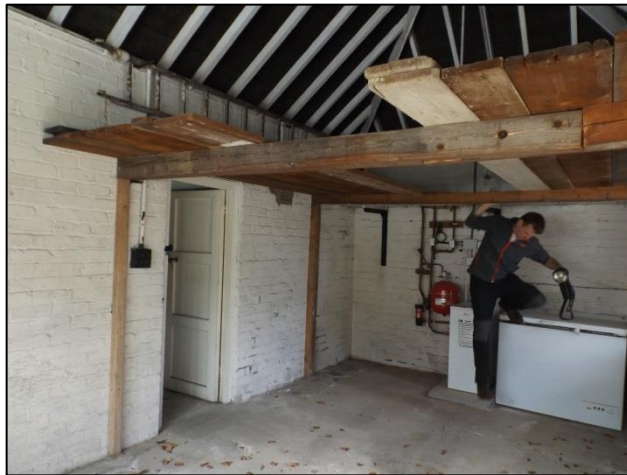
- 3.2.1 The underside of the roof of the garages was clear of any signs of bat activity. Additionally thorough search of the floor and the walls of these areas was conducted. None of the usual signs such as scratch marks, droppings or staining were found anywhere in the garage, nor the outer open garage (see Plate 12). It is worth noting however, that there was a wren (*Troglodytes troglodytes*) nest with fledging chicks situated in the open garage at the far north east of the property.

*Plate 12: No signs of bat activity were found anywhere in the garages.*

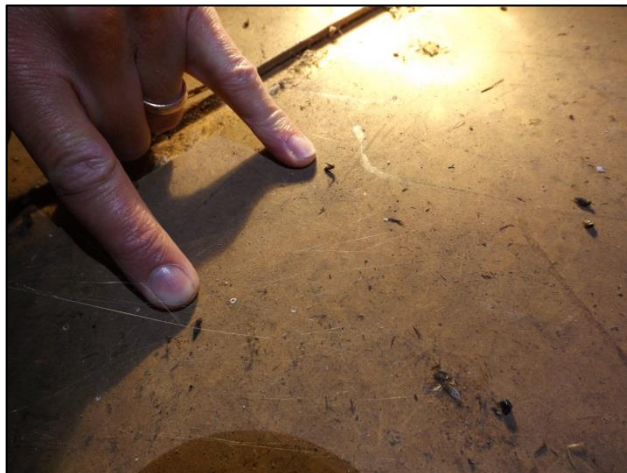
- 3.2.2 Upon searching the main loft space of the building it was clear that there had been historic and relatively recent bat activity present. The floor of the area had scattered droppings dispersed (see Plate 13), as well as small areas of concentrated droppings (see Plate 14). These droppings were of various ages, some clearly relatively old, whilst some appeared to be relatively recent. There were also droppings located on the walls within the roof void (see Plate 15). Despite this clear evidence of activity, the ridge beam and rafters were for the most part covered in old spider webs (indicating bats had not recently rested on the wooden structures), and there were no visible signs of scratch marks to be seen (see Plate 16).

*Plate 13: Scattered droppings were dispersed around the entire loft space.*

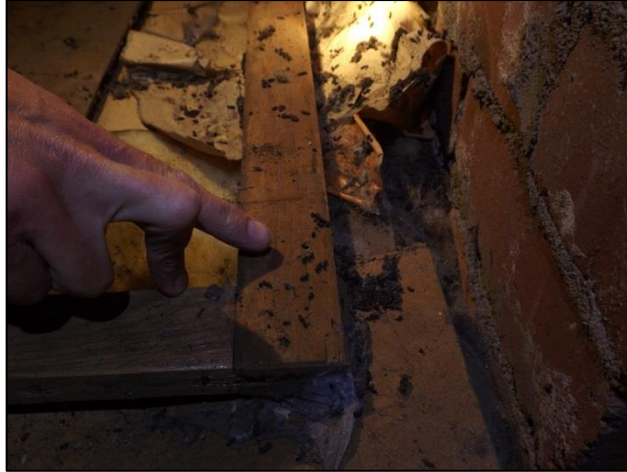
*Plate 14: In the centre of the loft space there was an accumulation of bat droppings.*

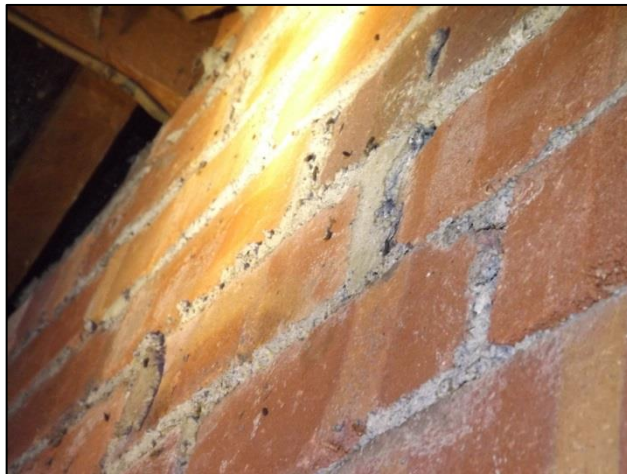
*Plate 15: Droppings were found to be present on the brick work within the roof void.*

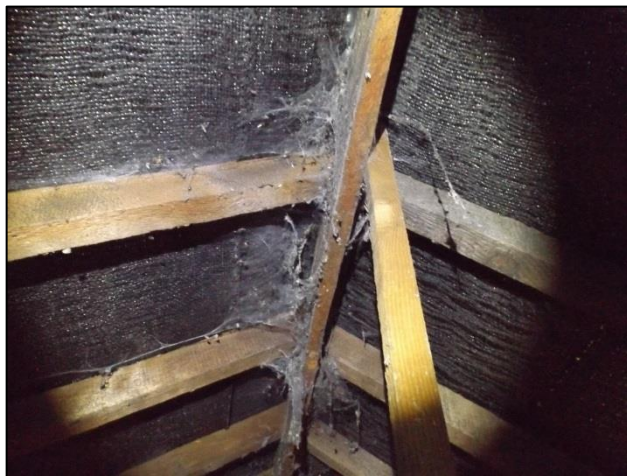
*Plate 16: The presence of old spider webs across the wooden framework indicated little use for recent roosting bats.*

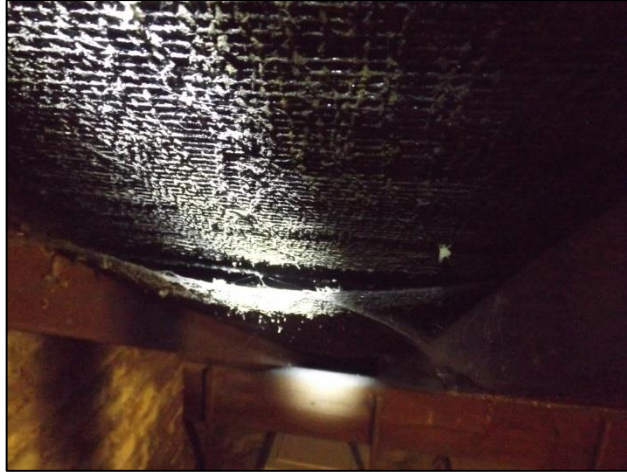
- 3.2.3 With regards to signs of visible access, there were voids behind the sagging bitumen felt large enough for bats to be utilising (see Plate 17). There were also gaps in the brickwork, as well as crevices between the brickwork and the overlying felt (see Plates 18 and 19).
- 3.2.4 **To summarise, there were signs of bat activity inside the loft space of the building, in the form of old and recent droppings, dispersed throughout. Additionally after a thorough search, possible entry points included: gaps in the brickwork, between the brickwork and the felt, and from behind the felt itself.**

*Plate 17: There were voids behind the bitumen felt that may provide resting places/access to bats.*

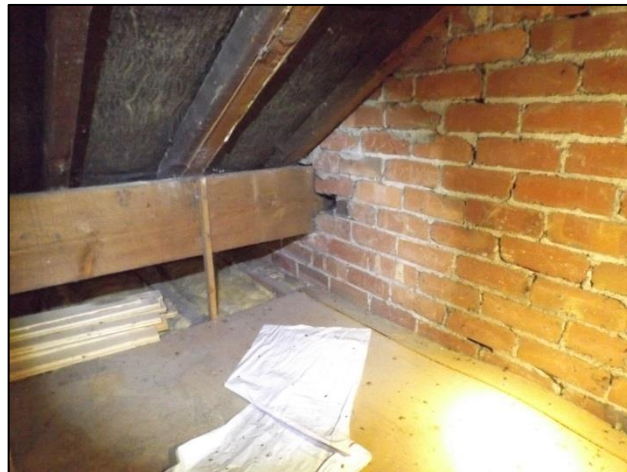
*Plate 18: Gaps in the brickwork were large enough for bats to acquire access to the loft void.*

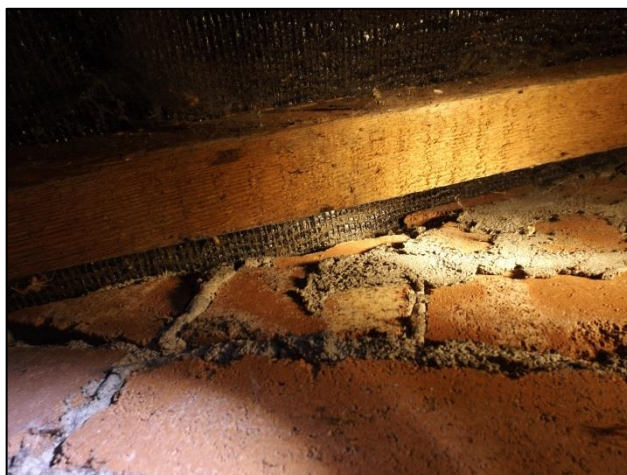
*Plate 19: There were spaces between the brickwork and the felt large enough to allow access.*

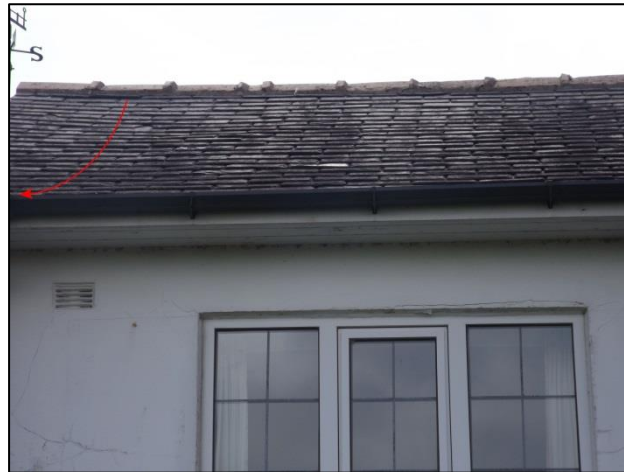
Plate 21: The exit from the 2<sup>nd</sup> ridge tile near the weather vane on the North end of the roof (emergence flight line represented by the red arrow).

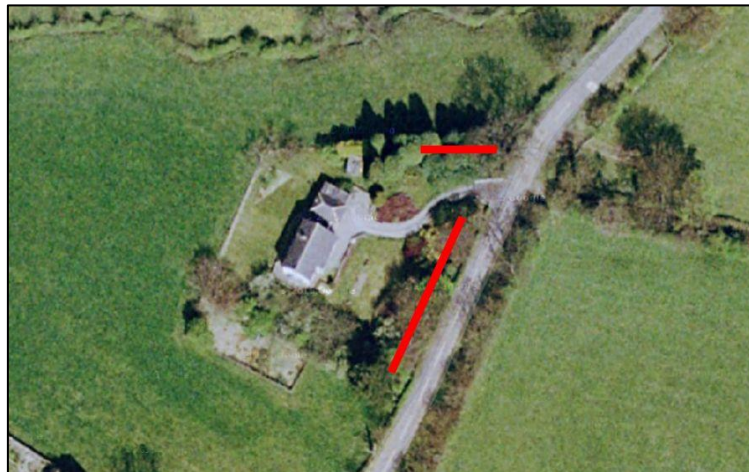
*Plate 22: Alternative roosting sites will be provided for the bats prior to any works going ahead. Red lines indicate the location of mature trees, within which there should be 2 bat boxes placed.*

- Before works commence, 2 bat boxes will be fixed to the mature trees located immediately North and/or East of the building (see Plate 22). The bat boxes will face East and South and be more than 4m above ground. These boxes will remain on site permanently.

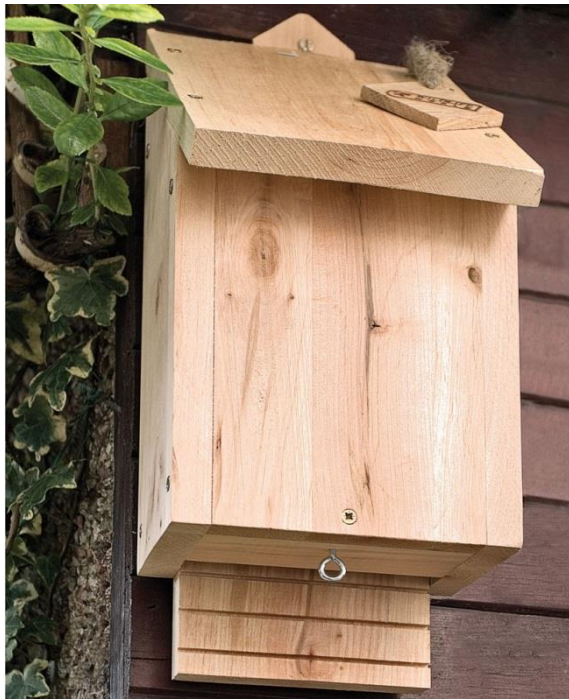
*Plate 24: The tree mounted bat roost to be installed prior to any redevelopment works.*

- **The new tree mounted roosts will be completed and ready for use by bats prior to and re-development works commencing.** This will ensure that alternative roosting is available at the site prior to roost destruction.
- **As the new houses are built, the 2 x Schwegler 1FR roost boxes will be constructed directly building: one on the south and one on the east elevation (see Plate 25).** This will ensure that the roosts have good thermal properties and they must be on the south and east facing aspects. The 1FR tubes will also be installed beneath the eaves. This arrangement will provide a roosting space suitable for crevice dwelling bats. The new gable wall will be rough/textured, so that bats can alight before entering the roost. The roost will also be well away from any potential disturbance.

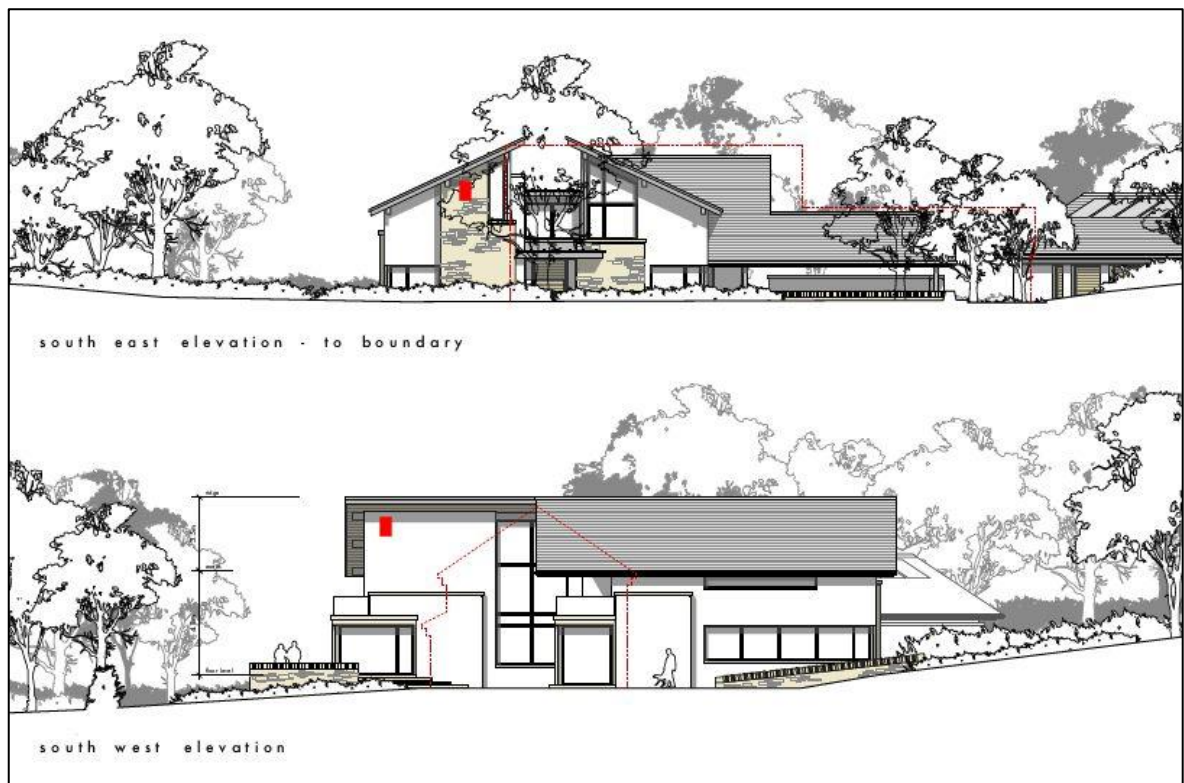
*Plate 25: Locations of the new Schwegler 1FR bat boxes (red) to be built into the structure of the new building.*

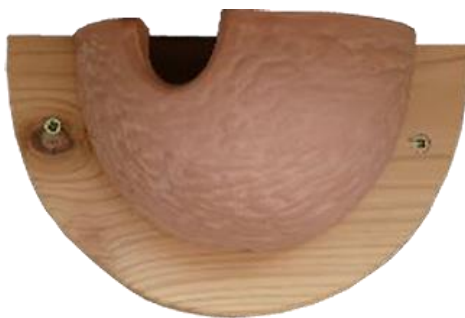
*Plate 25: At least four house martin bowls should be situated around the building to compensate for the loss of existing nests.*
