## **LAND TO THE REAR OF 9 DOWNHAM ROAD, CHATBURN:**

### **HERITAGE ASSESSMENT**

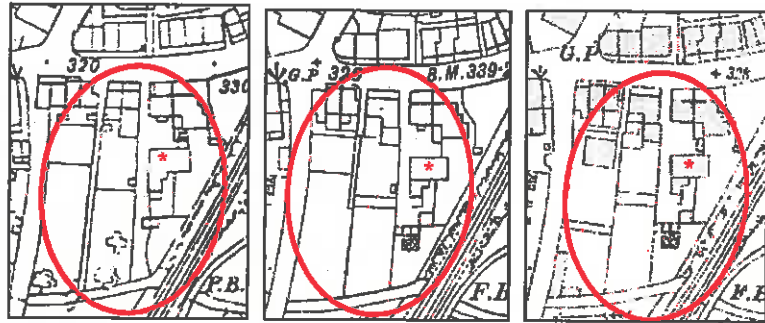
Figure 2: OS 1:2500 maps, published 1886, 1912 and 1932<sup>4</sup>

- 4.4 Maps of 1886, 1912 and 1932 all show an L-shaped arrangement to the buildings within the site, with some very minor structures to the south and west.

- 5.3 Almost all of the south side of the barn is also of original fabric, where the more random character of the masonry suggests that the builder was less concerned with appearance. Much of this wall now faces into the adjoining workshop, and formerly faced into its predecessor, as indicated on the historic maps. There is a good pedestrian doorway with monolithic sandstone lintels in this wall, opposite the arched entrance, though it is damaged. Above this doorway are two further slit breathers. There is a second doorway further to the west, but it is roughly finished and was probably inserted when the present workshop was built.

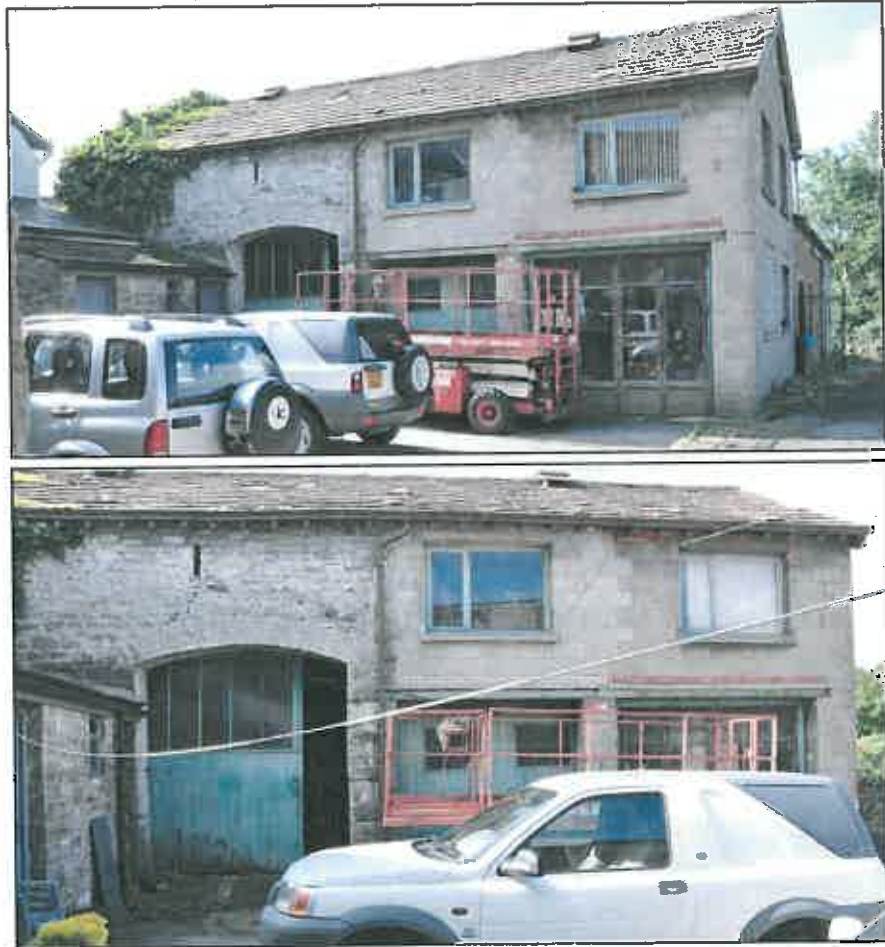
- 5.1 The northern part of the existing buildings comprises a former barn, now in use as a workshop. It appears to date from the early 19th century and is a four bay structure, of which the west gable and the west half of the north wall were rebuilt in the mid 20th century. Much of the east end of the building is hidden by ivy.

- 5.2 Within the unaltered part of the north elevation, the original arched doorway (with modern doors) forms the main entrance; the surrounding masonry is of squared limestone and incorporates two high level “breathers”, small slits just below the eaves. Modern toilets adjoin to the left of the doorway. Further breathers exist in the original east gable, arranged in a row of three with a fourth near the ridge, although vegetation cover means these are only clear from within the building.

Former barn: north elevation

- 5.4 The barn's west gable was entirely rebuilt in the mid 20th century and although it must preserve the outline of the original, it has new fenestration which is most unlikely to replicate it. This is also true of the west half of the north wall, where the two vehicular doorways and large first floor windows are similarly mid 20th century.
- 5.5 The former barn's roof has been left essentially unaltered by the 20th century works and retains its stone slates and sandstone ridge, with roof lights, ridge ventilators and protruding rafter ends.
- 5.6 There are no historic divisions or floors inside the barn: the eastern half is open to the roof while the west end has an inserted floor carried on RSJs. The three king post roof trusses appear original but there are slight variations in their exact configurations.

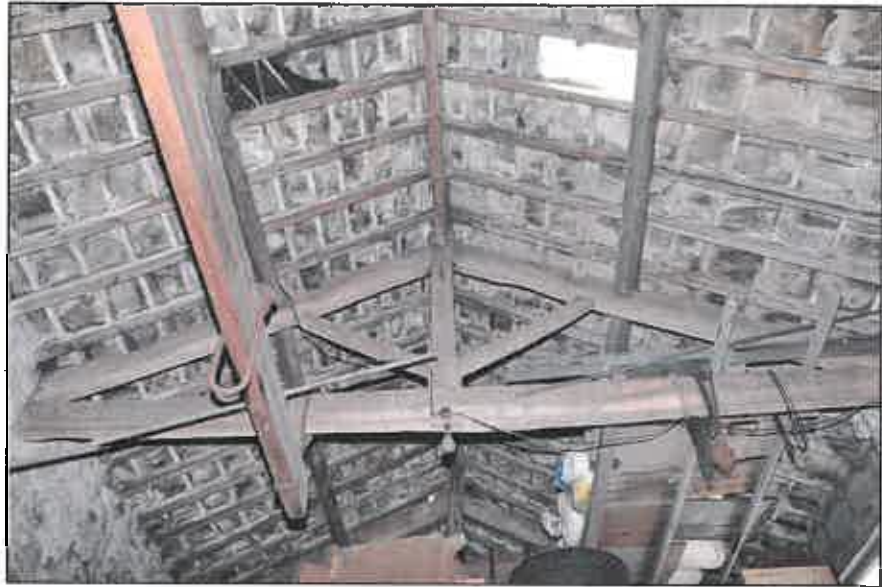
Former barn: underside of roof

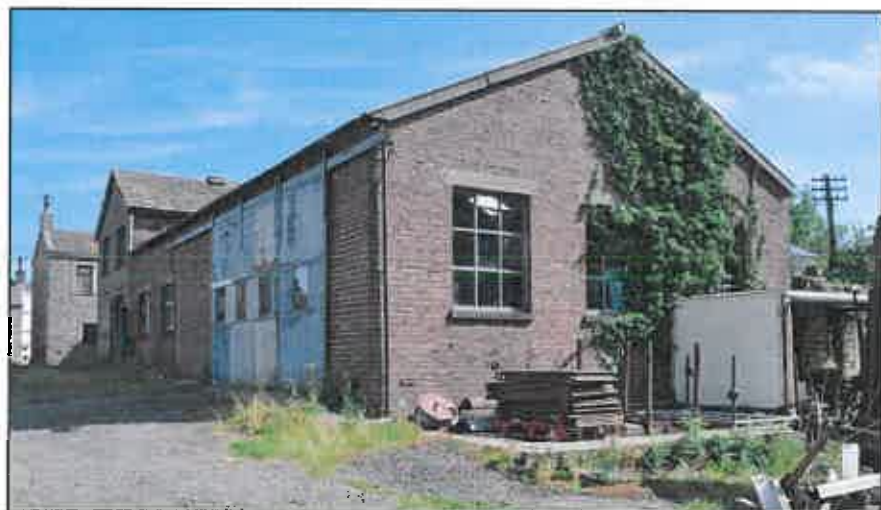
- 5.7 The mainly brick-built workshop at the barn's south-west corner is entirely of mid 20th century date and not of historic interest, although as noted above it, historic maps indicate that it replaced a smaller predecessor.

Mid 20th century workshop: south end
