BAT SURVEY
AT
THE MAPLES
STONEYGATE LANE
RIBCHESTER

DATE AND TIME OF VISIT
23rd Nov 2015

The proposal is the construction of a single storey porch to the front elevation.

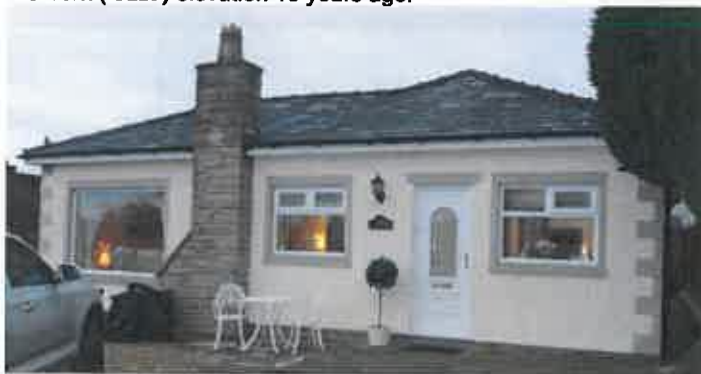
Front elevation

The house is a detached bungalow, the original building possibly dating from the 1960's but it was extended to the front (east) elevation 10 years ago.

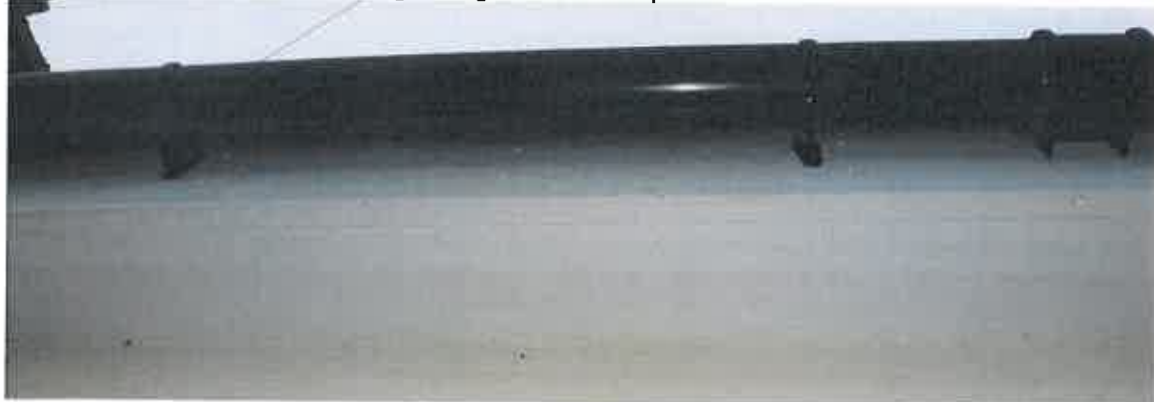
BAT ACCESS POINTS IN ROOF

The front section of the roof being affected by the extension is only 10 years old, the tiles and flashings are in perfect condition. The eaves soffit is tight fitting with no access points.

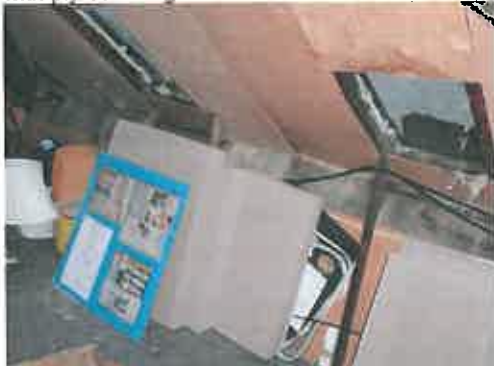
ROOF SPACE

The roof space is accessed via a loft ladder it is naturally lit by some roof windows in the side and rear roof pitch. The space is clean and dry with a boarded floor, it is used for storage. The rear section of roof is the original with ply boarding to the underside of the rafters.

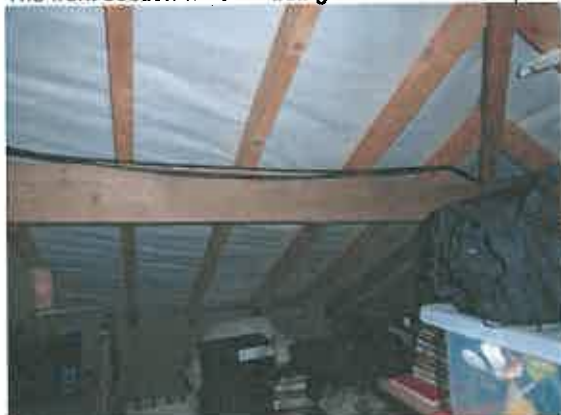
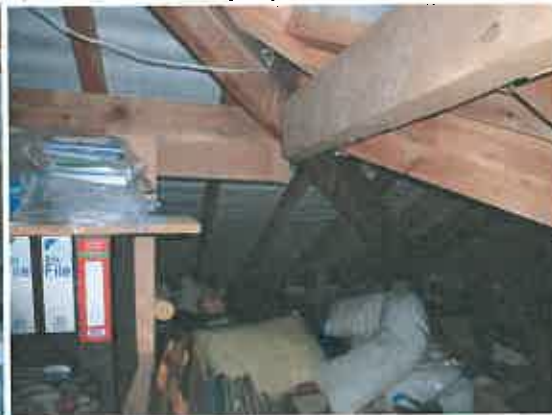
The front section which is being affected has new purlins, rafters and underlay in perfect condition.

COMMENTS: The roof space had no evidence of bat access, none of the above evidence was found.
