**Re: Proposed development at 27 College Close, Longridge, PR3 3AX**

Thank you for your request for a bat survey in relation to a proposed development at the above site. I understand the proposed development is for a single storey extension to the rear of the property (proposed plans attached).

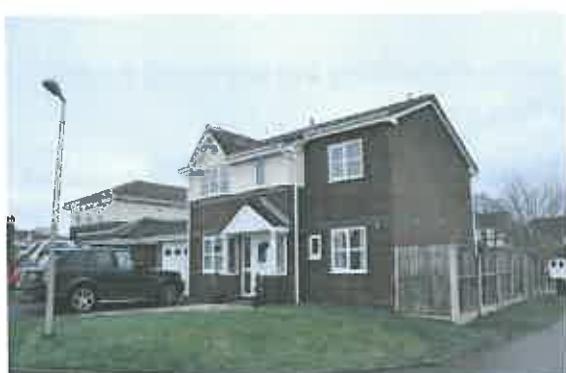
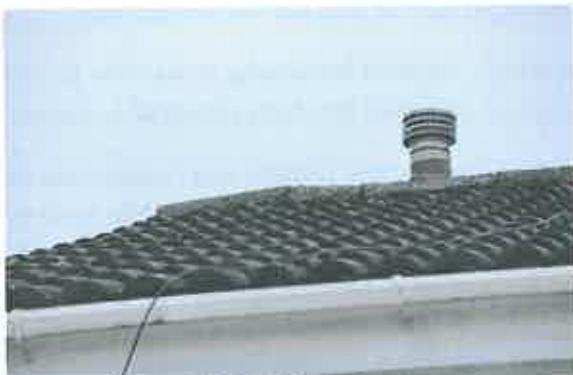
The building is a two storey, modern, detached dwelling house with adjoining garage to the east and a conservatory to the south. The walls are constructed of brick with some areas covered with pebble render. The main roof is dual pitched with a single dormer window at the north elevation; the adjoining garage roof is hipped. Both roofs are covered with tiles with timber soffits, fascias and barge boards present along the roof edges. The garage building is sealed tight with no visible gaps. There are a number gaps associated with the main roof, including occasional lifted tiles, (particularly on the west gable end at the ridge) and gaps beneath soffits and barge boards, most noticeably at the apex and along the roof edges of both gable ends. A small number of bat droppings were found on the external white pebble render, below the roof line at the corner of the north and east elevations.

View of 27 College Close, north elevation (lhs) and lifted ridge tile on west gable end (rhs).

- All contractors involved in the works should be given a tool box talk by a suitably experienced and licensed ecologist so that all works are undertaken with a clear understanding about legal aspects, precautions to be adopted and what to do if a bat is found.
- The gable ends and roof edges of the main house should remain clear at all times of disturbance and unobstructed. There should be a minimum of 2 metres, unobstructed drop allowing free access for bat at all times.

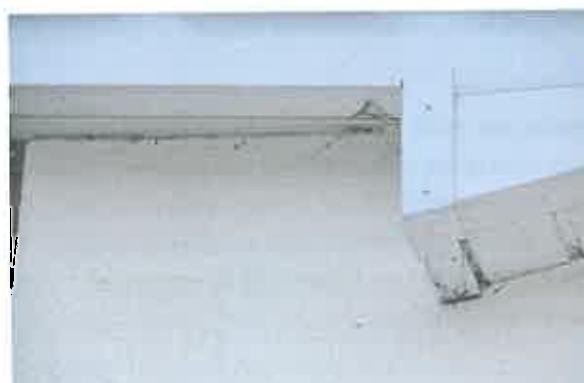
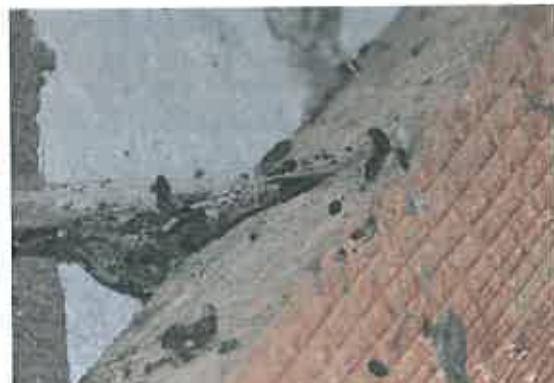
Signs of bats, in the form of older and more recent bat droppings were found clustered at both gable ends of the main roof void and a small number of scattered droppings are also present within approximately 2 metres of both gable ends. A small amount of staining was also observed around several potential access holes. The evidence suggests that bats are roosting within gaps and crevices associated with the wall tops and utilising up to 2 metres into the roof void on either side of the gable end. It is regarded as likely that bats are roosting within the space between the roof covering and roof lining.

Location of bat dropping on external render (corner of north and east elevations) (lhs) and bat droppings found in roof void on support timber (rhs).

It is advised that a bat roost is present and associated with both gable ends of the dwelling house.

It is advised that due to the nature of the proposed development (ground floor extension only) a number of precautionary measures will need to be adopted in order to avoid unlawful activities (e.g. by causing disturbance to bats). Precautionary measures must include:

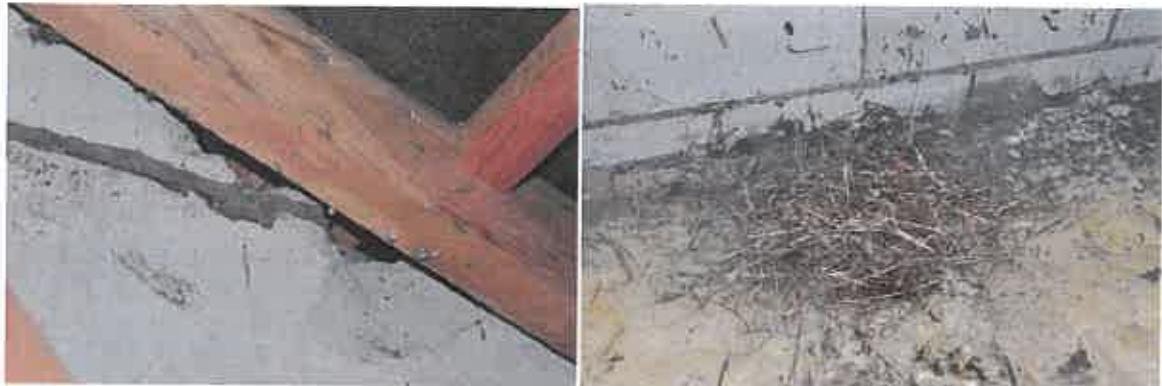
Nesting bird material is also present at the west gable end. Due to the gaps associated with the roof and roof edges on the main house there is high potential for nesting birds to be present during the nesting season.

Gaps at the wall top on internal east gable end wall (potential bat access) (lhs) and bird nesting material found in main roof void, west gable (rhs).

It is advised that if works are to take place during the nesting season (February to October), a careful inspection of the building by a suitable qualified and experienced ecologist should be carried out immediately prior to the works, to check that birds are not present.
