# THE PREMISES OF LODEMATIC LTD, NOS 1, 2 & 3 WORKS, PRIMROSE MILL, CLITHEROE:

## HERITAGE ASSESSMENT AND STATEMENT OF SIGNIFICANCE

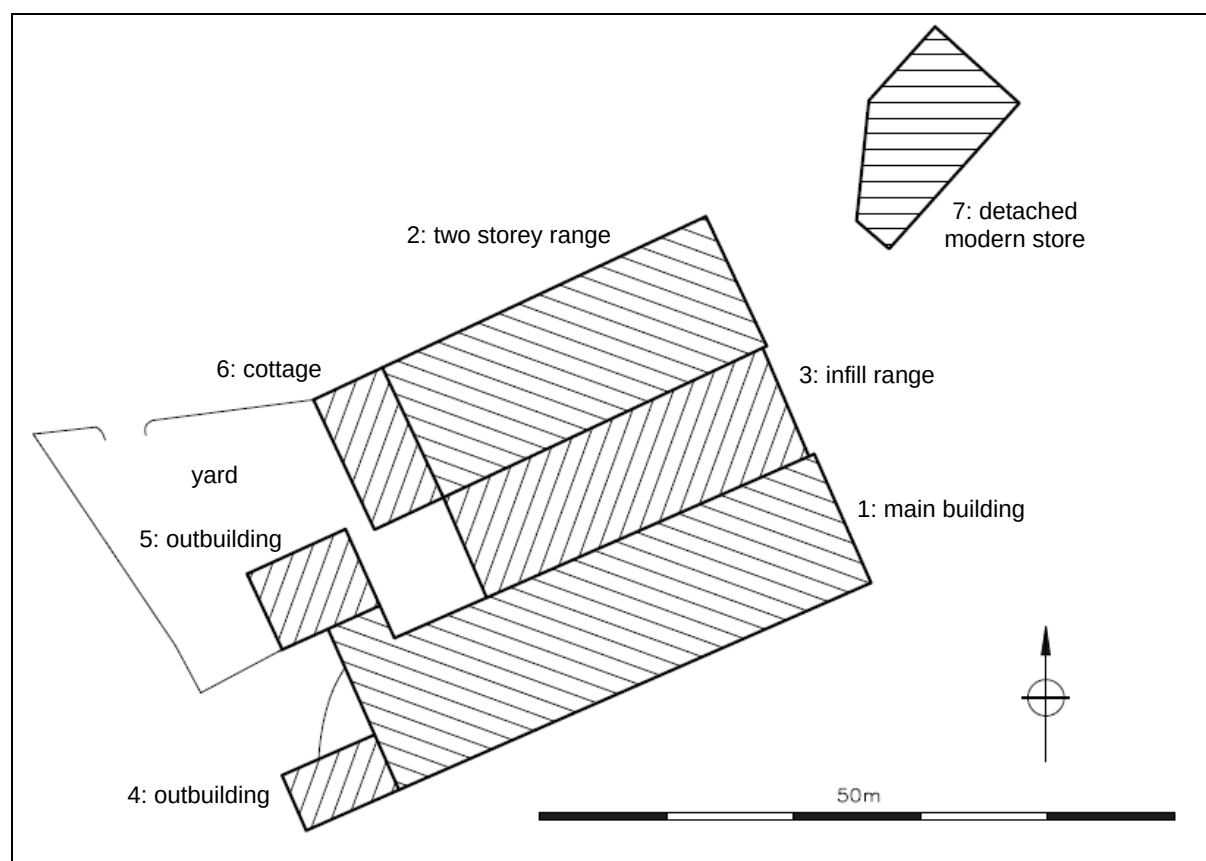
**Figure 2:** Main components of the site

- 2.1 The premises are located at NGR: SD 73718 40748, at the junction of Woone Lane and Primrose Road, and at the north-west end of the present Primrose Mill complex (figure 1). The main buildings comprise three parallel, adjoining ranges, but there are other structures within the group including a derelict cottage, outbuildings, and a detached, modern store, numbered from 1 to 7 on the plan below (figure 2).

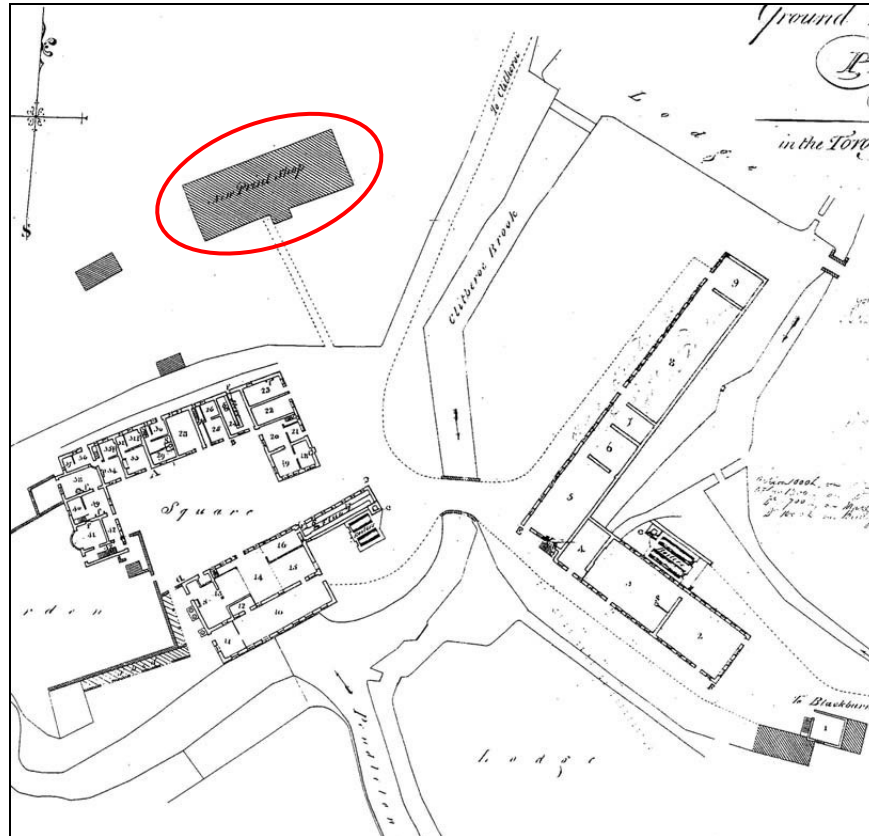
Figure 3: 1815 map<sup>4</sup>

- 4.2 Cotton spinning ceased at the site in 1810-11, and it was then adapted to calico printing, by its new owners Thomson, Chippendale & Burton, and between 1815 and 1827 they enlarged the premises considerably. A map of 1815 shows the site as already containing numerous buildings, but with a "New Print Shop" marked some way to the north of the existing structures (figure 3). A comparison with the later tithe map of 1842 (figure 4) clearly shows that this is not on the site of the Lodematic premises, but represents another building which stood further to the north off Woone Lane, on the site of the present residential development which followed demolition of a mill there in 2012.

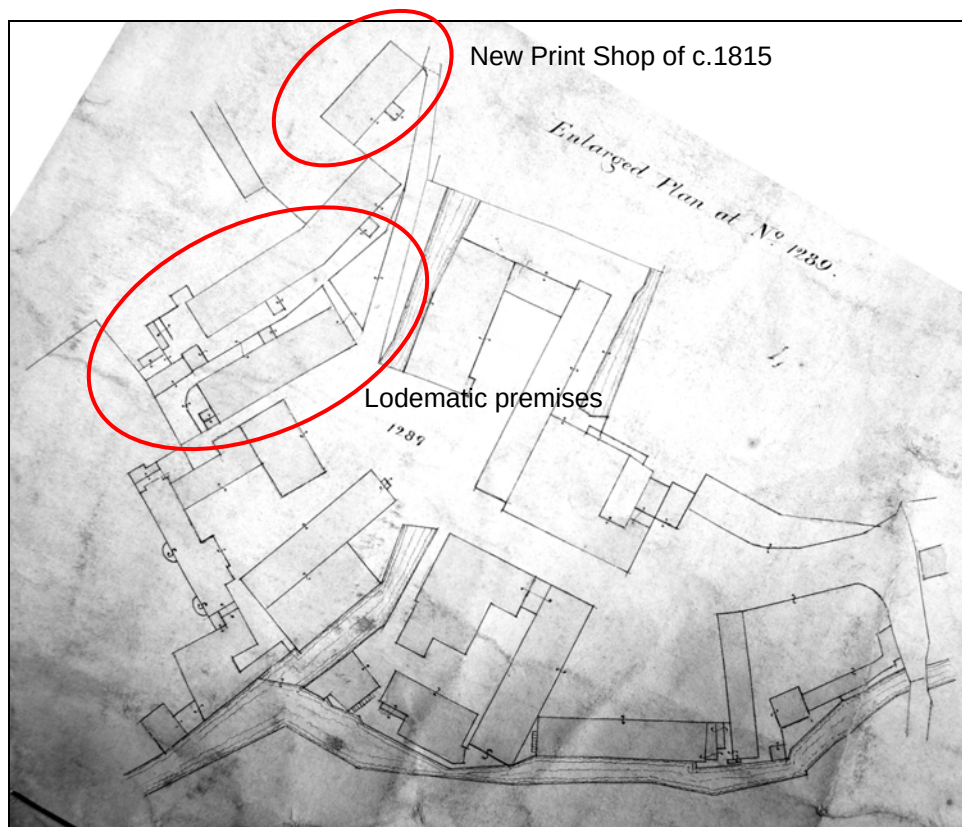
Figure 4: Clitheroe tithe map, 1842

- 4.3 Maps from the 1840s and 1850s show the site following the expansion after 1815: the earliest of these is the 1842 tithe map (figure 3), which depicts the main range at Lodematic, and a second range in the position of building 2, of crooked outline and longer than the present one. A number of minor outbuildings and projections to the buildings are also shown. The Ordnance Survey's first edition 1:10560 map shows the same arrangement, albeit at a smaller scale (figure 5).

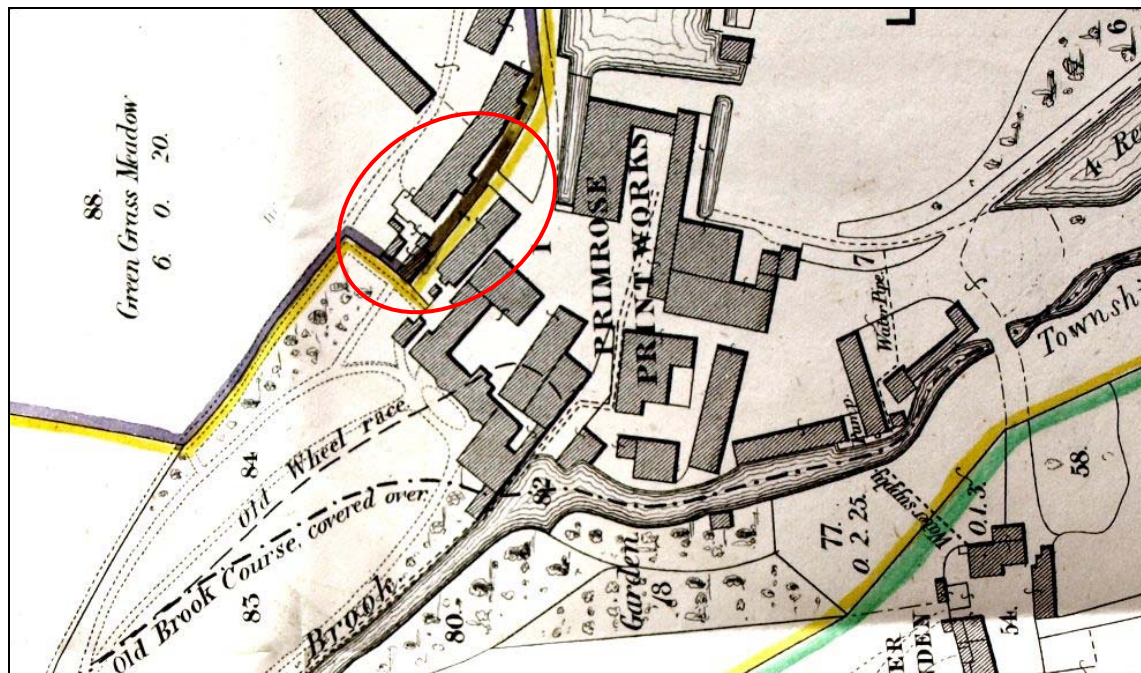
Figure 6: Sale plan of 1854

- 4.4 The fortunes of the printworks were in decline by 1850 and the business was put up for sale in 1854, when another plan of the site was made, which shows effectively the same arrangement of buildings. However, it may be significant that the site then appears to have been split into two lots, through the middle of what are now the Lodematic premises (figure 6). The whole site was acquired by Richard Fort, who divided it into separate enterprises: the north end, where the "New Printshop" was located, became a cotton spinning mill, later to become known as Primrose Mill; the remainder became two parts, known as the Upper and the Lower Works, and were given over to paper manufacture, a function which continued until 1887, just after the OS first edition 1:2500 map was

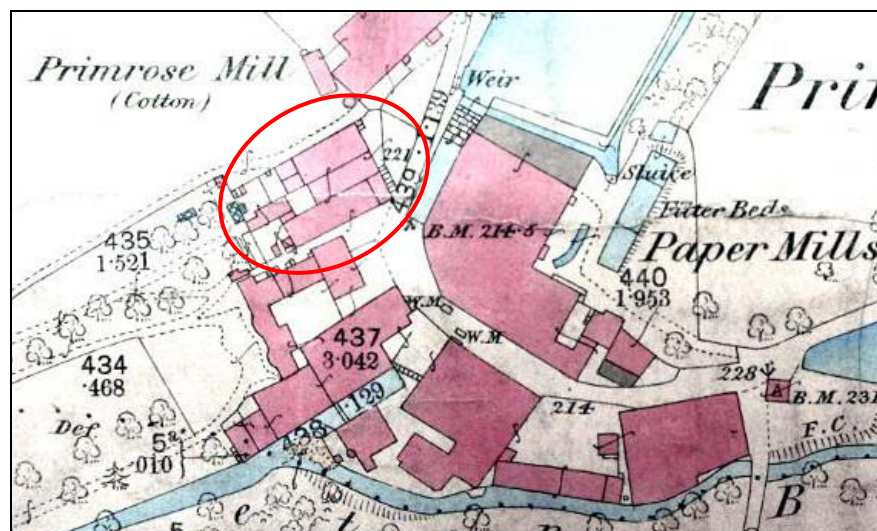
Figure 7: OS 1:2500 map, surveyed 1883

surveyed (figure 7). In the intervening years building 3 had been shortened to its present length, and an infill block (building 3), between it and the main range building 1 had been added. The cottage (building 6) also appears to have been built in the previous thirty years.

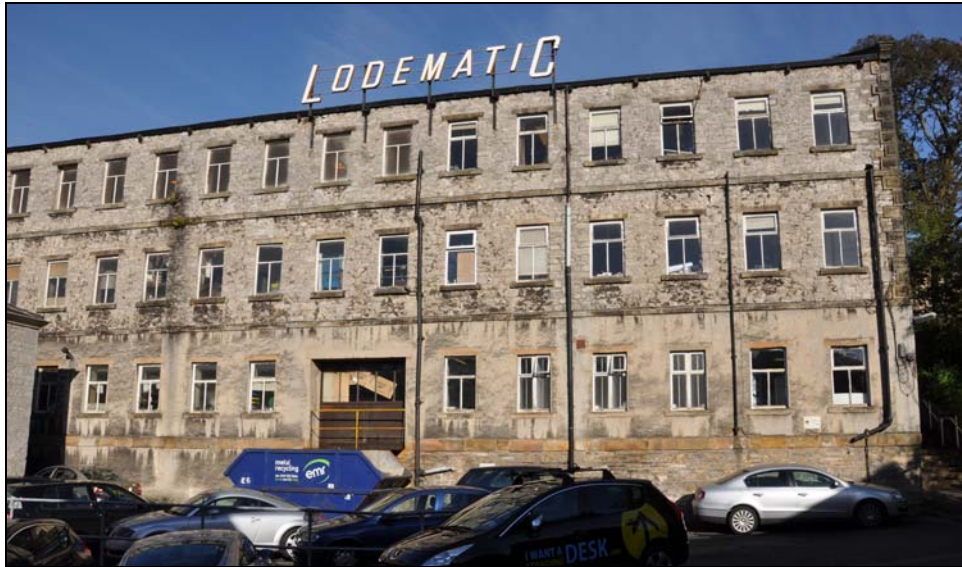
- 5.1 The main block, building 1, can be dated by the maps above to the period between 1815 and 1842, and was quite probably added *circa* 1827, as part of the expansion of the calico or cotton printing works, and is described by Rothwell as a former “print shop”. It is a long, narrow building, of three storeys, twenty

bays long and two bays wide, whose walls are of limestone rubble with sandstone or gritstone dressings, including bands between storeys, and rock-faced quoins. The present entrance is in the north-east gable at lower ground floor level, but the arrangement of openings at this level is modern. The five-light gable window to the upper ground floor is original however and is a motif used elsewhere at the site, as is the circular opening within the gable, though the latter is decorative only, as it is located over the valley between the twin spans of the roof which this gable conceals. The openings to the long south-east elevation are plain and repetitive, though disturbed by the inserted loading entrance on the lower ground floor; the pattern is repeated in the north-west side of the range, facing into the infill block (building 3), where it has also been disturbed, but it also lacks lower ground floor openings, due to the rising ground.

**Photo 1:** Building 1, main block

| <b>Building</b> | <b>Significance</b> | <b>Notes</b> |
|---|---|---|
| 1 | Medium | Built between 1815 and 1842 and one of the Upper Works' earlier buildings, probably built for printing. Good, little altered elevations to three sides with important external detail. Interior not of interest. |

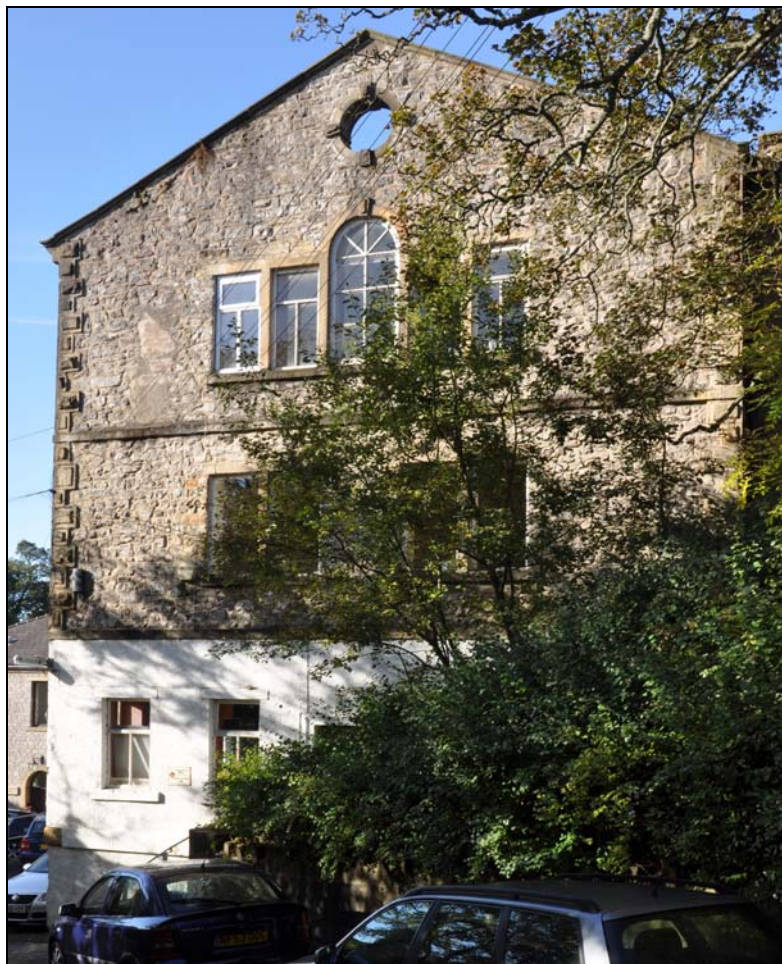
**Photo 2:** Building 1, north-east gable

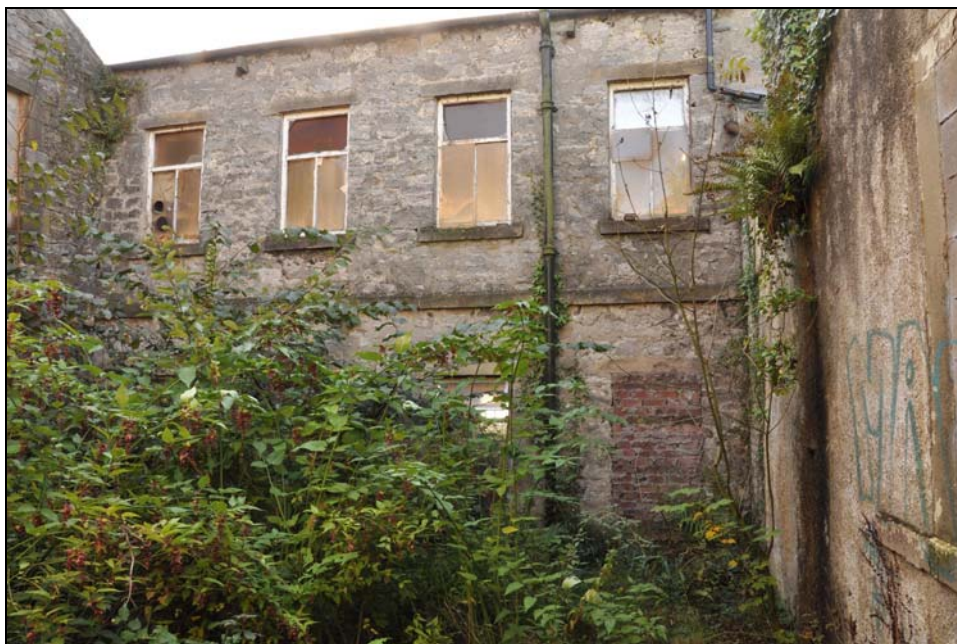
**Photo 3:** Building 1, main block, north-west elevation

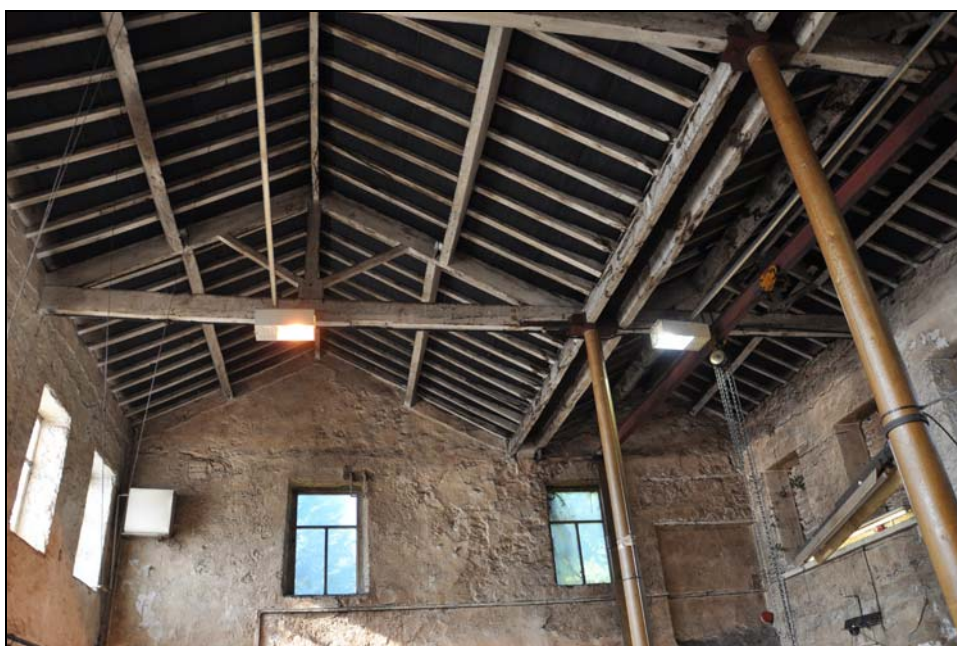
- 5.3 The interior of building 1 has very little of historic interest. The lower ground floor (narrower than the upper floors, and lit only on two sides) has modern partitions of timber and blockwork at its north-east end, and twentieth century steelwork forms the structure of the ceiling above. Now part of the engineering workshop, there is nothing of historic character visible, except for the basic form of the window openings along the south-east side.

- 5.4 The two upper floors of building 1 now form a single space open to the roof, though there are also modern partitions at the north-east end. The removal of the historic first floor was accompanied by the replacement of the (presumed) central line of cast iron columns by the existing taller ones, though the roof structure, of bolted, softwood king post trusses, is probably original.

**Photo 4:** Building 1, main block, interior

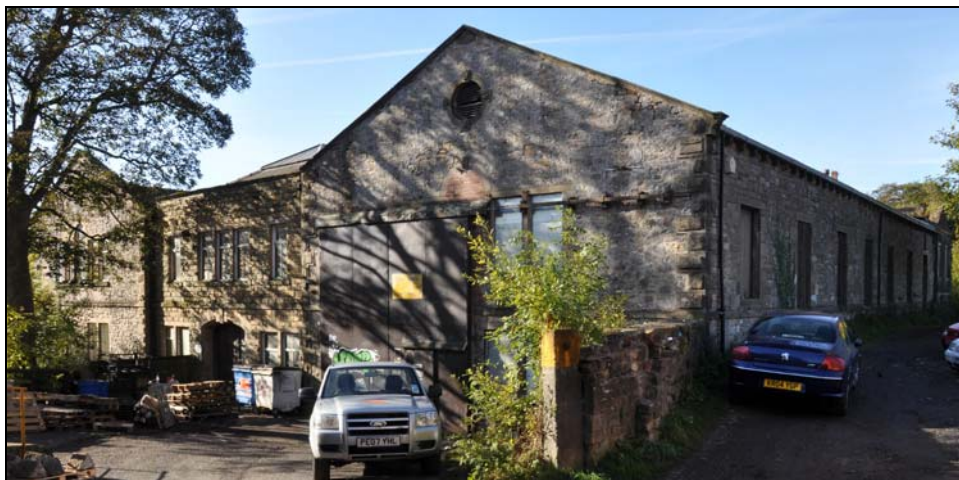
- 5.5 The north-western range of the Lodematic site (building 2) lies approximately parallel to building 1, and was formerly separated from it by a yard, subsequently roofed over to create building 3. The north-east gable shares the same fenestration pattern as that of the main range (albeit with a large modern doorway inserted), but other aspects, principally the predominance in the masonry of squared sandstone with jumpers, rather than limestone rubble, suggest that the building is significantly later in date, or has been substantially

rebuilt. There is however a distinct difference in the fenestration between its south-west and north-east elevations, the former being similar to that in building 1, while the latter has far fewer windows, so perhaps rebuilding was confined to that side. The shortening of the building between 1854 and 1883 (see figures 5 & 6 above) may account for this drastic remodelling, which also seems to have included the replacement of the former roof structure by the present trusses containing iron ties. Internally there were two storeys, though the upper floor has been removed and there are no features of historic or architectural interest, though the owners recall that the north corner of the building held a stable when they acquired it in the 1960s, but this was later altered.

**Photo 5:** Building 2

| <b>Building</b> | <b>Significance</b> | <b>Notes</b> |
|---|---|---|
| 2 | Low | Possibly established between 1815 and 1842 as part of the print works, but truncated, with remaining portion much rebuilt. Interior not of interest. |

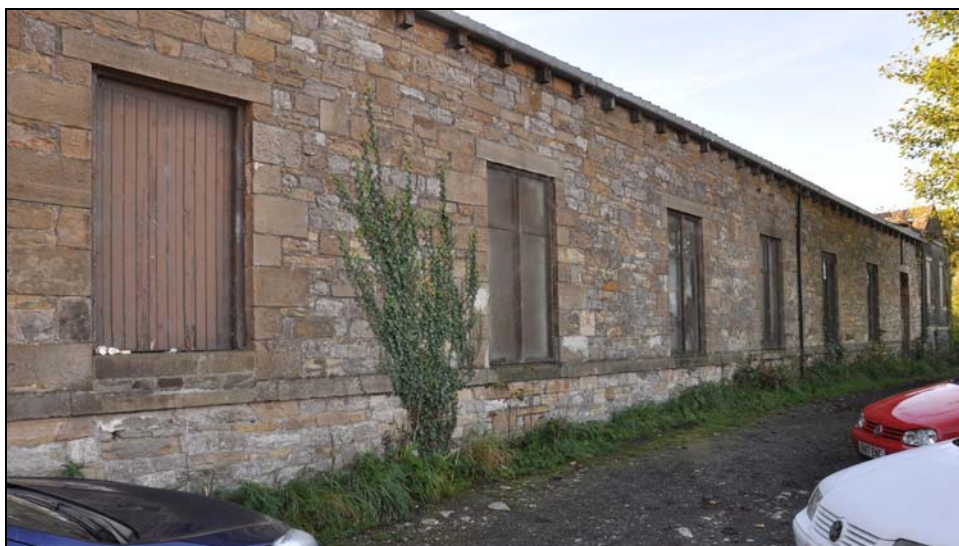
**Photo 6:** Building 2, north-west elevation

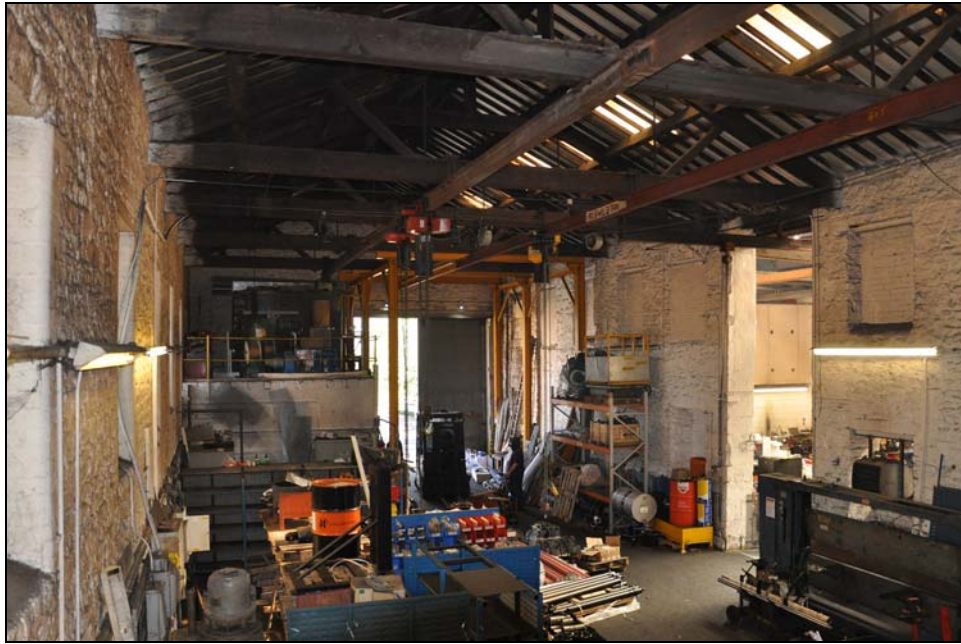
**Photo 7:** Building 2 interior

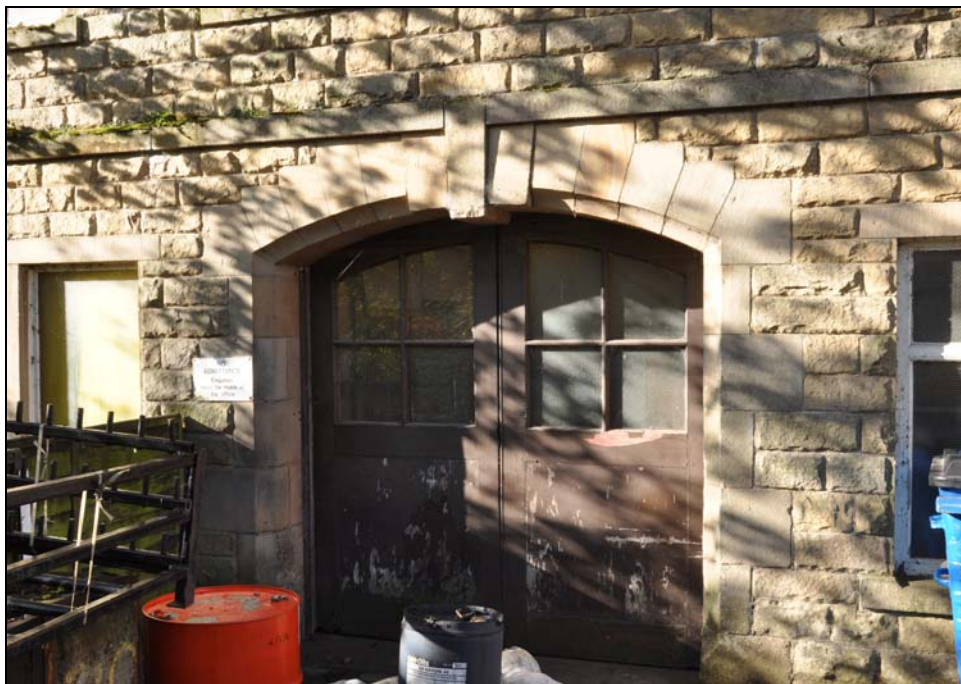
- 5.6 Added between 1854 and 1883, this component simply represents the roofing over of the yard between the adjacent ranges, though the north-east gable has some decorative quality, in the balanced façade with central arched doorway. Internally, if there was at one time an upper floor, it has since been removed.

**Photo 8:** Entrance to building 3

| <b>Building</b> | <b>Significance</b> | <b>Notes</b> |
|---|---|---|
| 3 | Low | Built between 1854 and 1883. Infill building, lacking distinguishing features; not of particular interest. |

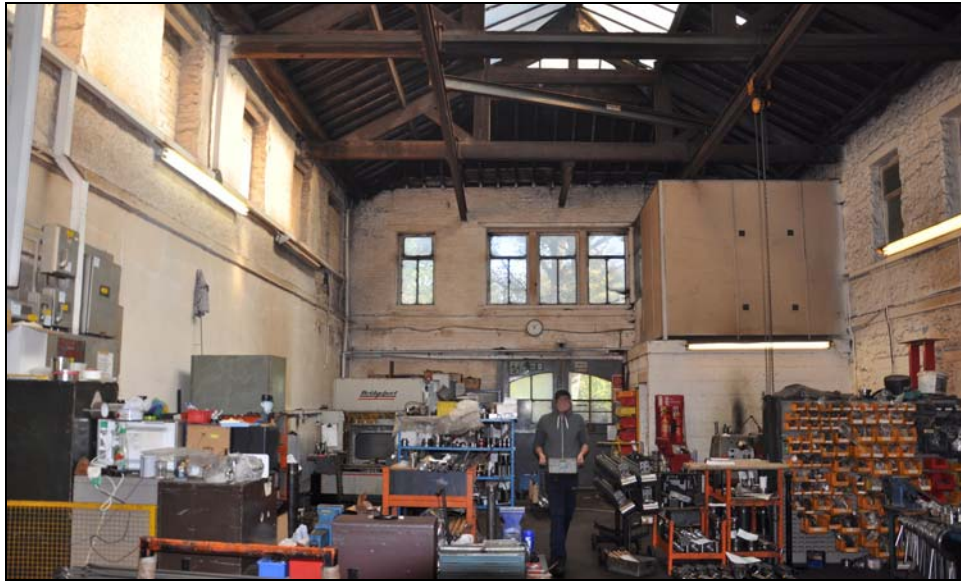
**Photo 9:** building 3

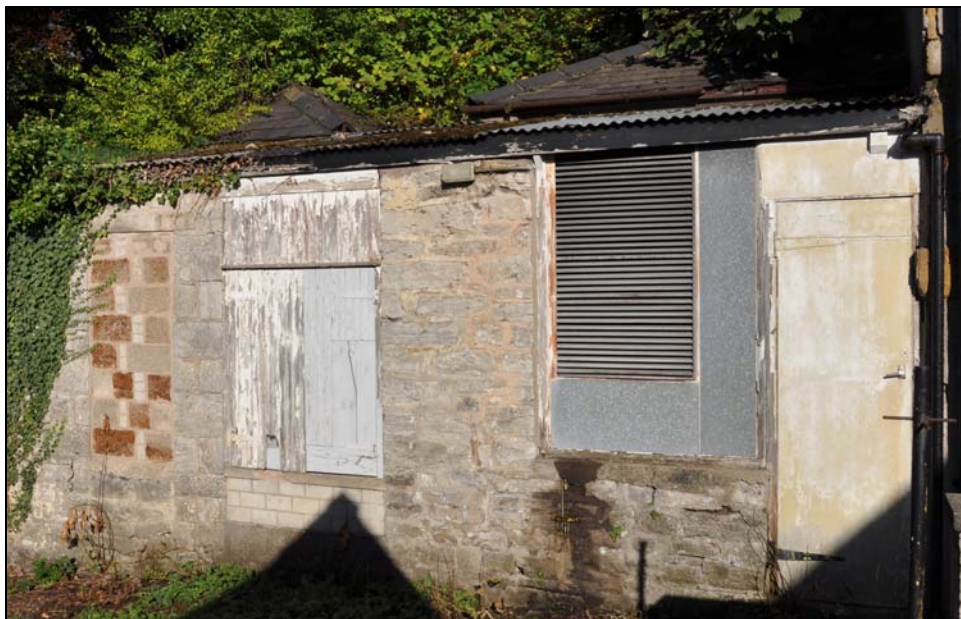
- 5.7 This minor, single storey building at the south-west end of building 1 actually comprises a pair, separated by a short flight of steps, though these are now linked by a modern roof. They have limestone walls and otherwise the roofs are of blue slate. That closest to building 1, but not the other one, is shown on the 1842 map. They have no distinguishing features and former functions are not known.

**Photo 10:** building 4

| <b>Building</b> | <b>Significance</b> | <b>Notes</b> |
|---|---|---|
| 4 | Low | Minor outbuilding with no distinguishing features. |

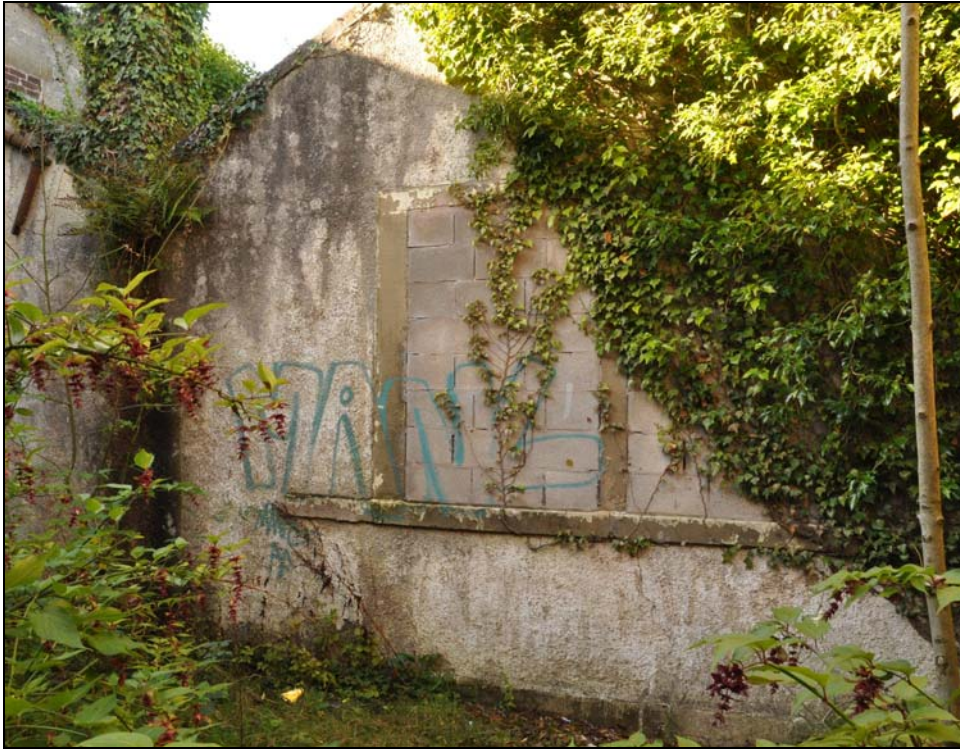
- 5.8 Building 5 is another small, single storey building, much overgrown and with all openings blocked so no internal access is possible. It has monolithic surrounds to the openings, suggesting an early to mid nineteenth century date, but otherwise there are no distinguishing features. It appears to be shown on the 1842 map.

**Photo 11:** building 5

| <b>Building</b> | <b>Significance</b> | <b>Notes</b> |
|---|---|---|
| 5 | Low | Small outbuilding with no distinguishing features, though probably pre-dates 1842. |

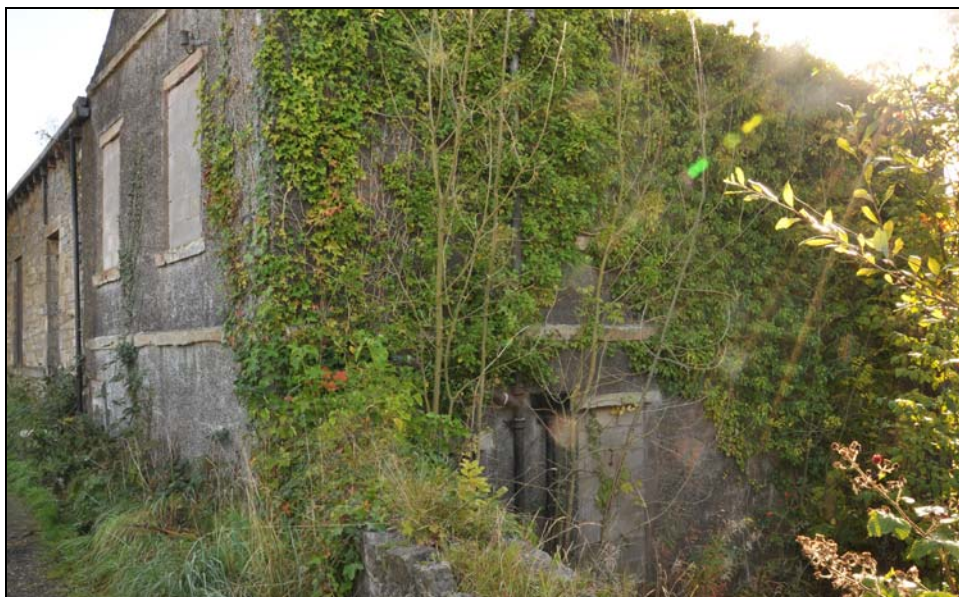
- 5.9 Attached to the south-west end of building 2, where blocked gable windows indicate that it was an addition, this two storey cottage (perhaps a pair of cottages originally) appears to date from the phase between 1854 and 1883. It has sandstone walls covered with roughcast, sandstone bands, heads and sills, and the remnants of a stone slate roof. It is plain and functional in appearance, and is believed to have accommodated a mill manager or other employees at one time.

**Photo 12:** building 6, cottage

| 6 | Low | Former cottage(s) of no particular merit, built between 1854 and 1883. Derelict. |
