BAT SURVEY  
AT  
LANE ENDS COTTAGE  
HUNTINGDON HALL LANE  
DUTTON

DATE AND TIME OF VISIT  
16<sup>th</sup> Nov 2015 3.30pm

REFERENCE. Howarth

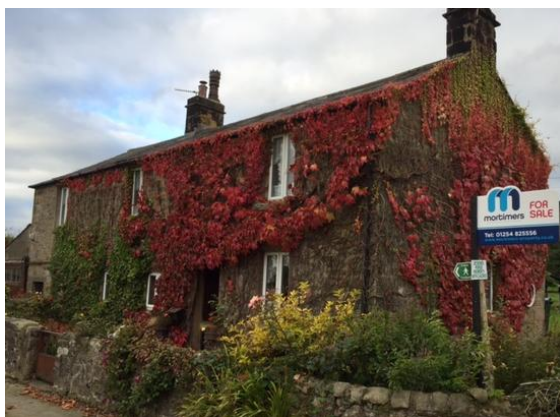
Front ( south ) elevation

The property is currently uninhabited it is a detached period property probably dating from the 1800's which appears to have been modernised during the 1970/80's.

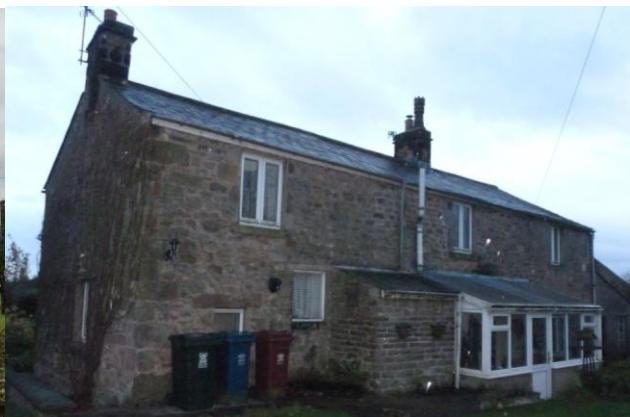
Rear (north ) elevation

It is proposed to build a two storey extension in the middle of the rear elevation of the property and refurbish the interior.

The work involved which could potentially affect a bat population is the disruption to the section of rear roof pitch where the new roof will abut. And the removal of the existing conservatory and Wc prior to commencement.

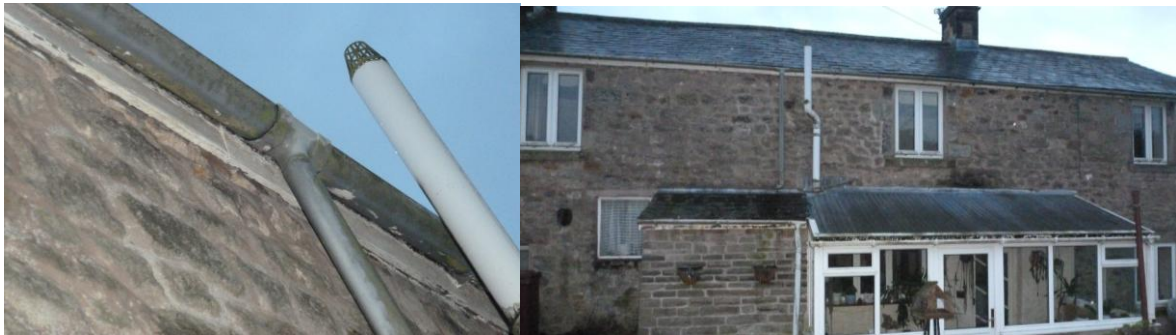
The main roof is pitched. The small ground floor wc has a lean -to roof, both have a blue slate covering. There is a timber fascia fixed directly to the wall. The glazed lean - to has a clear plastic sheet roof finish.

The single storey lean -to's were closely inspected, there were no access points. The main roof was examined with the aid of binoculars it appeared to be in reasonable condition with tight fitting slates, no access points were visible. The timber fascia had some very small gaps where the stone undulated, however there were no grease marks or staining on the timber or walls.

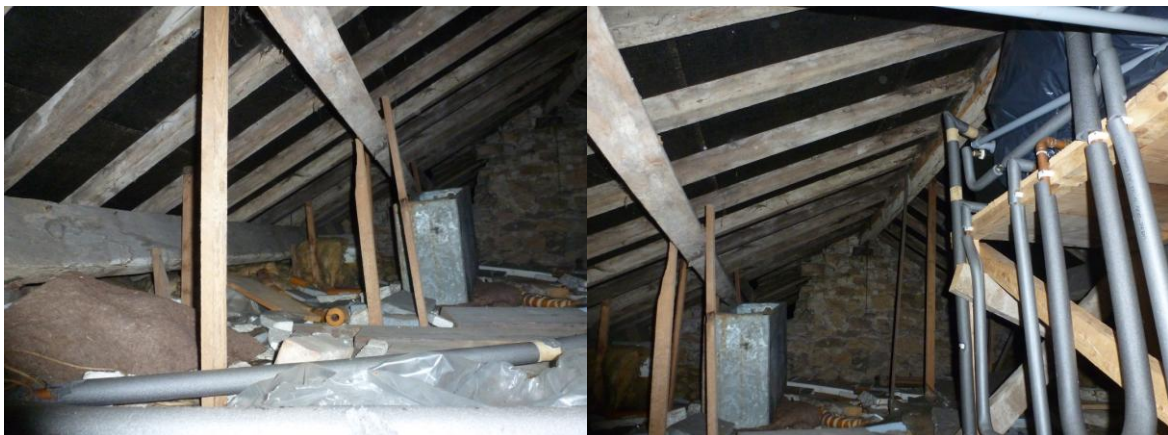
The main roof space was accessible via a ceiling hatch, there was an intermediate stone wall to support the timber purlins, timber rafters were fixed over together with felt. There was insulation quilt between the ceiling joists but this was obscured by plastic sheeting and other waste building materials. The surfaces were checked for droppings and feeding debris, nothing was evident. The timbers were in reasonable condition with no cracks or crevices.

COMMENTS: The roof section being affected did not reveal any evidence of roosting bats or any signs that it had been used in the past.
