**BAT SURVEY**

**AT  
DOWER HOUSE  
PARK ROAD  
GISBURN**

**DATE AND TIME OF VISIT  
14th Jan 2016 10.30 pm**

**REFERENCE NO. 4966**

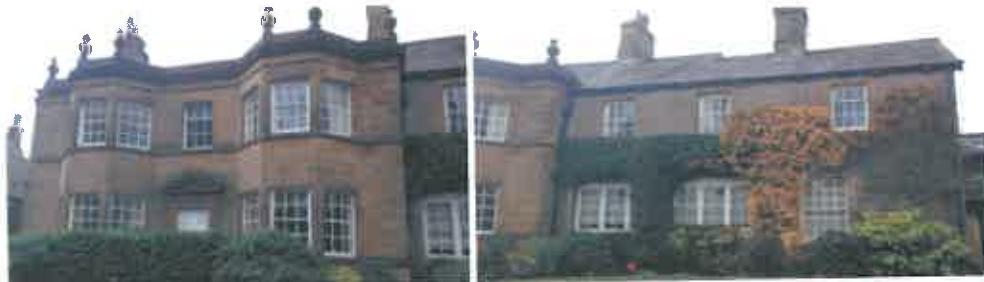
Front (west) elevation of main house

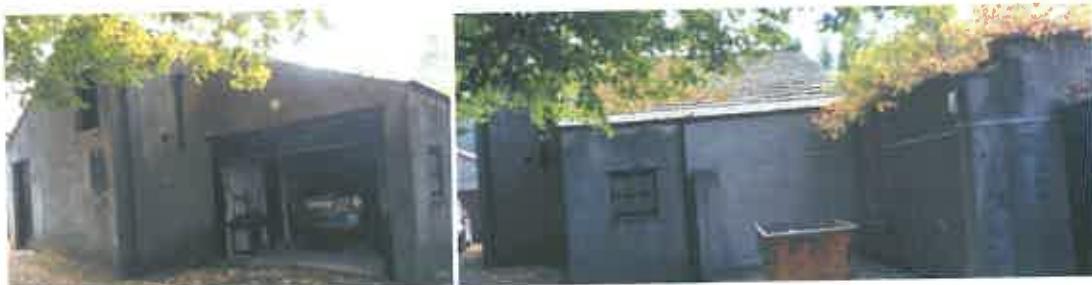
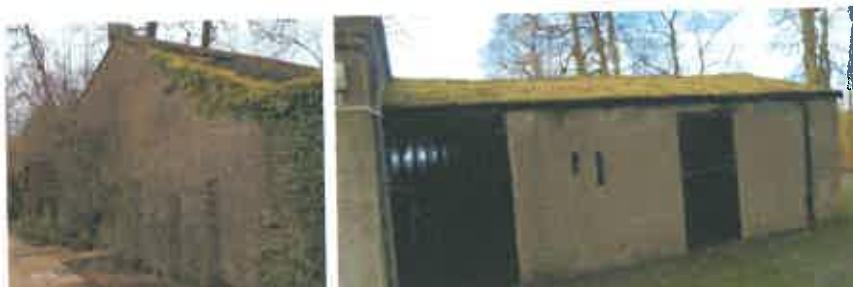
Garage/ store

The garage Walls are in reasonable condition, the render does not have any significant gaps or crevices suitable for bats. There is an opening at high level which provides access to the void over the store section of the garage.

The garage roof on the south east pitch was in a state of collapse allowing access to the roof void. The slates have significant gaps but approx 1/3 of the roof has a dense covering of moss.. The N.E pitch is in better condition with approx 1/2 moss covering. there is some gapping between the exposed slates and there is gapping at the ridge tiles.

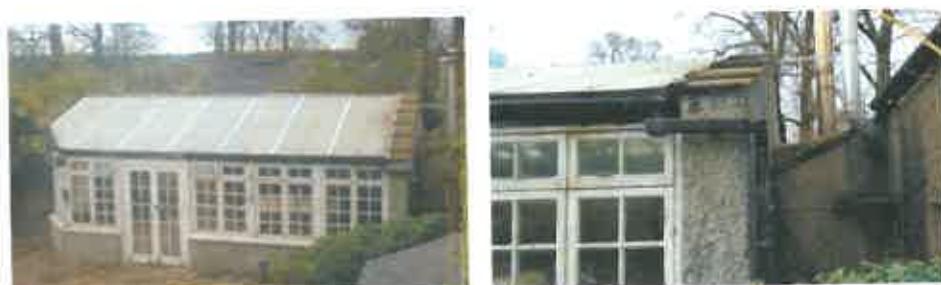
Conservatory front elevations

The conservatory base and rear walls are in reasonable condition with no gaps or crevices suitable for bats. Some of the windows are slightly open which could provide potential access to the interior.

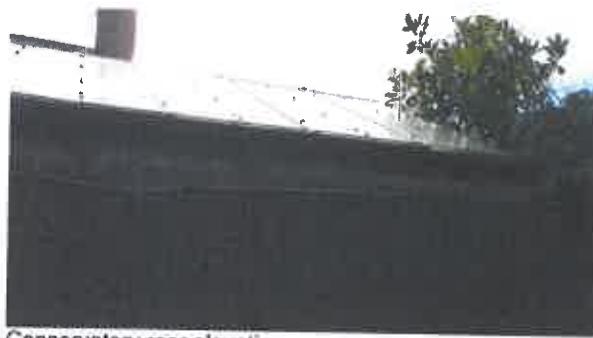
Conservatory rear elevation

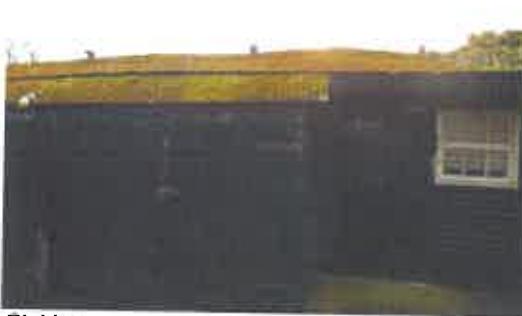
Stables

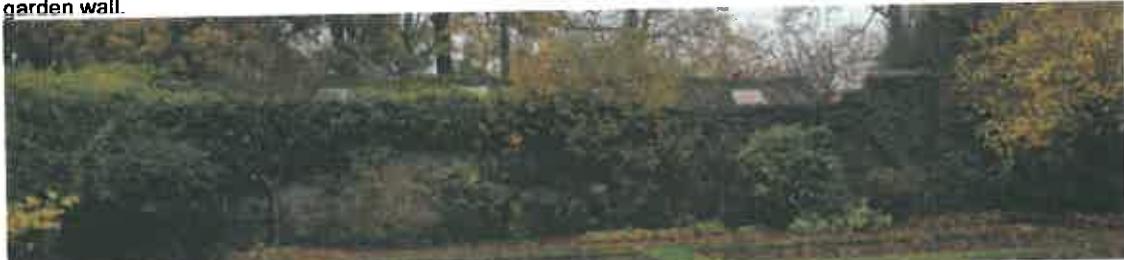
The stables are a combination of brick and timber boarding fixed over a timber frame. The rear wall is the stone garden wall.

The stables rear wall.

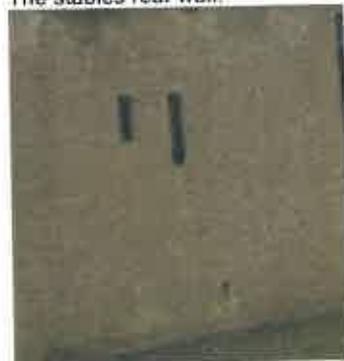
The garage walls are rough cast render.

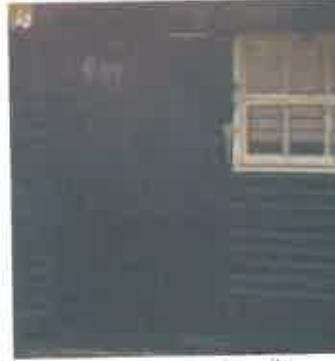
The stables are timber boarding.

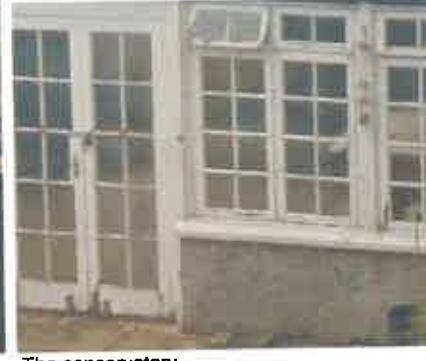
The conservatory

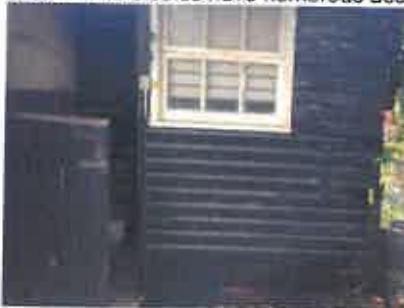
The stables Are in need of refurbishment, there are some sections of rotten wood mainly at low level. See below. The stables have numerous access possibilities.

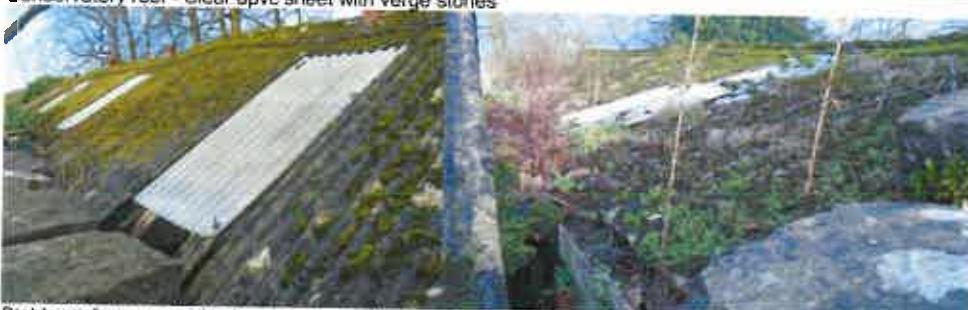
Conservatory roof - Clear upvc sheet with verge stones

The conservatory roof covering had no access points. It was possible to examine the eaves ,crevices and any gaps closely. No signs were found indicating bat use.

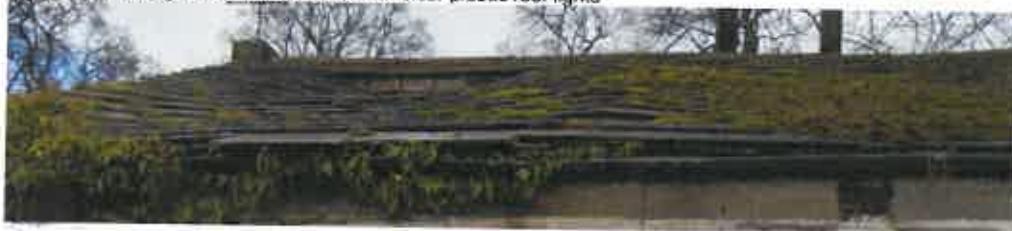
Stable roof- corrugated asbestos sheet with clear plastic roof lights

The stable roof has a corrugated Asbestos sheet covering with some clear plastic roof lights, there is extensive moss coverage. The roof is in poor condition and has gaps in the sheets and circular openings at the ridge ( probably for vent cowls ) allowing potential access for bats and water ingress.

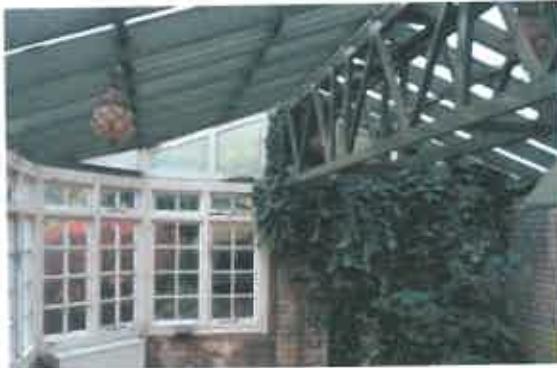
The conservatory does not have a roof void. The roof clear sheets are supported on timber trusses and purlins. The structure is not original to the house and the timbers appear quite recent and in good condition with no cracks or crevices suitable for bats.

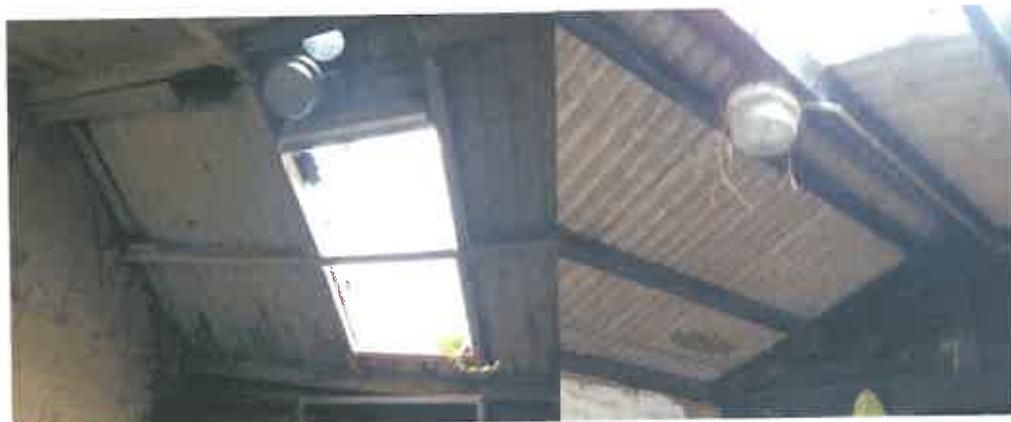
The Stables Do not have an enclosed roof void some of the stables have timber boarding to the underside of the asbestos sheets the timbers are in poor condition the space is generally very draughty and damp. And does not provide good hibernation or roost potential.
