## **Robin Hill, Bashall Eaves, Clitheroe**

### **Bats: Building and Activity Surveys**

**Simply Ecology Limited**

**April 2015 Updated June 2015**

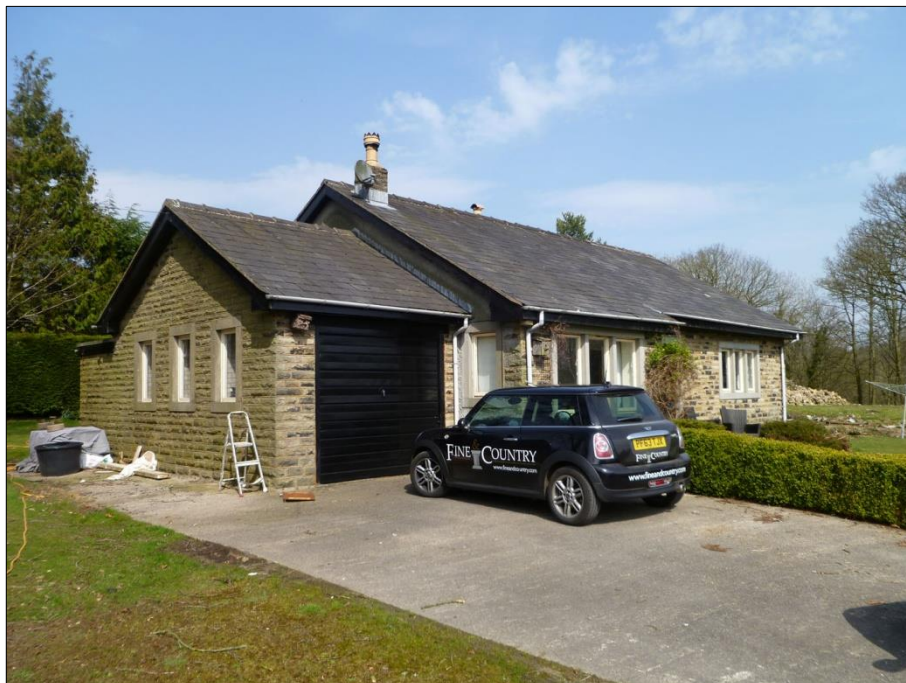
- 3.1.1 The inspection began by checking the exterior of the building for signs of bats including dropping as well as potential access opportunities (See Plate 1). The building was single storey bungalow construction with a pitched slated roof and 150m<sup>2</sup> in size. A garage was adjoining the west side of the building where the inspection began.

Plate 1: Front overview of the building

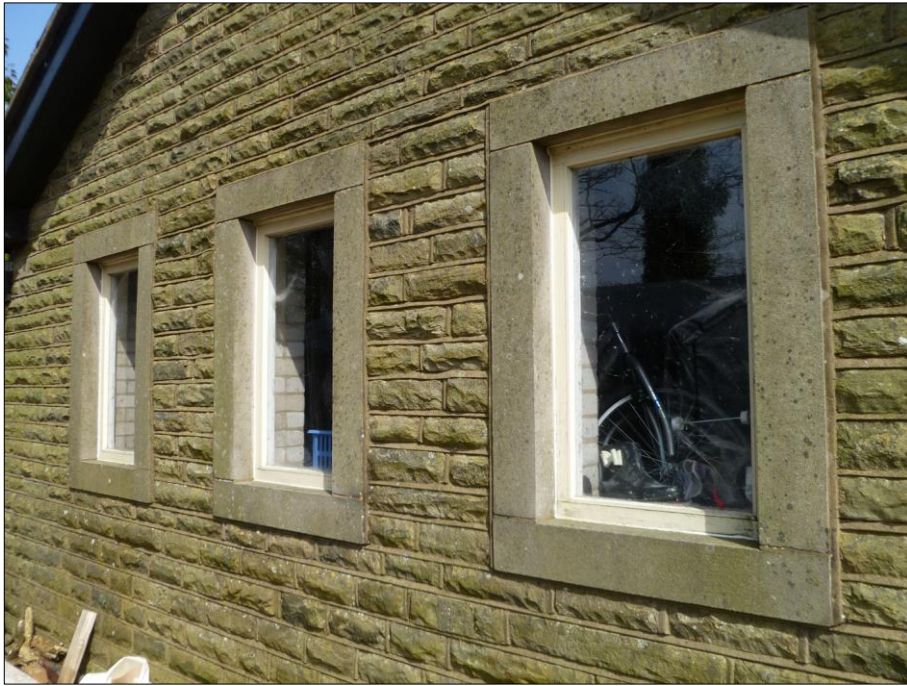
- 3.1.2 A systematic check began by looking for signs of bats beginning with the ground and walls around the building, however no signs were discovered. All windows and doors were timber construction with no cracks or crevices for bats to enter (See Plate 2). A number of gaps and cracks were observed along the underside of the soffit board of the gable where bats could enter (See Plate 3). The roof of the garage appeared in good order with no missing or slipped tiles, however there were a few gaps present within the mortar of the ridge tiles (See Plate 4).

*Plate 2: All the windows and doors were well sealed with no bat access potential*

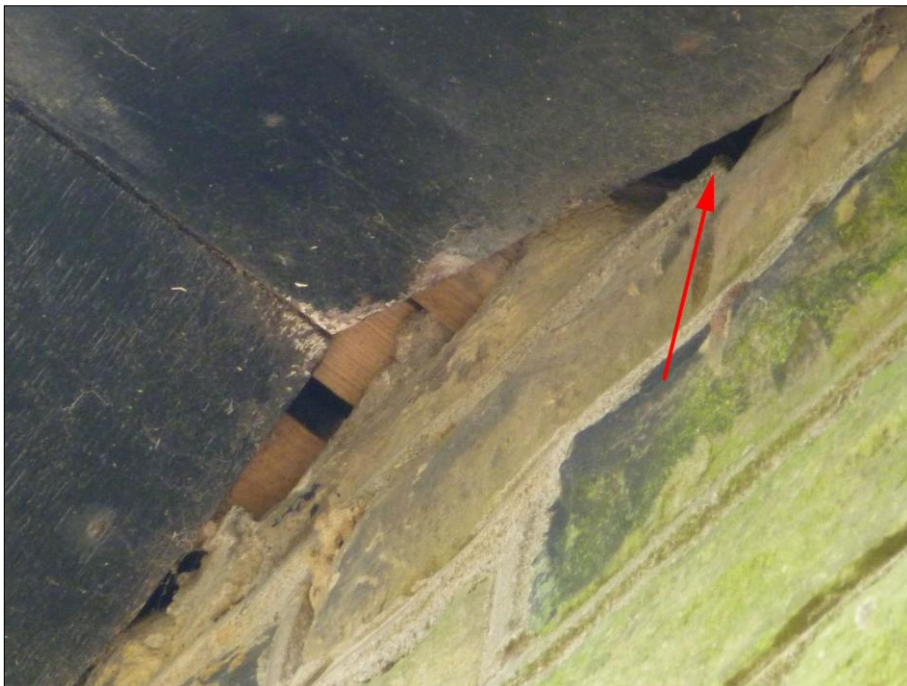
*Plate 3: Gaps where bats could gain access were observed on the garage end gable under the soffit boards*

- 4.1.2 Therefore it is recommended that:-
- A full summertime emergence survey will need to be undertaken on the building to determine location of roosting bats, species and numbers. These surveys should be carried out during the period May-August when bats are active. Upon completion of the bat surveys, the scale of impacts upon bats will be known and appropriate mitigation could be designed accordingly. **Reason:** In order to comply with the Wildlife and Countryside Act 1981 (as amended) (Section 9, Schedule 5 and The Conservation of Habitats & Species Regulations 2010 (Regulation 41).

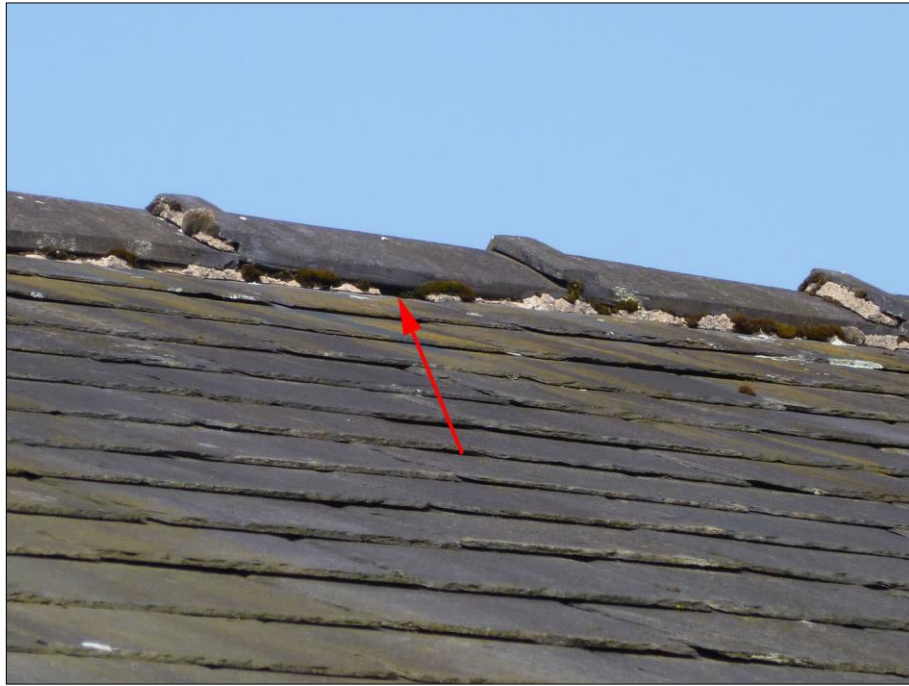
*Plate 4: Potential access opportunities were observed along the ridge line of the garage section of the building*

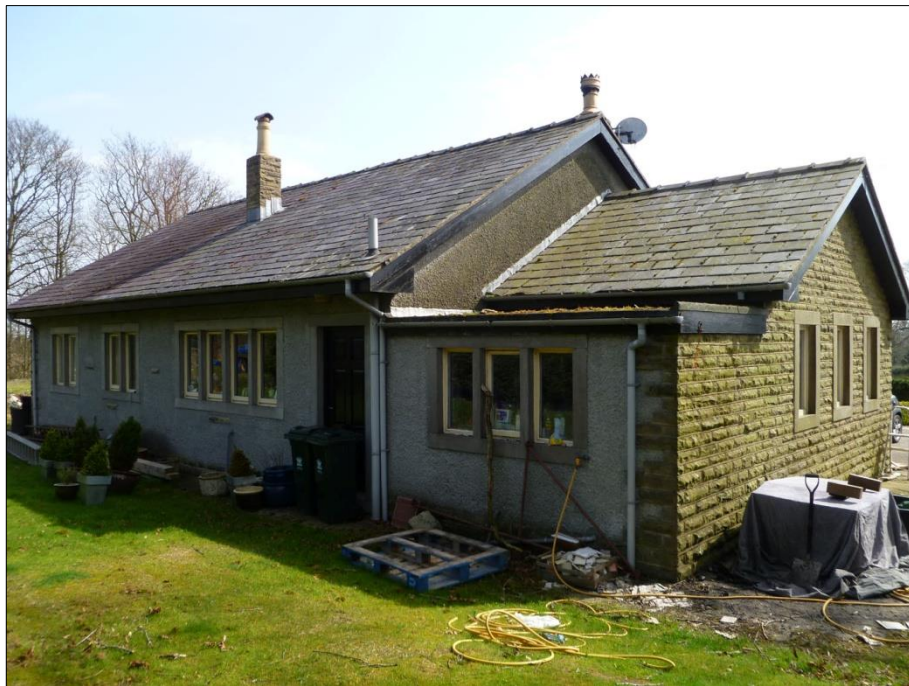
- 3.1.3 The inspection continued around the rear of the property where a small storey flat roof extension was located (See Plate 5). The fascia board on the flat roof was checked and shown to have bat access potential due to the side of the gap (See Plate 6). The windows around the rear of the building were well sealed with no bat access potential. The rear side of the building revealed no bat access opportunities, the undersides of the soffits were well sealed against the building (See Plate 7). The rear side of the roof appeared in good order with no slipped or missing slates or ridge tiles (See Plate 8). The east end gable and front face of the building were finally checked but all shown to be well sealed with no bat access potential (See Plate 9 & 10). **Overall the external inspection revealed potential bat access on the west side of the garage. The rest of the main building showed no access potential.**

*Plate 5: Rear side of the property showing a flat roof extension attached to the garage*

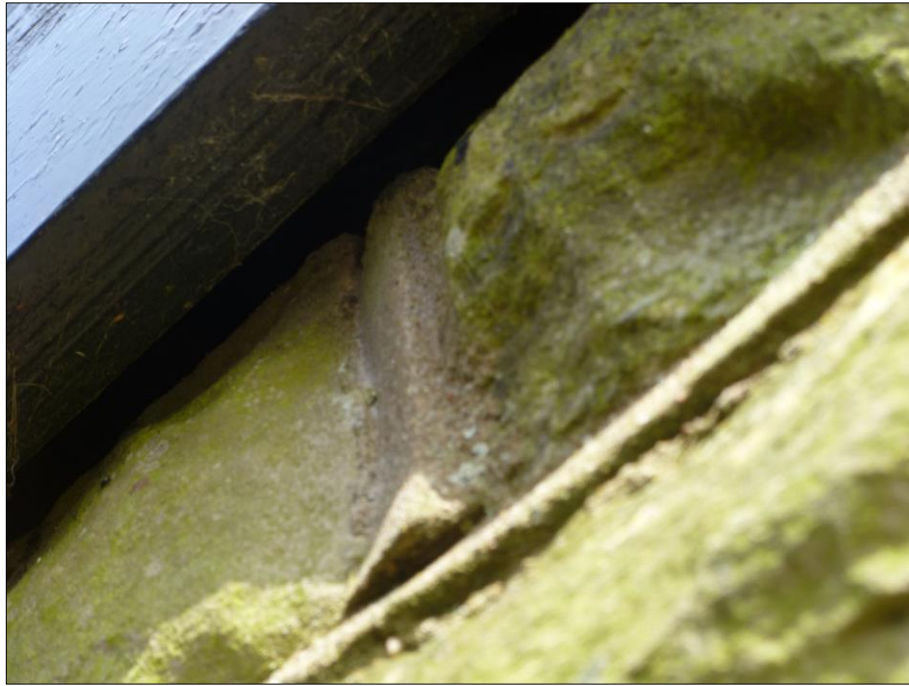
*Plate 6: Gaps between the fascia board and wall could allow bat access*

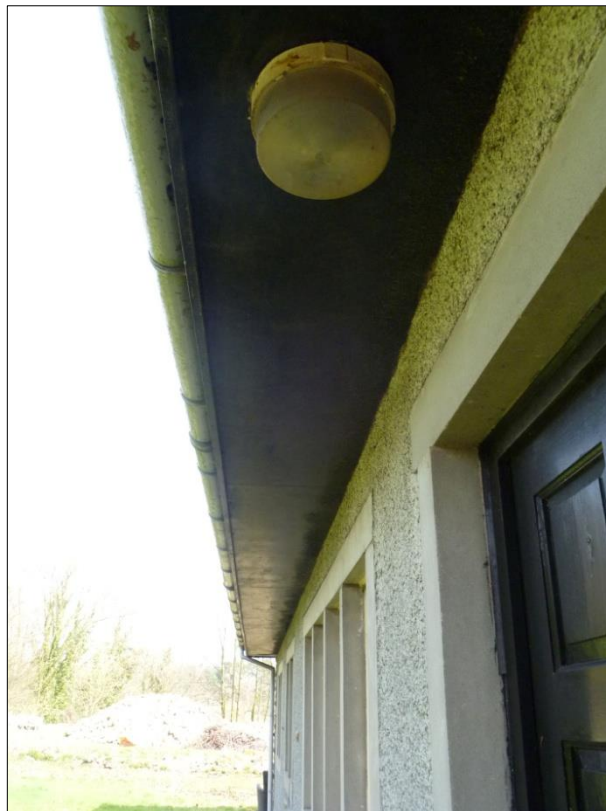
*Plate 7: Underside of the soffits running along the rear side of the property were well sealed so stopping any bat access potential*

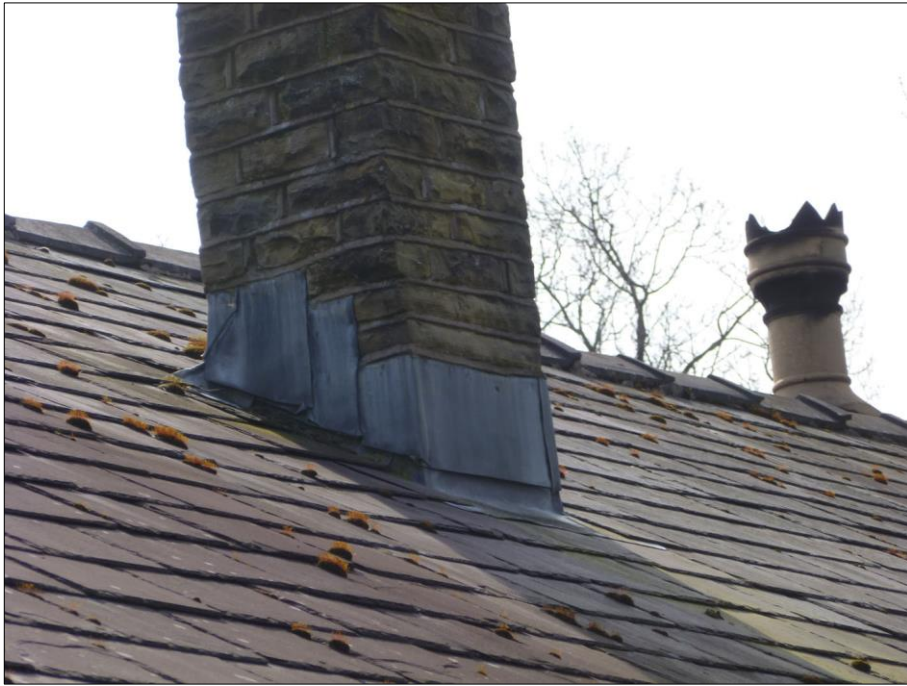
*Plate 8: Rear side of the roof revealed no bat access potential*

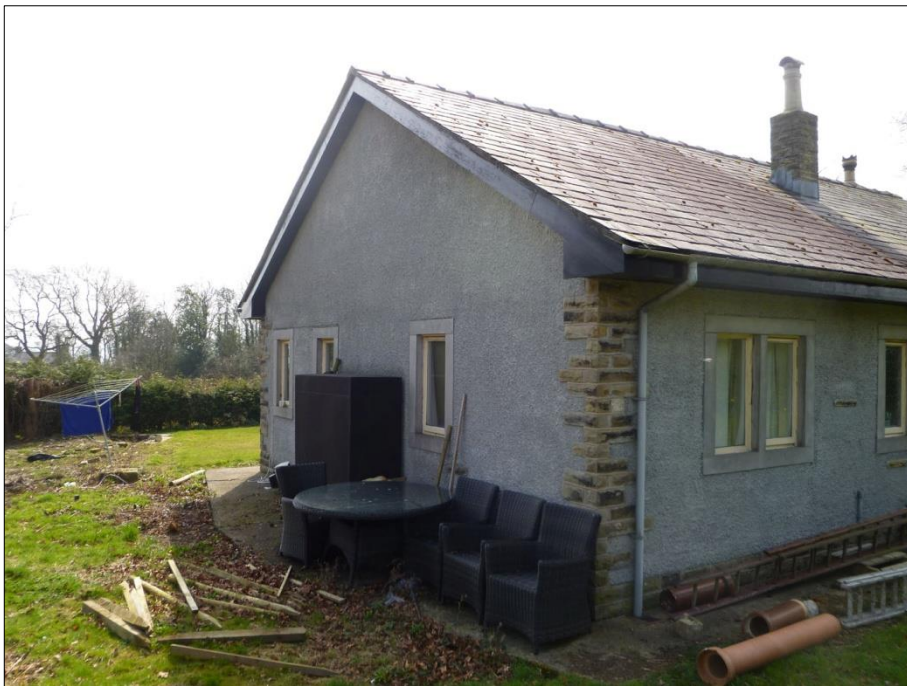
*Plate 9: East end gable with well sealed windows and no access potential around the soffit*

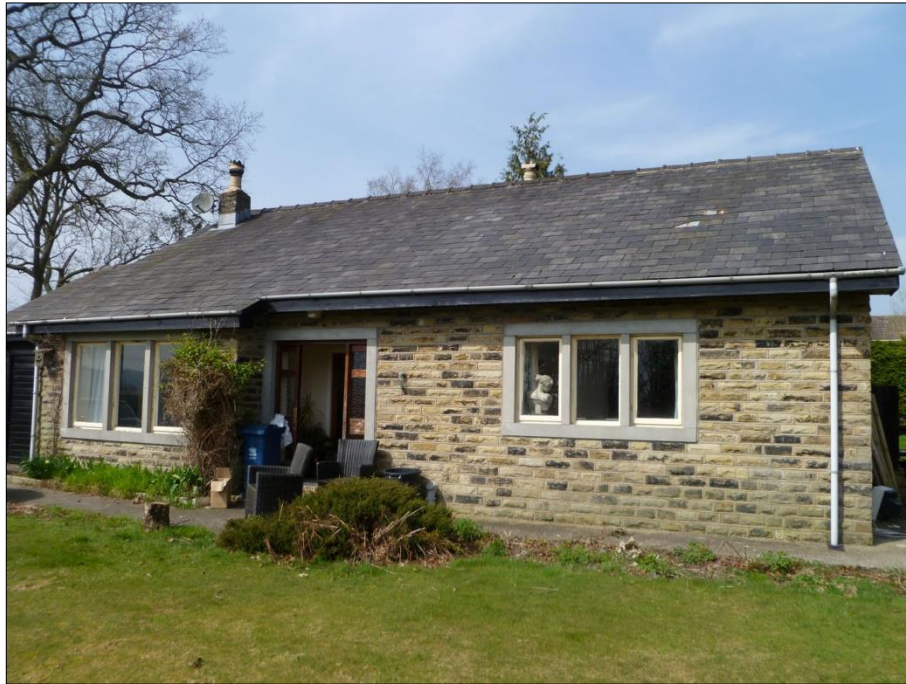
*Plate 10: Front face of the property showed no bat access potential*

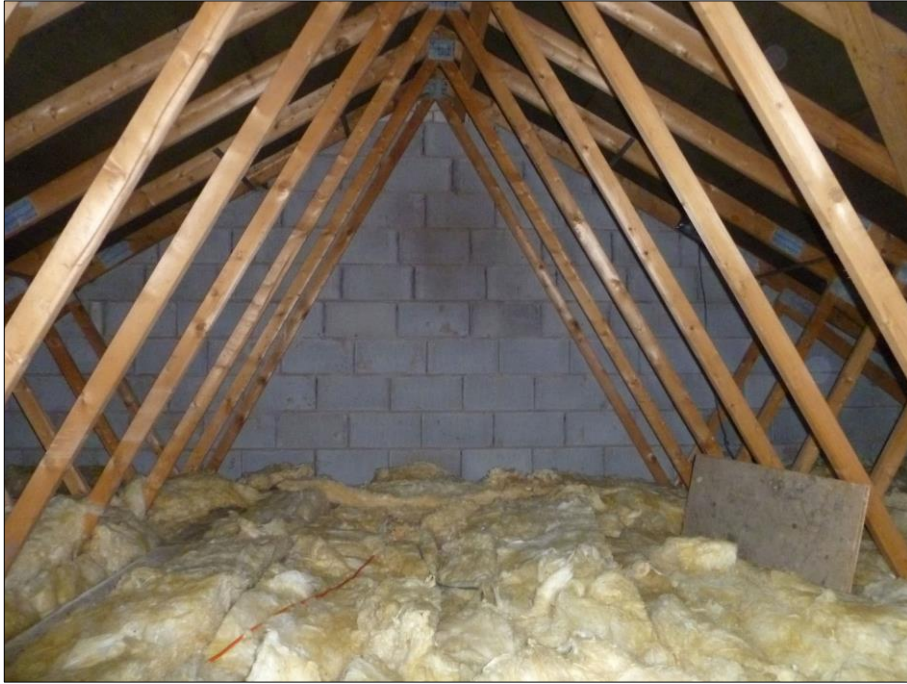
- 3.2.1 An internal inspection was undertaken inside the loft/attic space within the main part of the building (See Plate 11 & 12). This revealed a large open space with prefabricated truss framing and bitumen roofing felt. The space was thoroughly searched and no signs of bats were discovered including droppings or feeding remnants.
- 3.2.2 An internal inspection of the garage area revealed an open floor to roof space with plasterboard on the underside of the roof (See Plate 13). A number of droppings were discovered caught within cobwebs on one of the walls (See Plate 14). These were checked using the standardised crumble technique and shown to be bat droppings. **Overall the internal inspection discovered bat droppings inside the garage section of the building.**

*Plate 11: Internal loft space of the main building showed no bat signs or access potential*

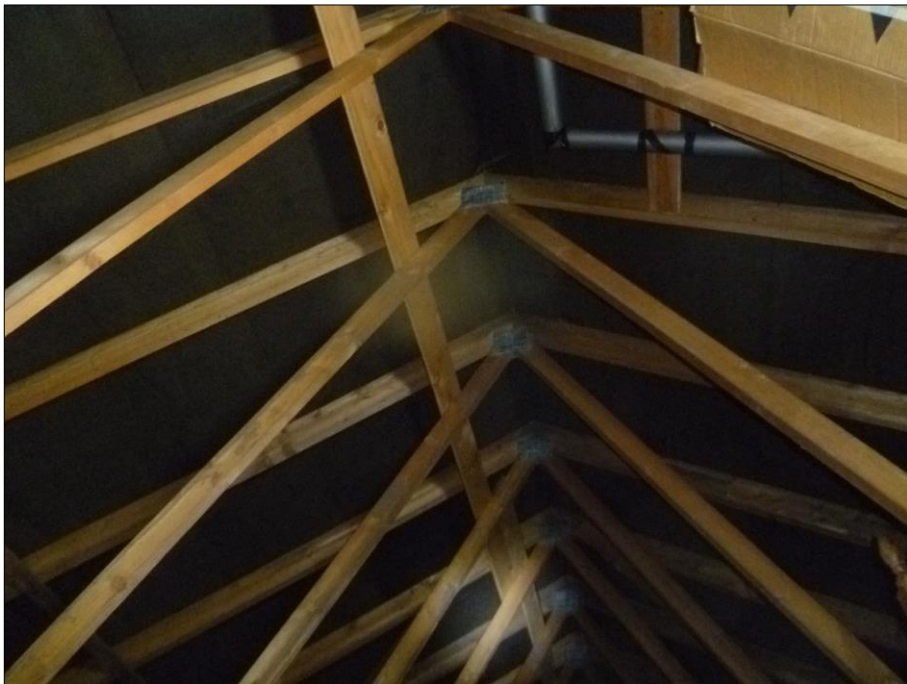
*Plate 12: The underside of the roof revealed bitumen felt in good order*

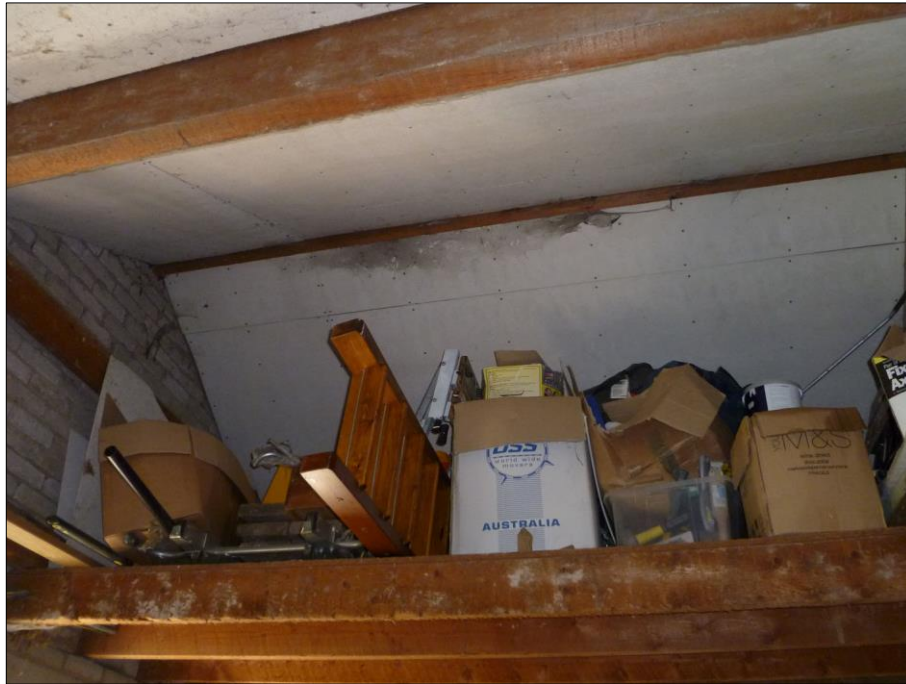
*Plate 13: Internal loft space of the garage showing plasterboard*

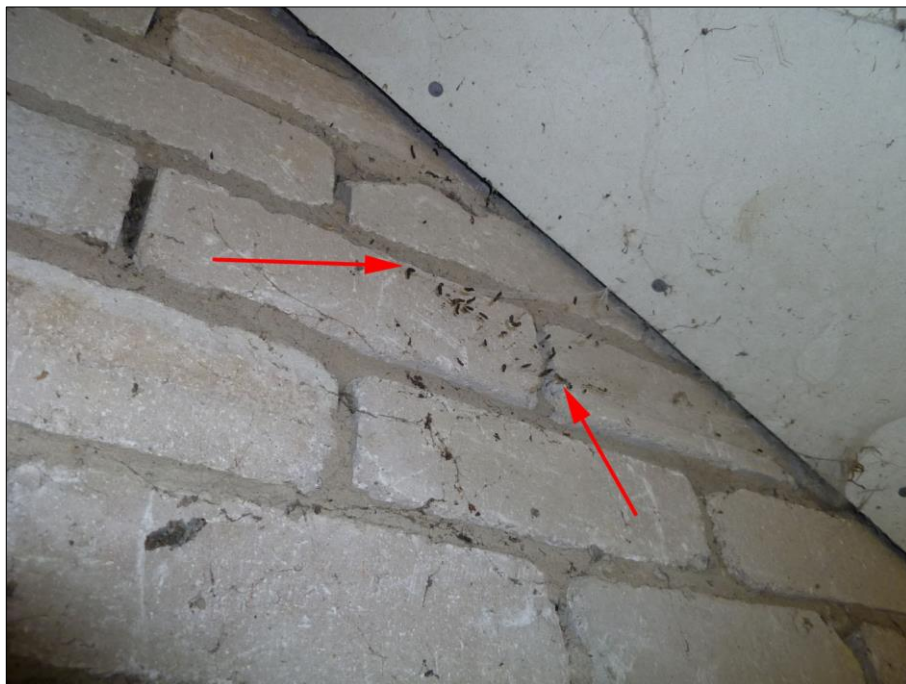
*Plate 14: Bat dropping discovered on interior wall caught within cobwebs indicating bat presence*

- 4.1.1 An external visual inspection survey of the building revealed potential access into the garage section of the building which was confirmed by the presence of bat droppings during the internal inspection of this section. The exterior and interior of the main section of the building revealed no bat access potential or signs.
