**Little Dudlands Farm, Rimmington Lane, Clitheroe, BB7 4EA**

## **Bat, Barn Owl & Breeding Bird Survey & Assessment**

**Sept 2013 (released Jan 2014)**

Ribble Ecology ref: RB-13-137

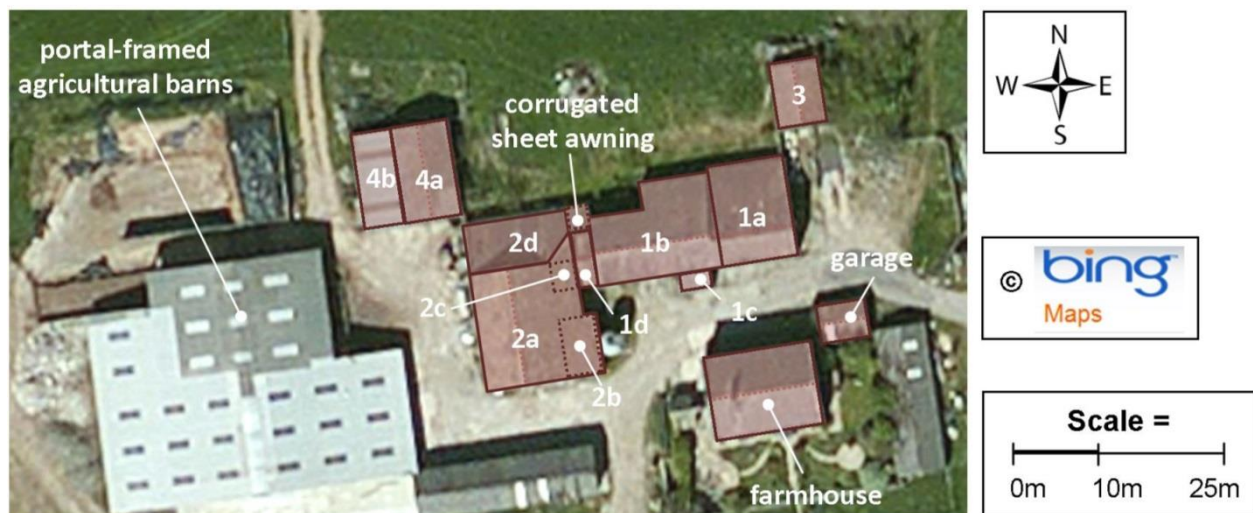
**Fig. D.1: Labelled layout of the buildings at Little Dudlands Farm**

**Fig. D.1** shows the orientation and size of the buildings at Little Dudlands Farm. As well as exemplifying those within the Site (labelled 1 – 4), it also shows the relative locations of others, including the farmhouse and portal-framed farm barns that are not included in the proposal.

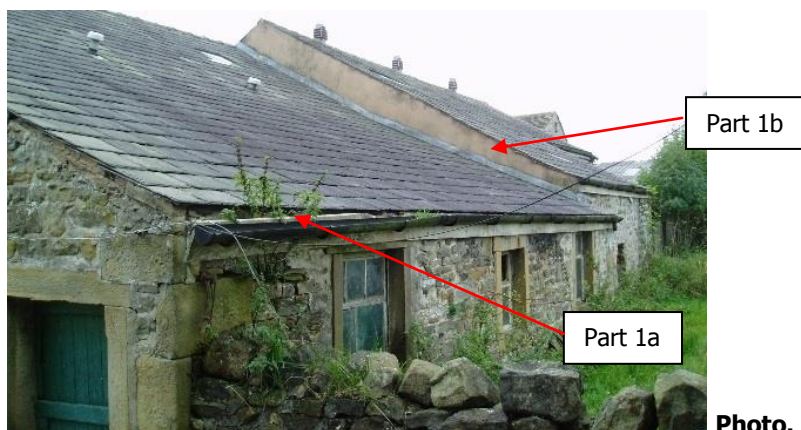
The northern elevation of this large stone-walled barn is shown in **Photo. 1** (next page), though additionally Parts 1c and 1d are small single-storey additions that are seen at the southern elevation, as labelled in **Photo's 2 and 3** (next page). All four parts are described in a little more detail in the following paragraphs.

**Part 1a** is the easternmost end of this large stone-walled barn, for which the eastern gable end is seen here in **Photo. 4**. As shown, it comprises a structure that is predominantly two-storey in height, but diminishes to single-storey at its rear (northern) elevation, as exemplified in **Photo. 1**.

In relation to the roof, this comprises a traditional queen-post timber frame, externally finished with slates and underlined with bitumen felt. The roof is in good condition, as can be seen from **Photo. 1** (preceding page), yet there are still occasional gaps under slates and where the edge slates are bedded on mortar at the eastern end there are occasional gaps beneath them. Additionally, there are ceramic ridge tiles that are bedded on mortar, but again there are occasional gaps where mortar is missing. Many of the gaps are likely to be suitable for use by crevice-dwelling bats. It is judged that they will afford low-moderate potential value for roosting, though they will be of no value to hibernating bats.

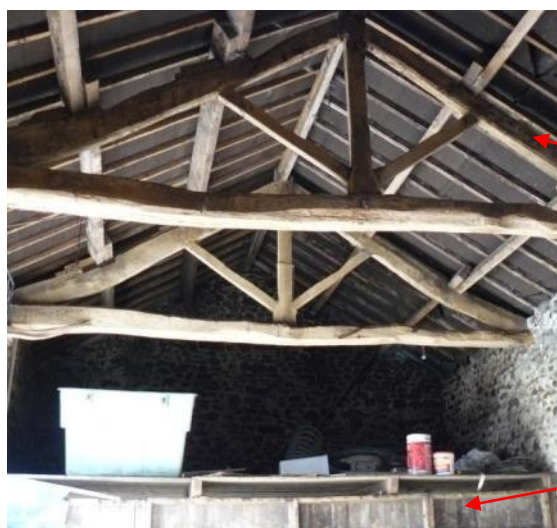
As shown in, **Photo. 5** (next page) structurally there is a traditional king-post frame, over which there is an exterior finish of slates, mounted over bitumen felt underlining (there are also a small number of skylights). Comparable with Part 1a, the slates are neatly laid, but with occasional small gaps beneath them, including at the western gable end. The ceramic ridge tiles are affixed with mortar, but with a small number of gaps. Resultantly there is low-moderate potential value for crevice-roosting bats, though no value for hibernating bats.

Roof in good condition

Single-storey area partitioned off with timbers at northern end

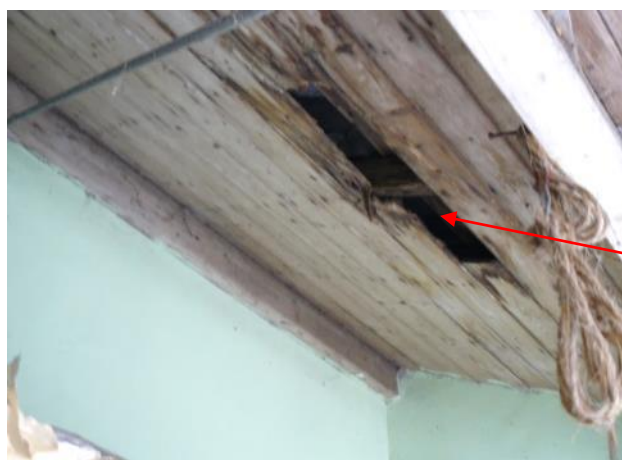
**Photo. 6**

Slates visible through the gap

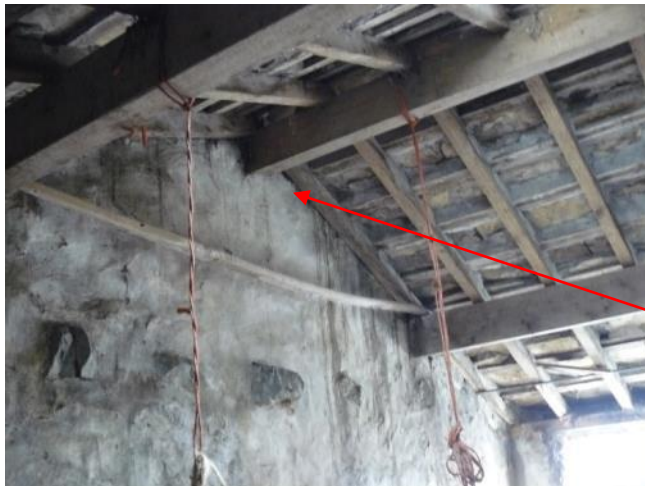
**Photo. 7**

As shown in **Photo. 7**, the interior stone walls are skimmed with a thin layer of lime mortar parging, whilst the slates on the roof are also bedded on lime mortar. There is only low potential value for crevice-roosting bats in association with the roof, but the wall-tops are accessible to bats and thus afford low-moderate potential value for roosting bats.

Potential access gaps  
present at wall tops

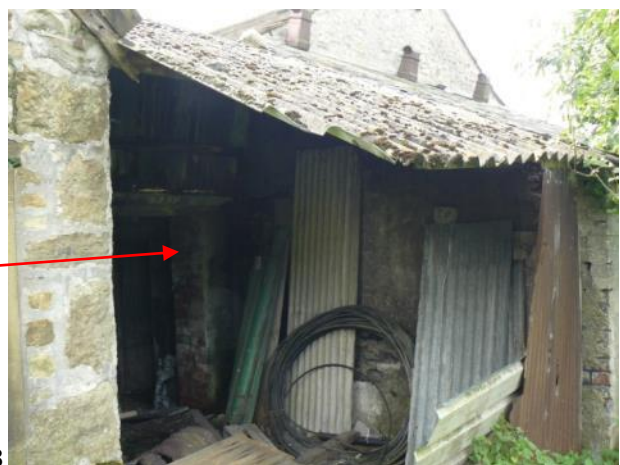
**Photo. 8**

Further, although the window at the southern elevation is sealed, there is open access for birds or bats to use the interior, both via the doorway on the northern elevation and over the door itself on the southern elevation. An awning of corrugated sheet concrete-asbestos is additionally affixed to provide shelter at the northern side, as shown in **Photo. 8**. This is of no value for roosting bats.

Rear wall of Part 1d visible here

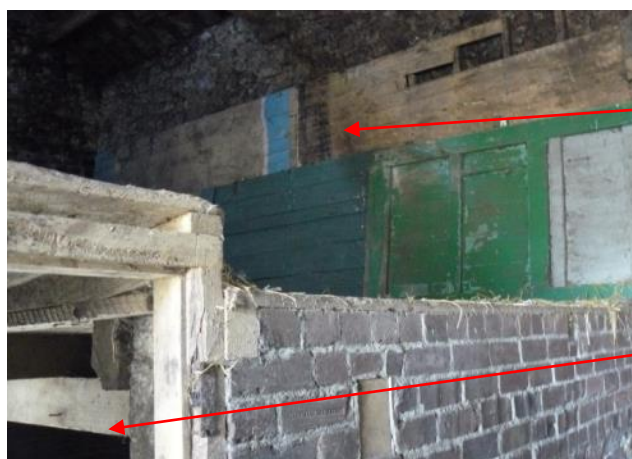
The structure is entirely two-storey in height and is predominantly open from the floor to the underside of the roof, though its southern half is further partitioned down into livestock housing at ground floor level by a combination brick walls and timberwork (see **Photo 11**, next page). As shown, the space above the ground-floor compartments is open at its sides. The compartments themselves display no value for bats, though aforementioned potential value associated with stonework of the walls still applies.

Space above the compartments is open-sided

Entry to livestock compartments via small doorway

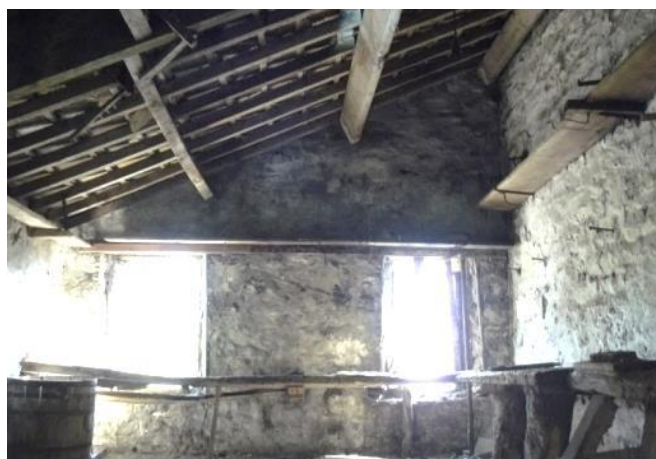
**Photo. 12**

There is then additionally a hayloft / first-floor section, which is exemplified in **Photo. 12**.

Again the roof slates are not lined in Part 2b, but there is local potential value for roosting bats atop the walls and in occasional mortar cracks into the stonework, plus additionally there is access for birds throughout because there are smashed-out windows on the western and southern aspects.

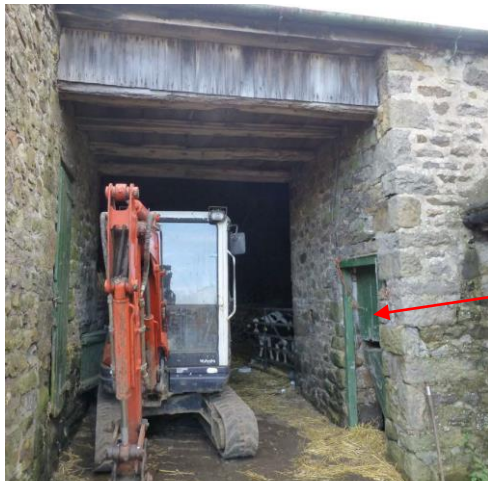
**Photo. 13**

**Part 2c** is another subsidiary section within Part 2a, comprising a small room that is separated from the main barn by the presence of stone walls and that is accessed via the small door shown in **Photo. 13**. The roof and wall structure is the same as for the rest of the building and only affords low potential value for roosting bats.

Entry to Part 2c via small doorway

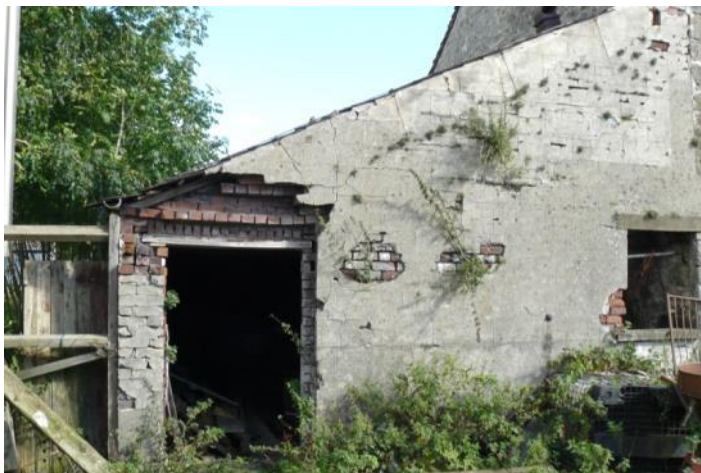
**Photo. 14**

**Part 2d** is the large single-storey extension that is attached to the northern gable of Part 2a. It has rendered brick walls, but as shown in **Photo. 14**, these are in disrepair.

An array of crevices can be found in association with the damaged brickwork and render of Part 2d, many of which afford moderate potential value for use by crevice-roosting bats and low potential value for use by hibernating bats.

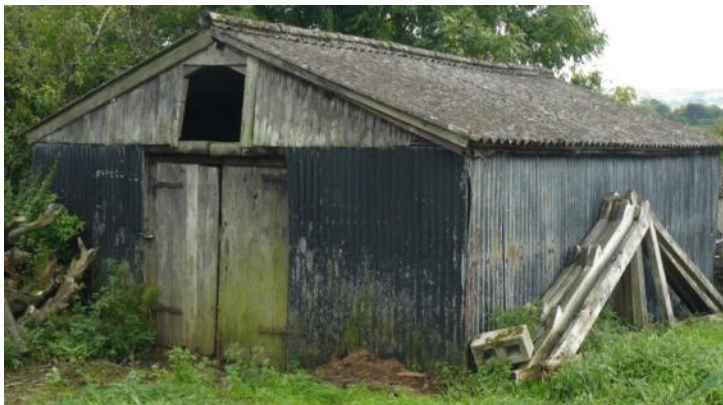
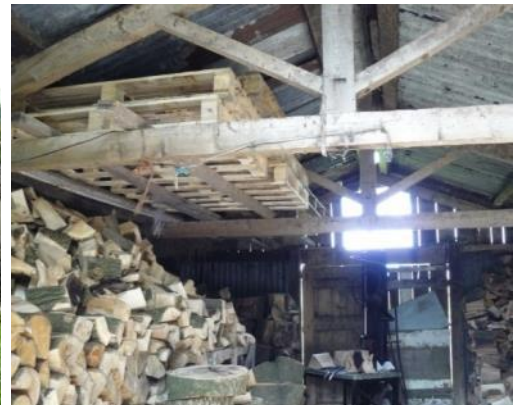
This structure comprises a sturdy timber frame, clad with predominantly corrugated metal sheets to its walls and corrugated concrete-asbestos to its roof, with a concrete-asbestos ridge finish and additionally with the western pitch displaying corrugated metal sheets underneath the corrugated asbestos, as can be discerned in **Photo's 15 and 16**.

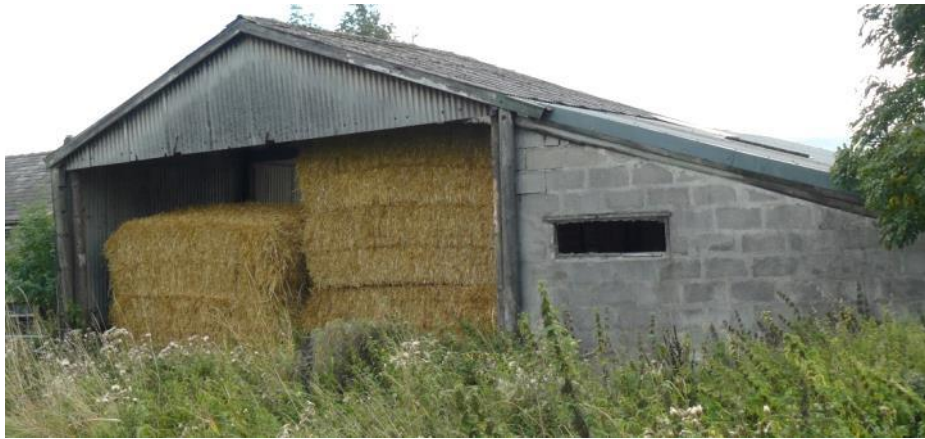
**Photo. 17**

**Photo's 17 and 18** (next page) illustrate exterior and interior structural features associated with

this modern building, which comprises a portal-frame structure, structurally distinguishable as having two parts, as labelled and described below.

**Part 4a** has breeze-block walls along its elevations, but is predominantly open at its gable ends, with only the upper gables finished with corrugated metal sheets to prevent ingress of rain. Its pitched roof is finished with corrugated concrete-asbestos sheets, which are not lined on the interior. As shown in **Photo. 17**, it is used for storing straw bales.

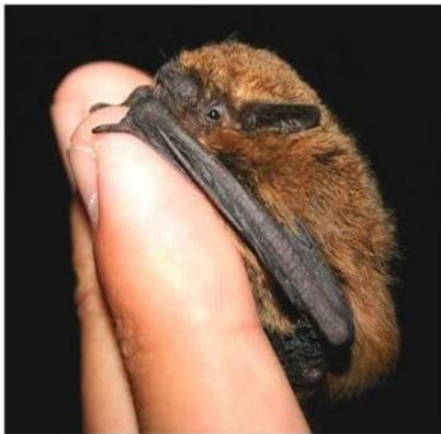
Fully grown Common pipistrelle bat

- All workers will have to be made aware of the potential for occurrence of bats and will have to be alert for the presence of bats, and/or any accumulations of bat droppings at all times when stripping features of potential value. For guidance, the photographs on the following page show a Common pipistrelle bat and an accumulation of bat droppings.

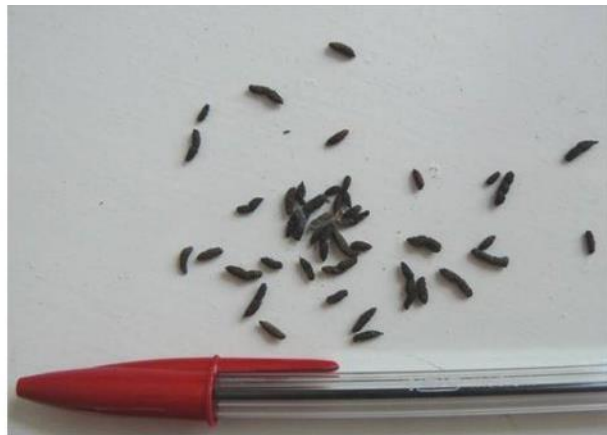
Pipistrelle bat droppings, which look like mouse droppings, but crumble to dust when squashed between the fingers (comprising tiny, glistening bits of insect wings etc.)

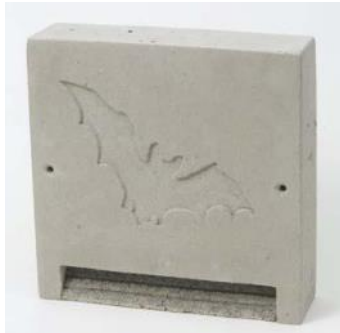
**Ibstock**

Height=265mm Width=180mm  
Depth= 240mm

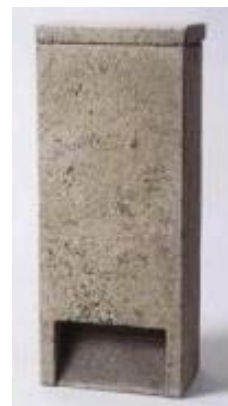
**Schwegler 1FR**

Height=475mm  
Width=200mm  
Depth= 125mm

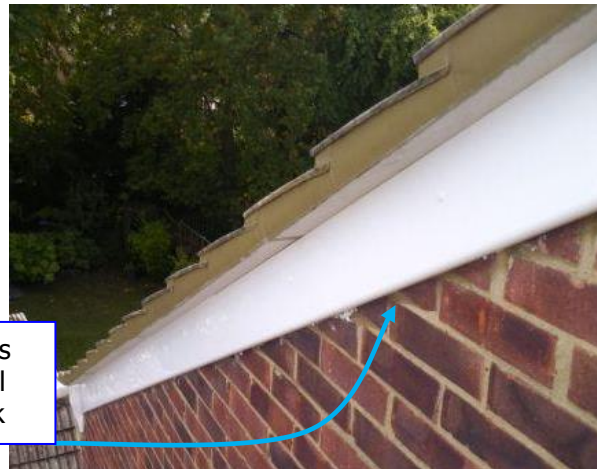
**Fascia boards and barge boards** provide valuable bat habitat, provided they are offset from the stone wall by about 20mm (3/4 of an inch)

Allow a gap for bats to gain access behind this board, where they will roost against the outer stonework

This should allow the bats two options:

- a) Roosting directly between the wall and the fascia board
- b) Access to the tops of the walls (see separate recommendation).

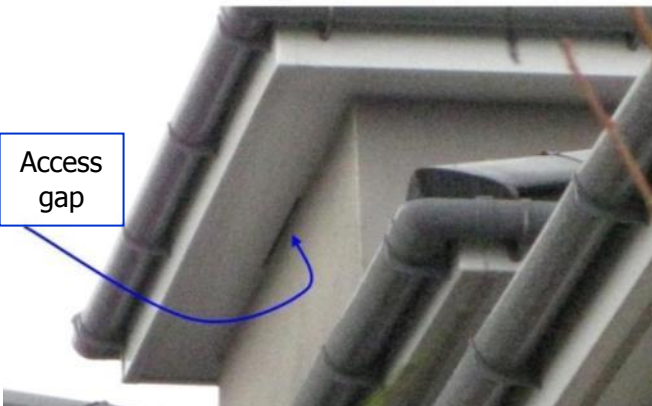
Soffit boxes can be fitted/adjusted so that there is a gap at the back, near the wall, to allow bats to crawl up into them to roost, as shown

Access gap

Depending on the design of the building, access provisions for the bats can then either allow:

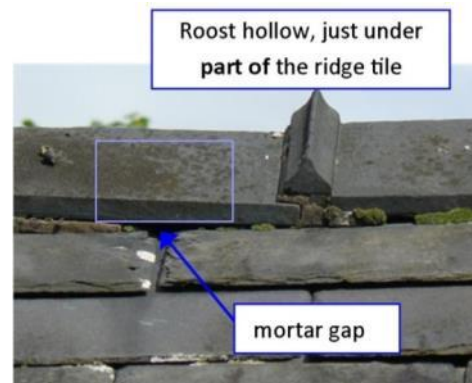
Access **under ridge tiles** can be achieved with no loss of water-tightness.

Small gaps are left out of the mortar of certain ridge tiles and the hollow under the ridge tile is not filled with mortar at these locations, so there is a roost hollow, as shown in the photo & diagram.

NOTE: There is no means of the bats getting into the roof void, or of them making noise that can be heard in the room below because:
