BAT SURVEY
AT
KIRKSTONE
80 MELLOR BROW
MELLOR

DATE AND TIME OF VISIT
9.15 am 4th Feb 2016

REFERENCE NO. 5046

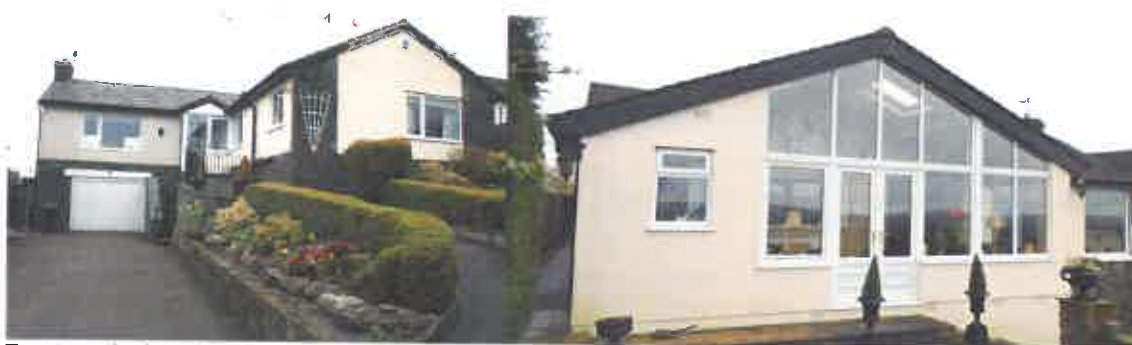
The building is a detached Bungalow currently inhabited , probably dating from 1970's . It is on a sloping site with a lower ground floor garage. The out rigger to the rear is an extension to the original property.

Front south elevation

Rear north elevation

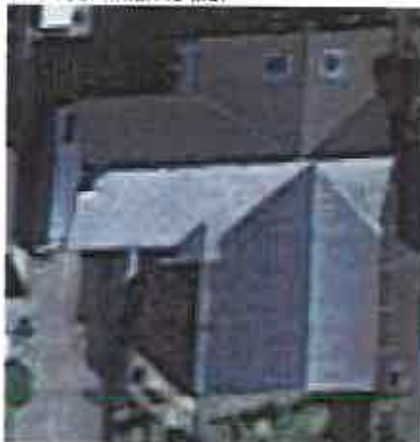
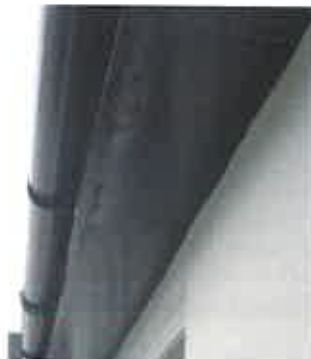
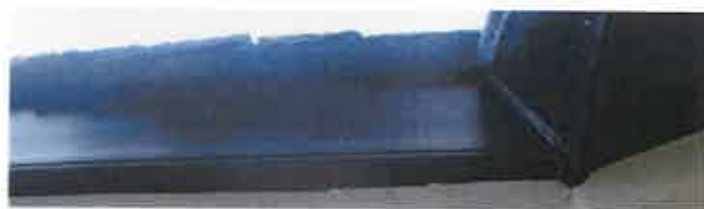
ROOF CONSTRUCTION

The roof has a main pitched roof from west to east, with an outrigger to the front south elevation. A pitched roof outrigger with 2 no roof windows, is located to the rear and is a more recent addition to the building. The outriggers abut the main roof forming valley gutters.

There is a small overhang at the eaves with timber or upvc soffits.

The roof finish is tile.

The roof is generally in very good condition, the tiles are very tight fitting as are the flashings. The fascias and soffits are all in perfect condition and very tight fitting. The roof does not provide any possible access point or cracks or crevices.

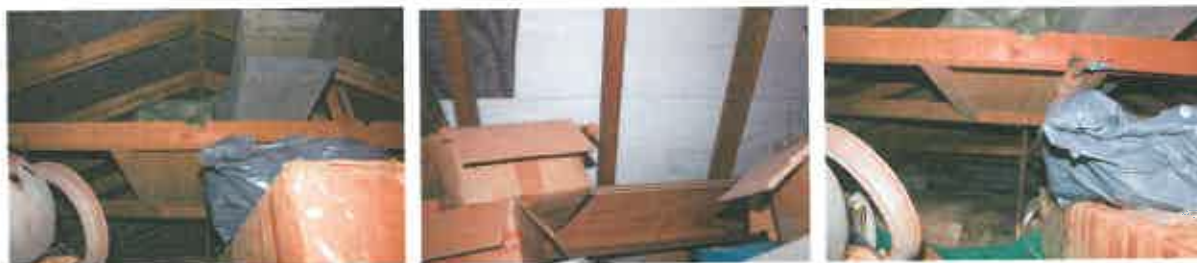
ROOF SPACE

The roof space was accessible via a hatch the space was clean and dry, the timbers were in very good condition as was the felt, no dropping or staining evidence was found. This space is not accessible to bats.
