320160327P

BAT SURVEY

**AT
10 THE HAZELS
WILPSHIRE
BLACKBURN**

**DATE AND TIME OF VISIT
16th May 2016 3.30 pm**

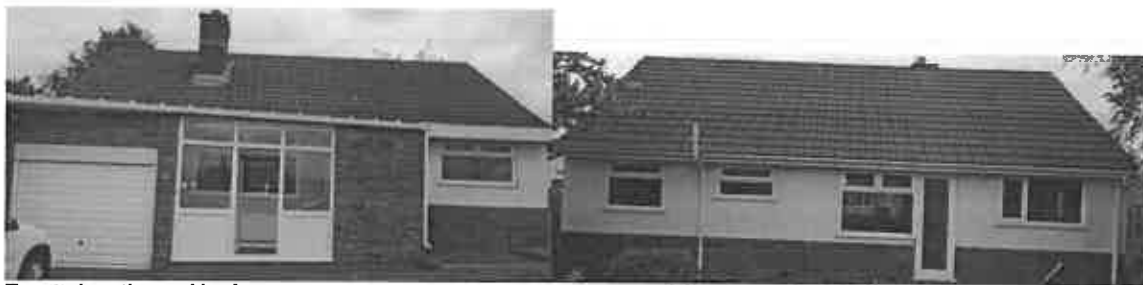
The property is a detached bungalow which possibly dates from the 1980's

Front elevation North west

Rear elevation South east

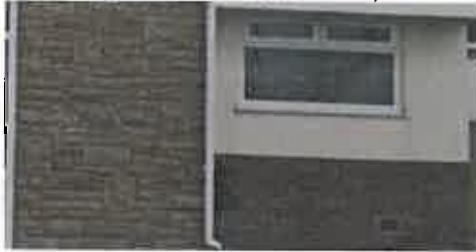
WALL CONSTRUCTION

The walls are a combination of brick, natural stone and painted render probably cavity construction.

BAT ACCESS POINTS IN WALLS

The walls are in excellent condition with no access points, cracks or crevices.

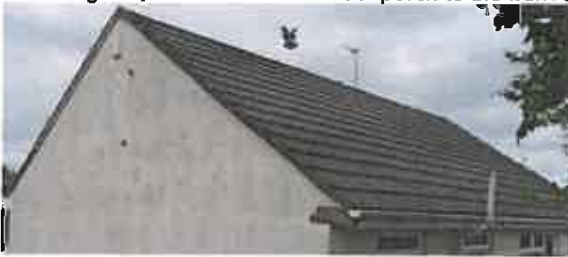
Rear roof pitch

The roof is a pitched construction with an eaves overhang. The roof finish is profile tile, the fascias and eaves overhang is upvc. There is a flat roof porch to the front elevation which will not be affected by the extension.

The roof tiles are in good condition and tight fitting with no access points. It was possible to closely examine the eaves and the upvc soffits, they are tight fitting to the wall however the rear overhang has vent holes two of which don't have grilles in place. However being at such a low level it is highly unlikely that bats would use the access points.

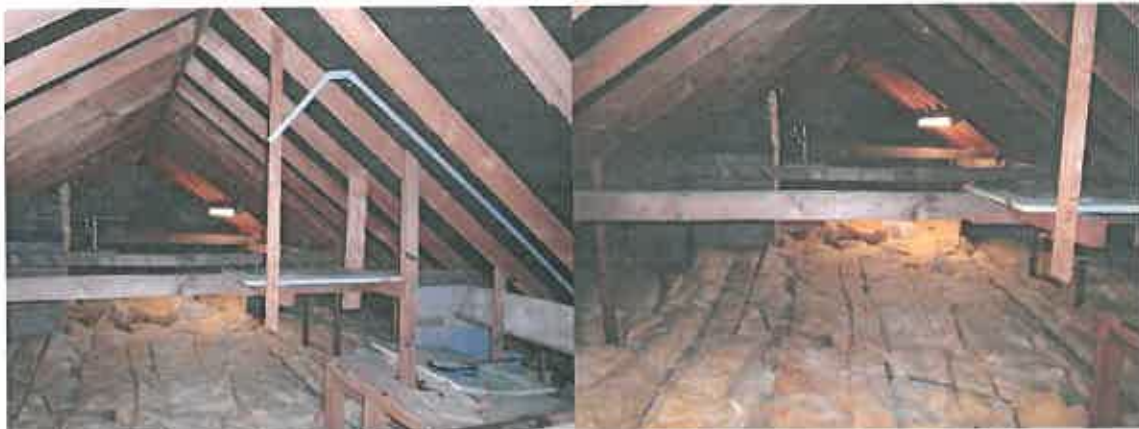
Roof void

The roof space was accessible via loft ladder and hatch. An area of boarding was laid over the joists but the majority of the space was insulated at joist level with quilt which had been laid approx 1 year ago, together with the installation of vents in the felt to provide cross ventilation to the void. The insulation and boarding were clean and free from any dropping or insect remains. The timbers and felt were in perfect condition, the space generally provided sub optimal roosting and foraging potential.
