BAT SURVEY

**AT
129 Pasturelands
Billington
Whalley**

**DATE AND TIME OF VISIT
7th June 2016 4.00pm**

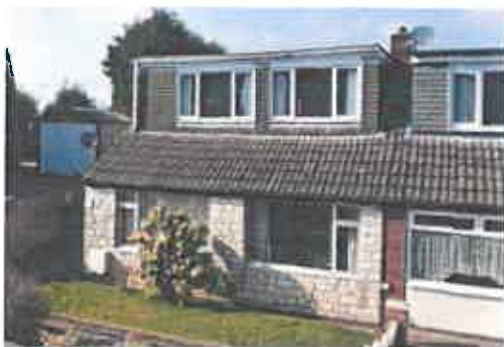
Front elevation

The building is a semi detached dormer bungalow with dormers to the front and rear.

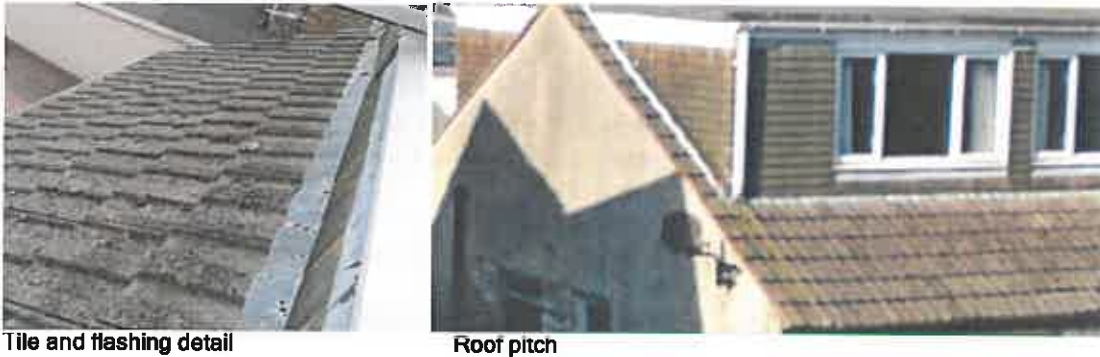
The roof is pitched with flat roof dormers to the front and rear. The roof covering is profile tile with no overhang at the eaves. The flat roofed dormers have a bitumen felt finish. The gable verge is pointed

The tiles are in good condition and very tight fitting. It was possible to examine closely the eaves and fascias for any potential gaps or access points. The pointed verge is in good condition with no access points or crevices. The roof felt appeared to be in good condition.
