**BAT SURVEY**

THE OLD POLICE HOUSE  
GARSTANG ROAD  
CHIPPING

DATE AND TIME OF VISIT  
6 April 2016 9.30 am

REFERENCE NO. 5024

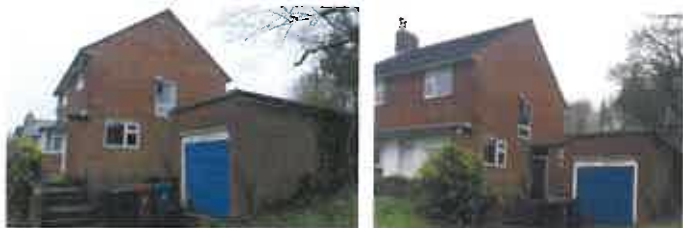
Side north east elevation of house and single storey section to be demolished

Rear north west elevation

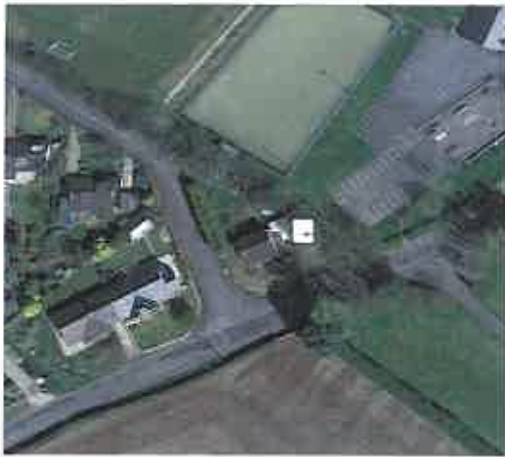
The front south east elevation faces Garstang road with open pasture land extending to the south. The house is located in a garden which extends to the front and rear, the rear garden tapers to a point and is bordered on the north west side by a small stream with the playing fields beyond and has Broad Meadow road on the south west boundary. There are potential foraging corridors in the form of hedge rows which radiate from the house following field and playing field boundaries however there are no significant wooded areas or areas of open water within 250m of the house. The nearest wooded area is beyond the settlement area of chipping to the north ( distance approx 550m )it lines a valley which contains weirs and lodges used by local Mills Further north The houses on Broad meadow and the adjacent houses on Garstang road are of a similar type all with gardens containing domestic planting. Whilst north of the village settlement area can be considered an optimal roost and forage habitat, the immediate area is not considered to have optimal foraging potential.

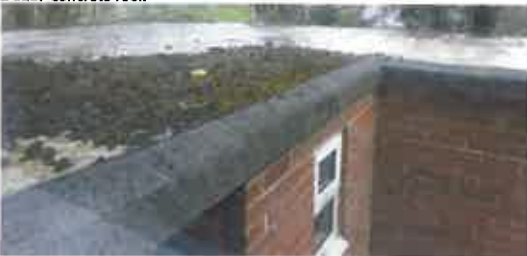
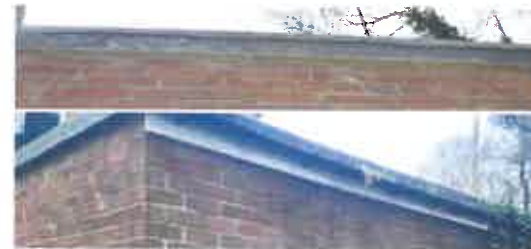
Eaves drip detail

Eaves detail of flat roof

The roof covering is in good condition, with the exception of a section of felt on the rear elevation (see below) which has lifted, however it was possible to closely inspect no bats are using the void. There is a barge board flush fit to the side (north east) elevation which does not provide a void behind. The recess behind the eaves drip detail is shallow and does not provide suitable habitat for bats.

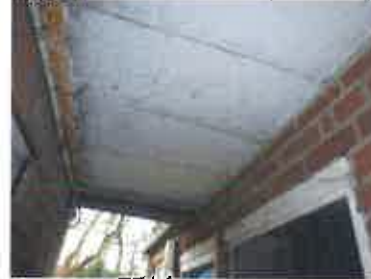
There is no enclosed roof void or suspended ceiling the concrete roof is cast over the walls.

The section of roof connecting the house to garage

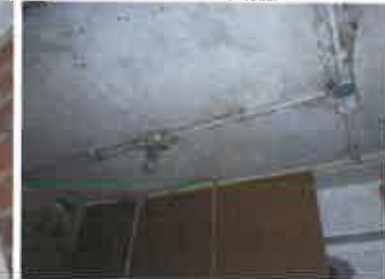
Internal view of roof in store

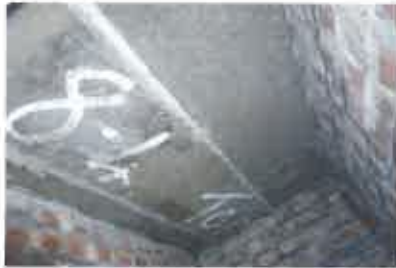
The walls and floors of the stores and garage were examined for any droppings or feeding evidence, nothing was found. This building provides sub optimal foraging and roosting habitat.
