Bat & Bird Survey & Assessment

**At 'Brambles', Vicarage Lane, Wilpshire,
Blackburn, Lancashire, BB1 9HY**

1st June 2016

Ref. LB-16-06 rev.1

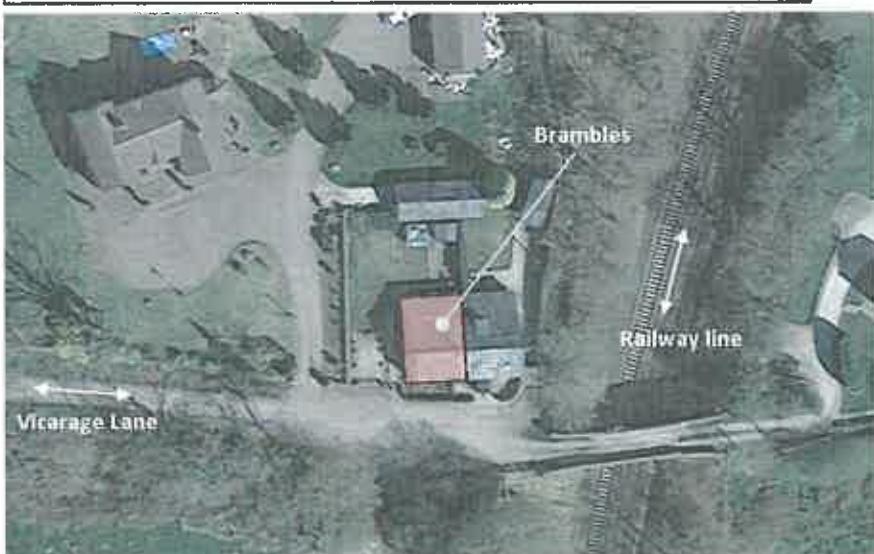
Fig. D1: Labelled layout of 'Brambles', Vicarage Lane

Below, **Fig. D.1** illustrates the layout of the Application Site, demonstrating that the semi-detached dwelling comprises the western side of the building. Accordingly, the new two-storey extension will be added on land to the west, tying-in to the western gable end of the existing structure.

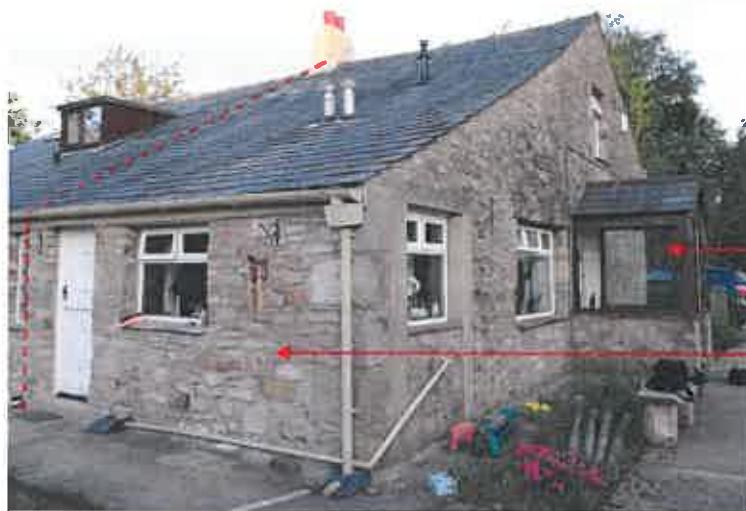
Photo. 1

The property is two-storey, but with the upstairs room situated within the roof space, facilitated by the presence of a vaulted ceiling. There are small loft voids along the southern and northern elevations, where the roof height is too low for inclusion within the living space. The combination of internal and external inspection reveals that the inner walls comprise a mixture of stonework and breeze-block, whilst the exterior finish comprises stone (see **Photo. 1**, next page).

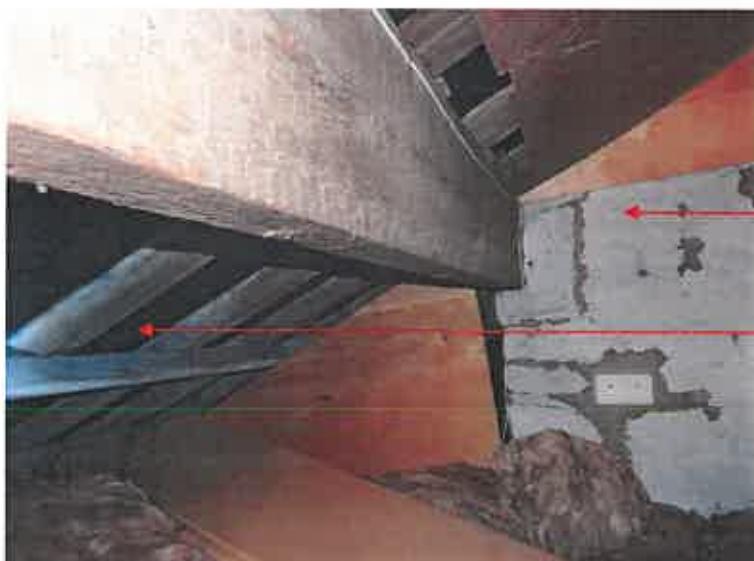
Photo. 2

Internally the small southern loft void has been boarded out; effectively with a vaulted ceiling that conceals all of the wall and roof structure. The other displays breeze-block walls, fibre-glass insulation to the floor and bitumen under-felt underneath the roof slates (see Photo. 2). There is no evidence of access or use by bats or birds and no evidence of potential ingress points.

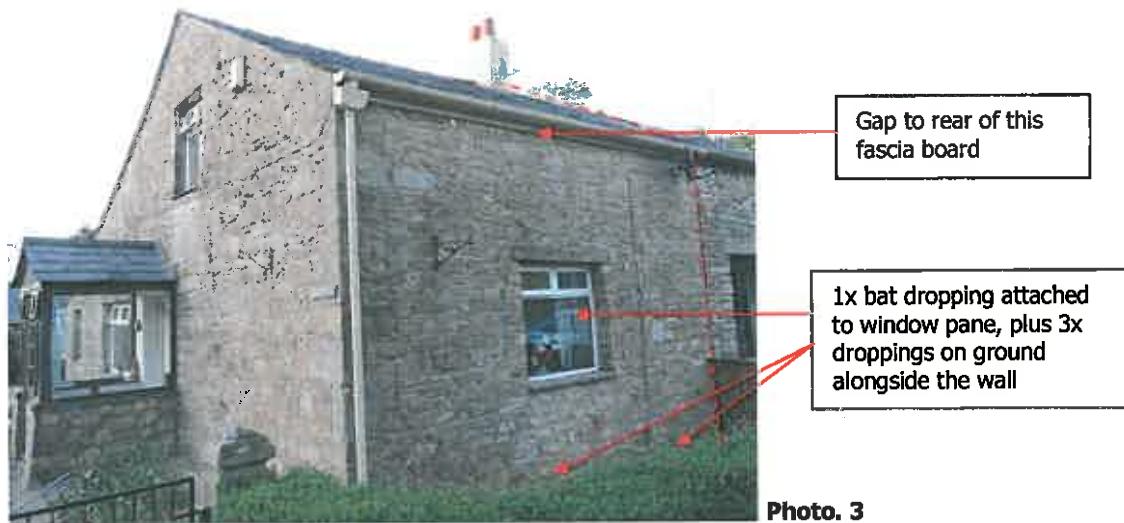
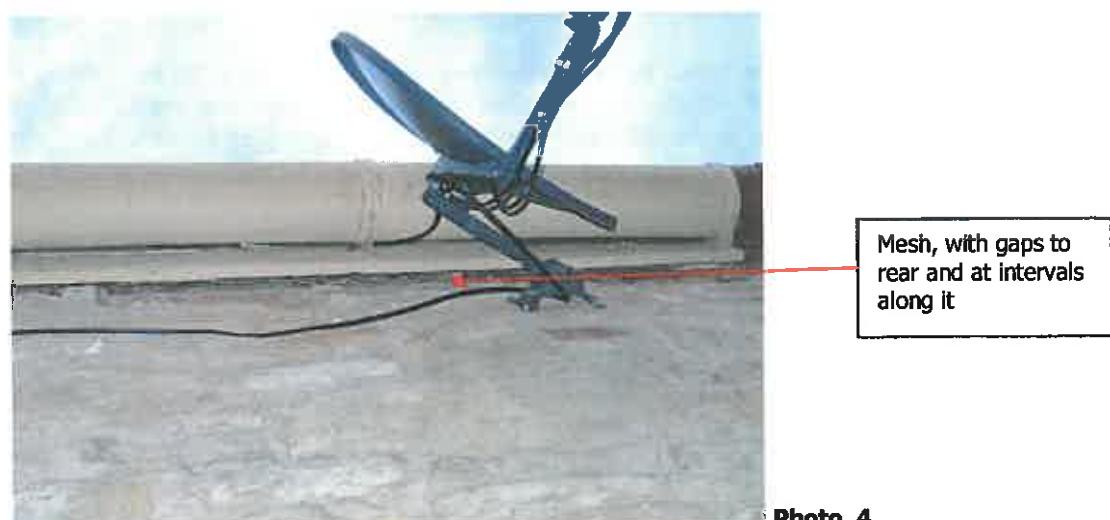
To the exterior, the walls are finished with stone and the mortar is all in good condition, with no habitat value for bats or birds. Along the northern elevation and the western gable end the wall-tops appear to be sealed, whereas along the southern elevation there is large gap to the rear of the fascia board and there is evidence of metal mesh along approx. ¾ of the length of the gap (see Photo's 3 & 4, next page). The mesh is discontinuous, with gaps at western and eastern ends, plus local small gaps to the back (flanking the wall), with these being of adequate size to allow bat entry.

At the time of survey there was one small bat dropping affixed to the property's south-facing window pane and there were three dry and relatively old bat droppings on the ground alongside the wall of the southern elevation. Such droppings gave evidence of active bats flying in the immediate vicinity of the dwelling, but they were not clustered and were not demonstrative of a roost site. All were indicative of a pipistrelle species. By daylight it is assessed that there is low potential for small nesting birds and moderate potential for roosting bats along the southern eaves, but that there is no evidence of a bat roost site or bird nesting site.

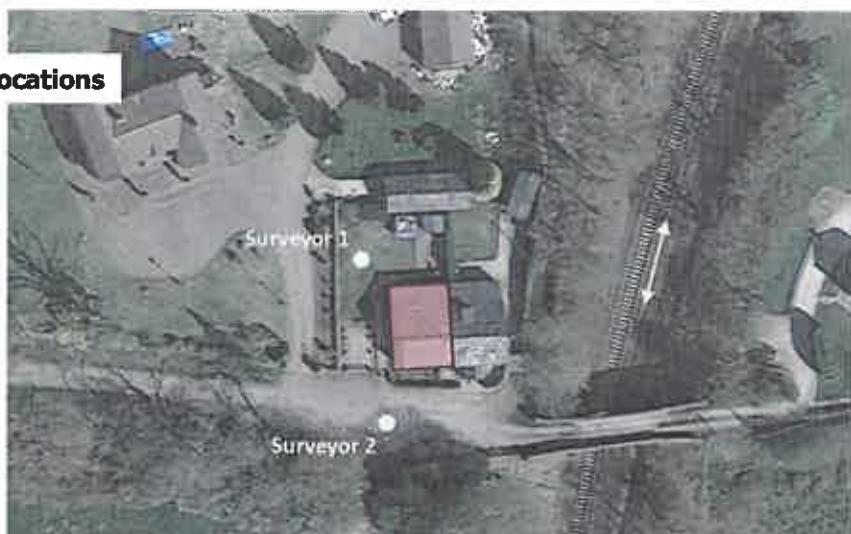
Surveyor locations

21:37hrs	First bat detected, comprising a Common pipistrelle flying into air-space from the south, not emerging from the property.
21:40hrs	<u>Emergence of 1x Common pipistrelle</u> from under a slate on the south-facing roof of the adjoining semi-detached property, from under a slate flanking the west side of the westernmost skylight.

21:55hrs until 22:15hrs	Very regular occurrence of 1 – 2x Common pipistrelle, foraging and passing around the house and wider gardens, including feeding and chasing behaviour, with two passes very close to the southern elevation of the property.

22.03hrs and 22.19hrs	Brief detection of 1x Soprano pipistrelle, foraging and passing.
22:15hrs until survey end	Bat activity levels diminishing. Only Common pipistrelles detected.
Summary	No bats emerged from the Application Site, but one came from a roost under a slate very close to the Site, on the adjoining semi-detached property
