BAT SURVEY

**AT
LOWER YEW TREE FARM
ALSTON**

**DATE AND TIME OF VISIT
5th May 2016 12.30 pm**

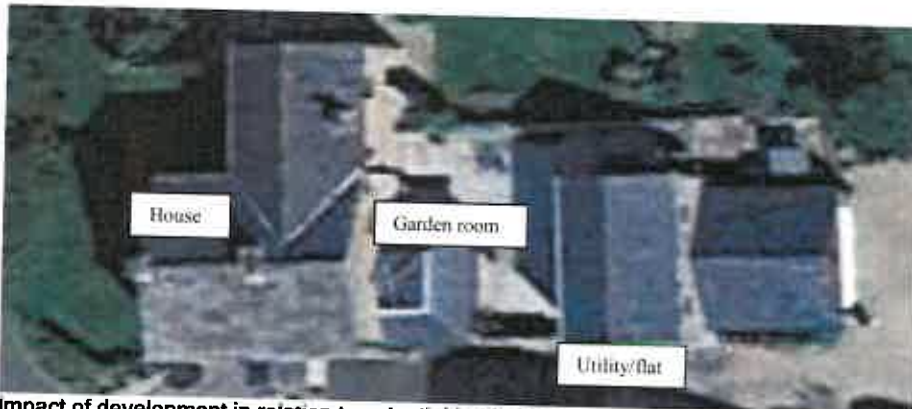
Removal of existing garden room (previous extension to the side of the house) prior to constructing a new single storey extension to connect the house with detached utility and granny flat.

Impact of development in relation to potential bat habitat:-
Removal of garden room roof. The roofs of the main house and utility/flat will not be affected.

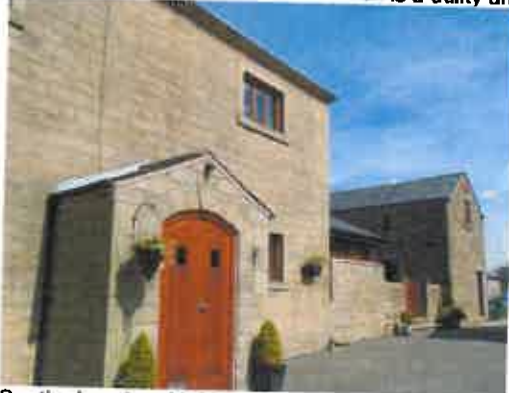
South elevation, Main house with attached garden room and detached out building (utility / Granny flat)

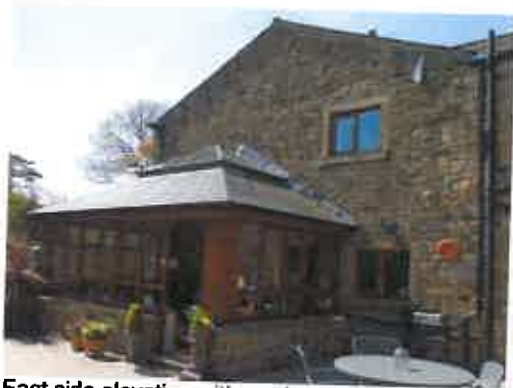
East side elevation with garden room extension

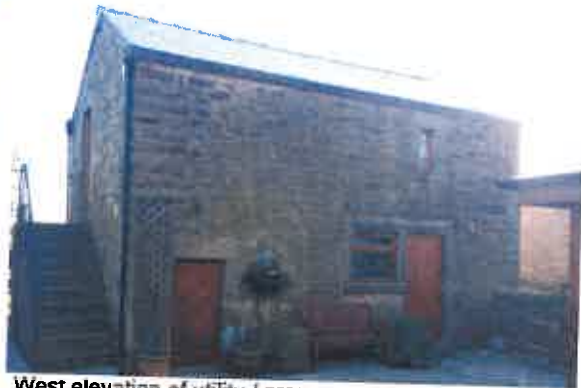
West elevation of utility / granny annex

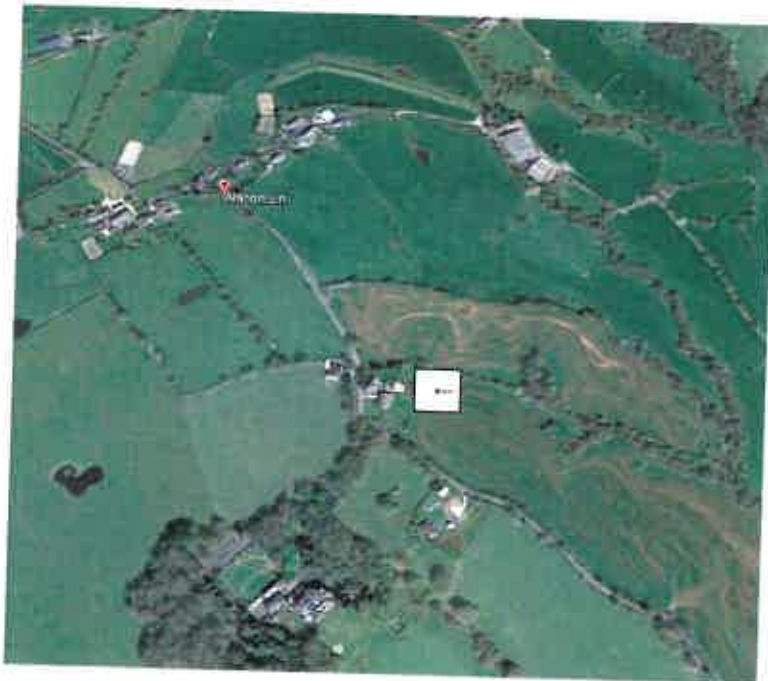
LOCATION SD:608342 50m elevation

The house is located in the area of Alston, remote from the main settlement area it is located on Alston lane adjacent to two further properties.

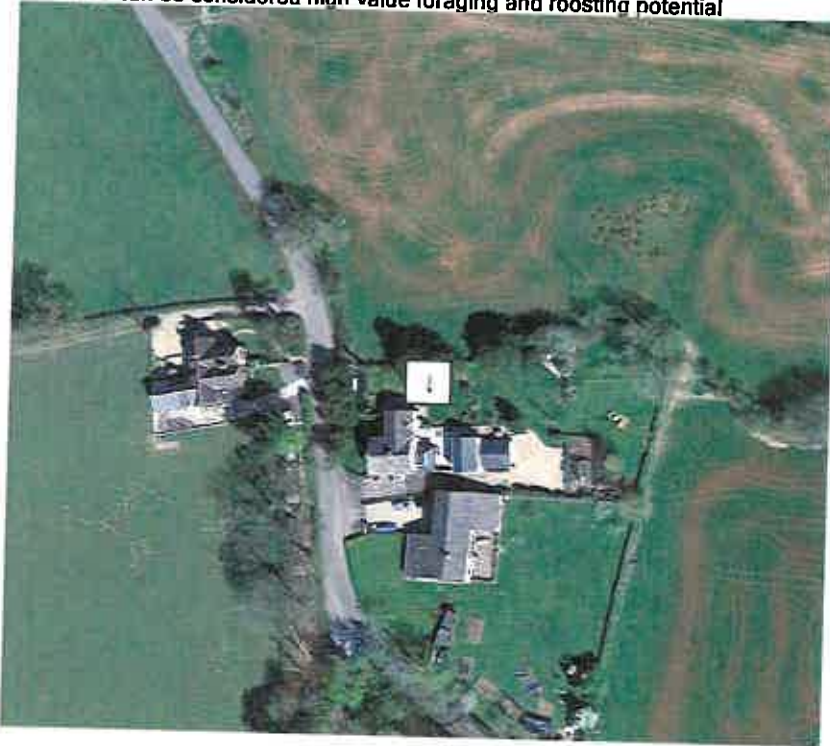
The houses in the small settlement area have gardens, containing mature trees. The gardens are surrounded by pasture land. The fields are and lane to the south and west are boarded with trees and hedging. Alston hall which

is located approx 220m to the southwest is surrounded by a significant plantation of mature broad leaf trees which connects to Alston wood which extends along the north bank of the river Ribble (approx 650m from Lower Yew tree farm).

The area can be considered high value foraging and roosting potential

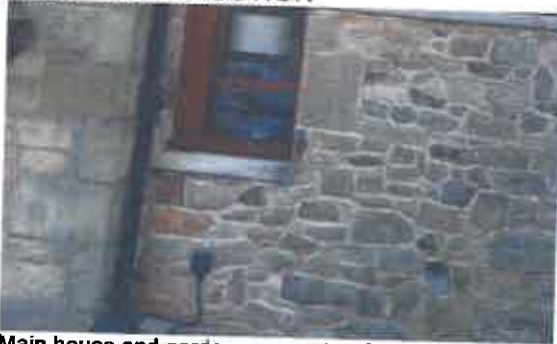
Main house and garden room extension wall.

The main farmhouse is coursed sawn stone, the garden room is random stone with strap pointing.

The walls are all in perfect condition with no cracks or crevices or access points for bats.

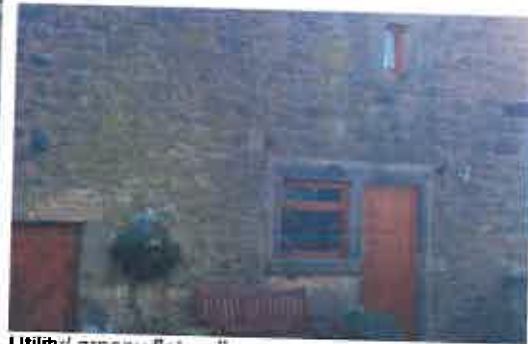
Utility/ granny flat wall

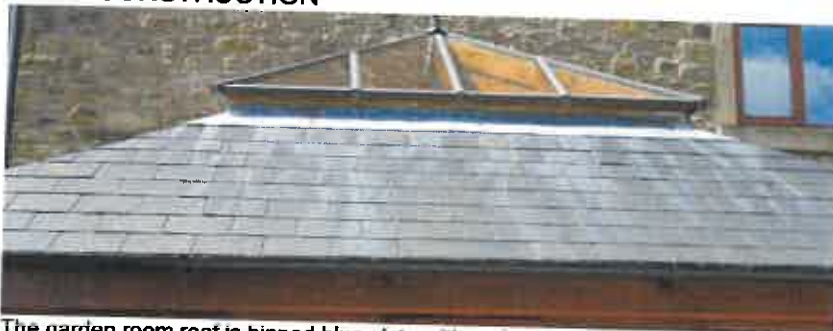
The garden room roof is hipped blue slate with a glazed top section. The eaves overhang having timber fascias and soffits.

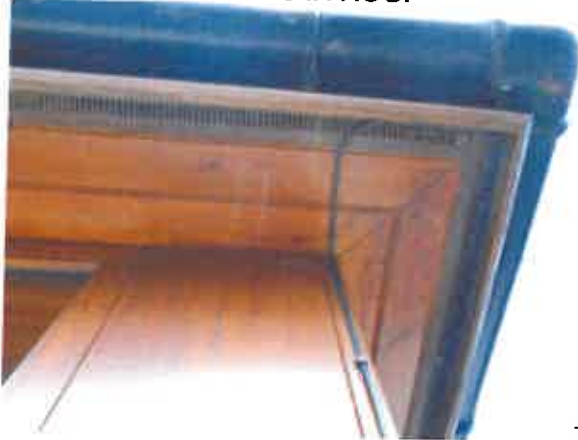
The roof overhang soffit

The slates and lead flashings are very tight fitting with no gaps. The soffits are in perfect condition with no possible access points.

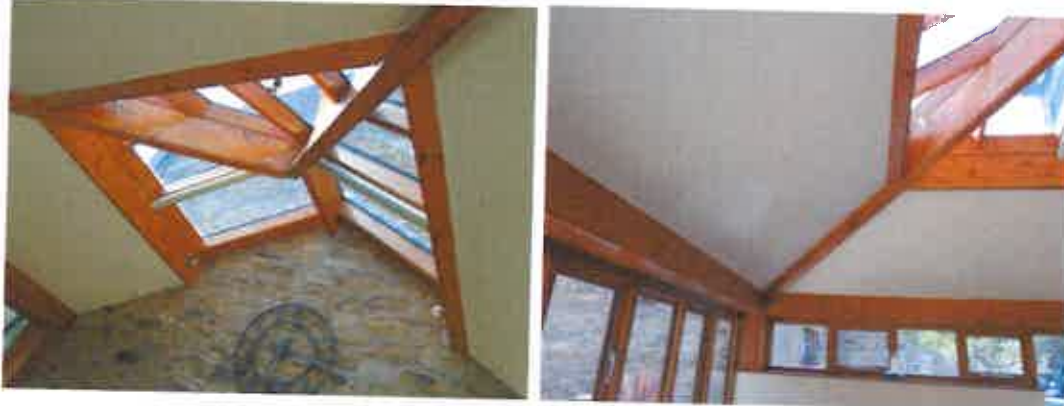
There is no enclosed roof space the timber rafters are lined to the underside with plaster board and the ridge section is glazed.
