BAT SURVEY

**AT
102 LOWERGATE
CLITHEROE**

**DATE AND TIME OF VISIT
1st June 2016 3.45pm**

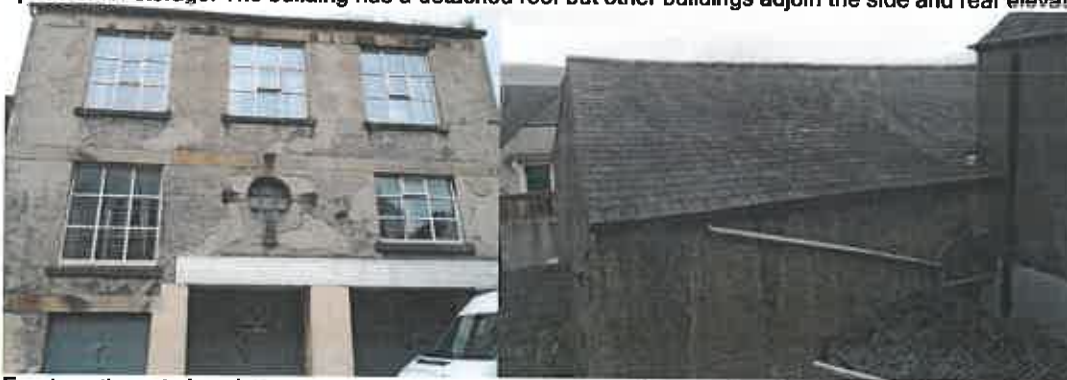
The building is a three storey structure which dates from the 1860's, it has had various uses but mainly as retail space or for storage. The building has a detached roof but other buildings adjoin the side and rear elevations.

Front south east elevation

Rear north west elevation.

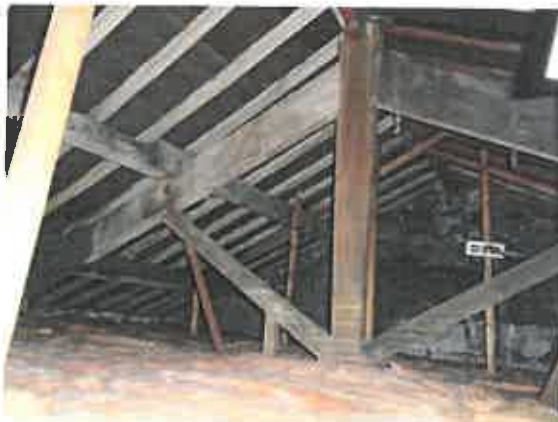
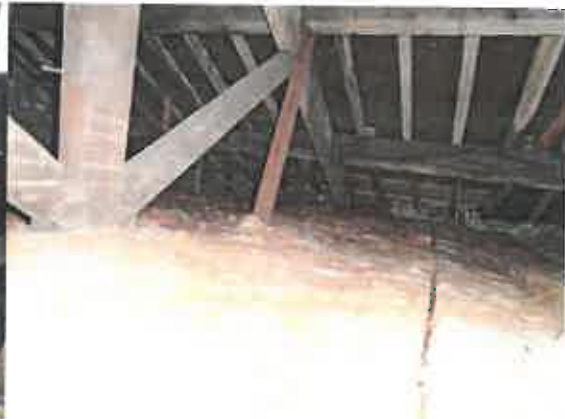
ROOF SPACE

The roof had been repaired approx 20 years ago. The timbers were in very good condition with no cracks, crevices or signs of rot. The felt was also in good condition. There was insulation quilt laid between and over the ceiling joists which was very clean with no dropping, dust or insect remains. The void was draughty.

COMMENTS: The roof void was a very clean space with no signs of feeding or dropping evidence. The rooms at first floor level were also examined, no evidence found.
