**Re: EPS – scoping survey: Painley Farm buildings, Knot Lane, Newsholme, Gisburn, Clitheroe. BB7 4JF**

## **BAT SCOPING SURVEY REPORT**

Painley Farm buildings, Knot Lane, Newsholme, Gisburn, Clitheroe, BB7 4JF

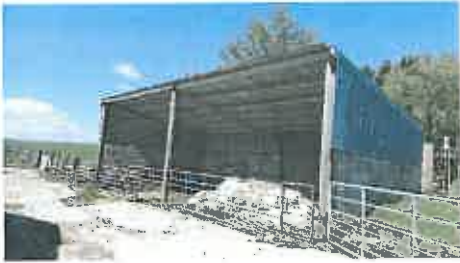
These buildings were formerly used as cubicle sheds and are mostly connected to one another although one open portal building stands alone on the north side of the track (figures 5 and 8) and there is row of brick sheds with 4 bays facing onto the central yard to the west of the farmhouse (figure 6).

Figure 5: Open portal shed.

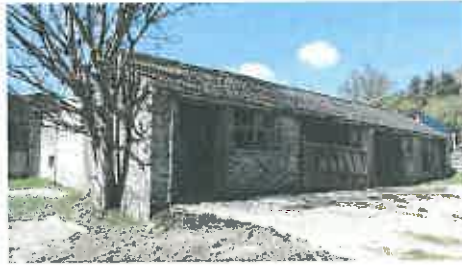
Figure 6: 4-bay shed – only one bay is closed

| Potential of buildings at Painley Farm to support protected species | | Barn swallows | |
|---|---|---|---|
| 4 bay brick sheds - figure 6 | Moderate potential | | Moderate potential |

Barn swallow roosting is likely within any of the open and accessible units. Clear nesting evidence was only found in three of the open-portal brick sheds (figure 6) which currently offer access and shelter to swallows.

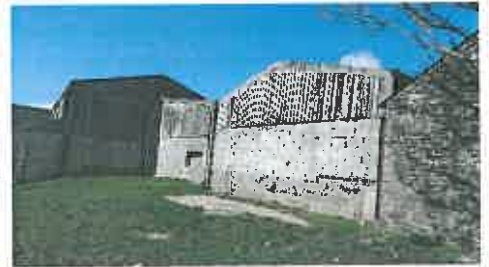
Figure 7: Cubicle sheds group 'A' at rear

All remaining buildings (figures 7 to 10) have a variety of construction types including a block work single storey shed with mono cement asbestos roof (figure 9), and at least four steel-framed sheds with duo-pitch

cement asbestos or box alloy roofs (figures 8 and 10). The buildings are largely redundant; lack of maintenance over many years has resulted in significant roof damage and decay. Although a small shearing shed remains in use, the majority of the buildings are now derelict and empty.

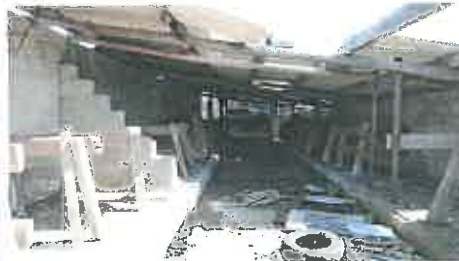
Figure 9: blockwork cubicle shed – group 'A'

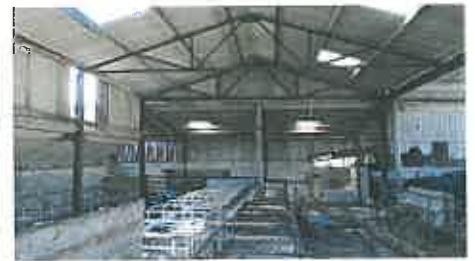
Figure 10: steel-framed cubicle sheds, group 'A'

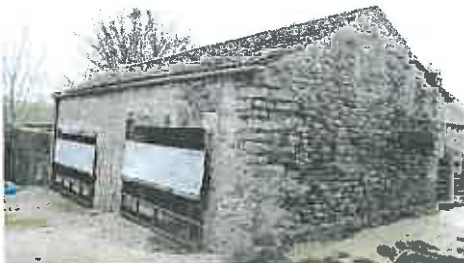
This building has two open bays separated by a brick partition wall (figures 11 and 12); the building has been recently re-roofed with stone slates and lined with a breathable membrane. There is evidence of roosting barn owl inside the south bay.

Figure 11: Stone shed / garage – group 'B'

| Potential of buildings at Painley Farm to support protected species | | Barn swallows | |
|---|---|---|---|
| Open portal shed figures 11 / 12 | High potential | | High potential |

Conversion of open portal barn (figure 11) to garages.

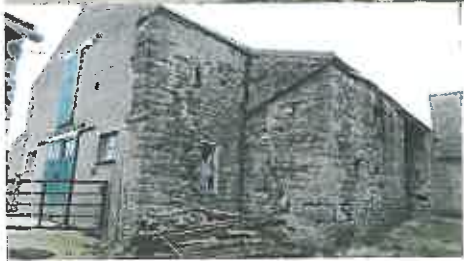
Figure 12: stone building internal

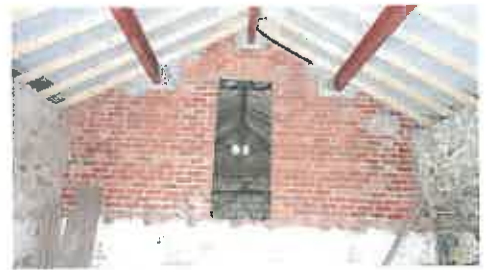
This is a large traditional 4 – bay stone barn (figure 13) with rubble infill wall construction, earthen floor, a large wagon door entrance (figure 14) duo-pitch steel-frame roof (figure 15) and internal hayloft (figure 16). Both gable ends are re-built with block work construction and all internal walls are mortar-pointed. The corrugated cement - asbestos roof has 10 clear skylight panel providing good natural light. The building is used for vehicle storage and materials. There is evidence of bat and barn owl activity inside the building.

An adjoining cubicle shed (figure 13) at the south end of the barn underneath the hayloft has minimal natural light and typically shows evidence of perching and feeding by long-eared bats around the cubicles.

Figure 13: stone barn (west)

| Potential of buildings at Painley Farm to support protected species | | Barn swallows | |
|---|---|---|---|
| Stone barn (west) figures 13 / 14 | High potential | | High potential |

Feeding and perching signs were located in one of the stone barns (shown in figure 13) approximately 200m from the farmhouse. Discarded insect prey, mostly fresh small tortoiseshell butterfly wings were found on the floor of the cubicles in the undercroft beneath the hayloft. Although a small number of bat droppings were also noted on vehicle paintwork in the main part of the barn, no accumulations of faeces were noted.

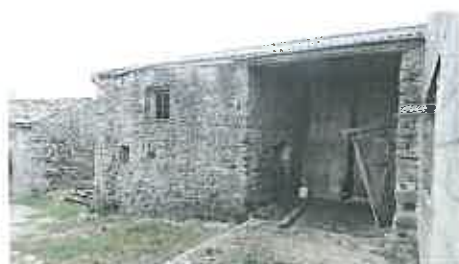
Figure 14: stone barn (west)

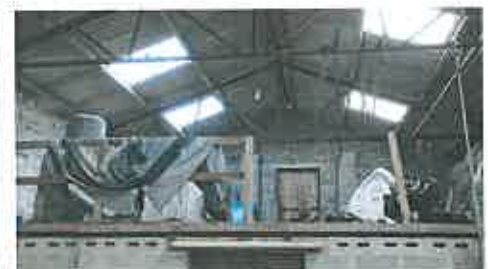
Figure 16: hayloft stone barn (west)

Barn owl feeding signs (discarded pellets and urine splash marks) were noted on the floor and on timber spars of the hayloft in the barn (figure 16) in addition to an accumulation of pellets on the floor of the open portal building (figure 11) below an open window on the south apex wall. Although regular perching and feeding signs are present, there is currently no clear evidence of activity by a nesting pair or any young birds being present.

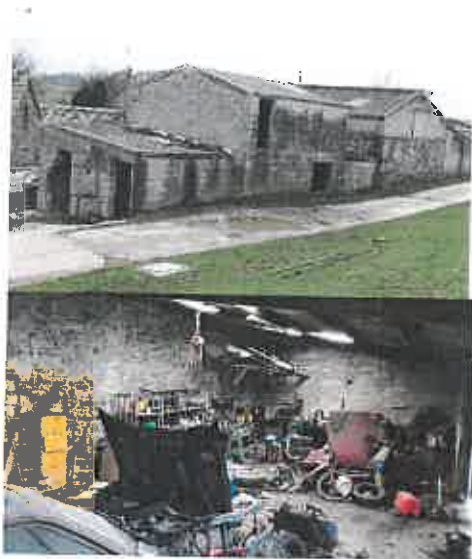
At the northern end of the barn is the milking shed with a timber loft formerly used as a feed store (figure 17). The shed has with block wall construction and is now semi-derelict with open windows and corrugated cement-asbestos roofs; internally the structure is generally are cold, draughty and wholly unsuitable for roosting bats.

Figure 17: Dairy sheds – group 'B'

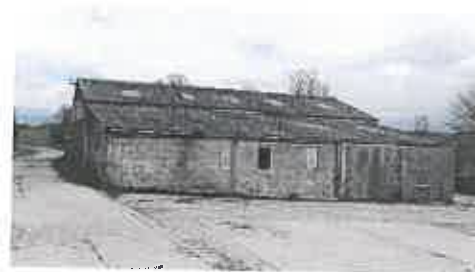
To the rear of the west barn is a large single storey lean-to workshop (figures 18 and 19) with mono cement-asbestos roof; the building is used as a mechanics workshop (figure 19) the area smells strongly of diesel oil and is considered largely unsuitable as a potential bat roost or as barn owl nesting area. This is a relatively low risk building in terms of likely disturbance of a protected species.

Figure 18: lean-to workshop (rear of west barn)

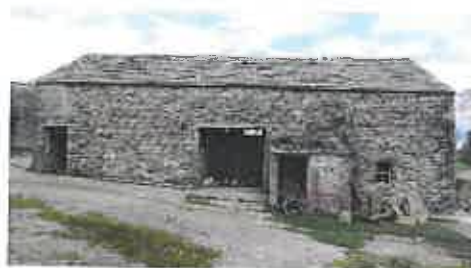
Located opposite the previous barn on the east side of the farm complex, this is also a traditional 4 – bay barn with rubble infill wall construction, large wagon door and duo-pitched stone slate roof (figures 20 / 21). The barn has a concrete floor and timber hayloft with three small under-crofts; there is a small brick lean-to shed with mono cement-asbestos roof to the front elevation; the shed has no potential for bats or wild birds.

Figure 20: Stone barn (east)

| Potential of buildings at Painley Farm to support protected species | | Barn swallows | |
|---|---|---|---|
| Stone barn (east) figures 20 / 21 | High potential | | High potential |

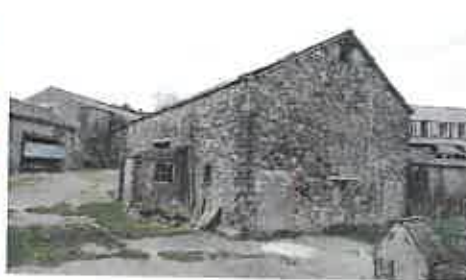
The barn roof is unlined and there is some damage to the stone slates; internally the barn is cool, dry and draughty. To the rear of the barn are several cubicle sheds (figures 22 to 25) mostly semi-derelict and all considered as low potential in terms of suitability for attracting roosting bats or nesting barn owls. The largest shed has a duo-pitched steel-frame construction roof clad with cement asbestos sheeting. It is likely that bats and owls may fly within the building or roost there occasionally; generally the building has low potential for roosting bats and nesting wild birds.

Figure 21: stone barn (east)
