BAT SURVEY

**34 GEORGE LANE
READ**

REFERENCE NO. 5117

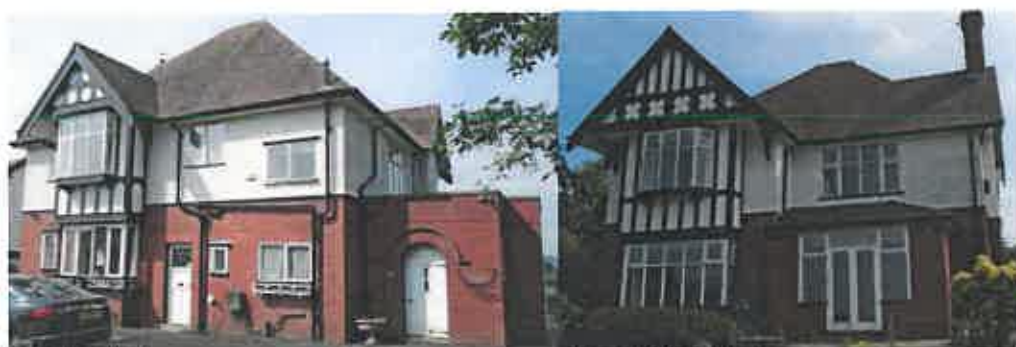
Front East elevation

Rear west elevation

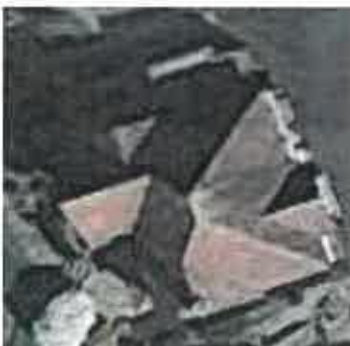
The roof is a tiled hipped construction with timbered effect gables to each pitch. There is a substantial overhang to the eaves with a boarded underside. The single storey extension to the north elevation it has a flat roof with a parapet wall to the perimeter the roof finish is chippings.

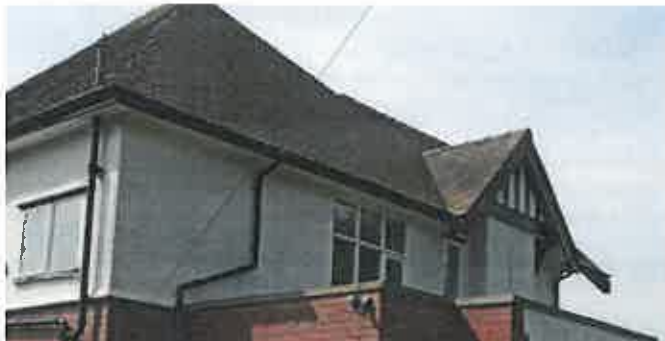
Aerial view of roof

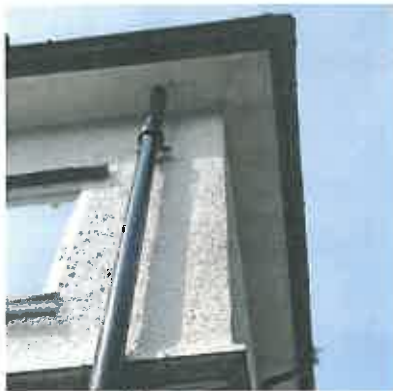
Roof pitch and elevation being affected

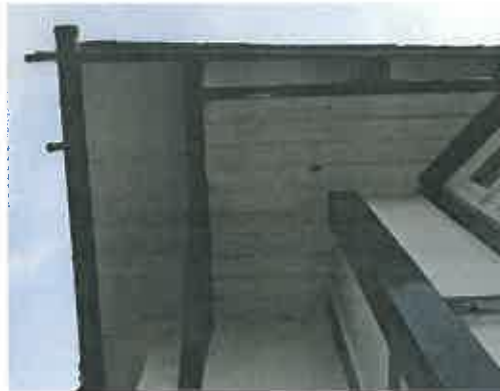
Boarded soffits

The tiles are small and tight fitting and in reasonable condition there is a slipped tile on the north east hip, but does not provide an access point or a crevice suitable for a bat. The abutment of tiles with the fascias is tight fitting with no gap and the boarded soffits are in perfect condition with no possible access points. The flat roof does not provide any access or roosting potential for bats.

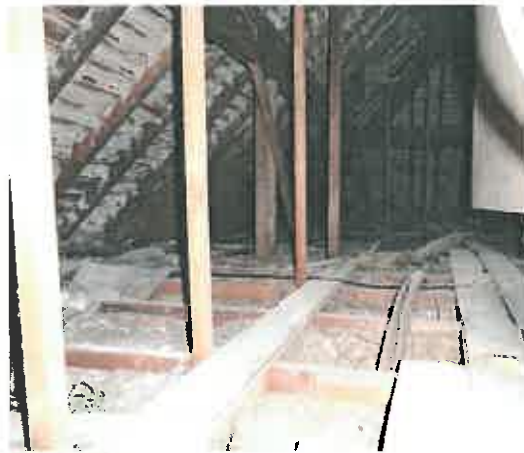
The roof space is accessed via a ceiling hatch and ladder. The tiles are mortar fixed over the timber battens on the rafters and purlins. There are hangers to the ceiling joists and some boarding laid over the joists for access. The timbers are in good condition with not rot or cracks, the space is dusty due to the mortar tile fixing. The floor and boarding was clear of any insect remains or dropping evidence. The space was not accessible to bats and does not provide any high value roost potential.

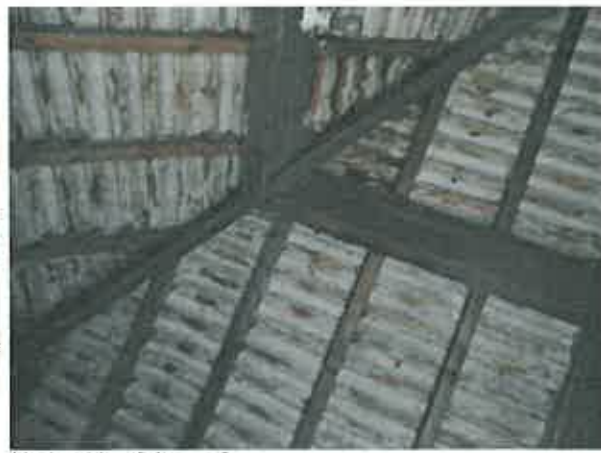
Roof void

Underside of the roof
