**BAT SURVEY AT - 30 GREEN DRIVE  
CLITHEROE**

**DATE AND TIME OF VISIT**  
13<sup>TH</sup> July 2016 10.00am

REFERENCE NO. 5157

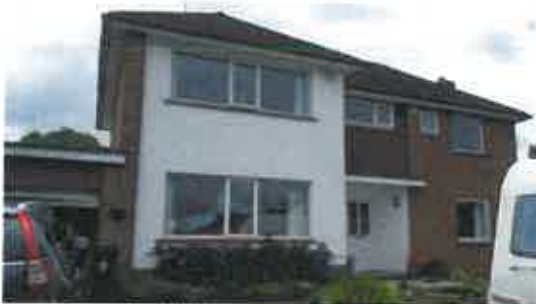
Front elevation N.W

Detached house built in the 1960's with a single storey garage and conservatory to the side.

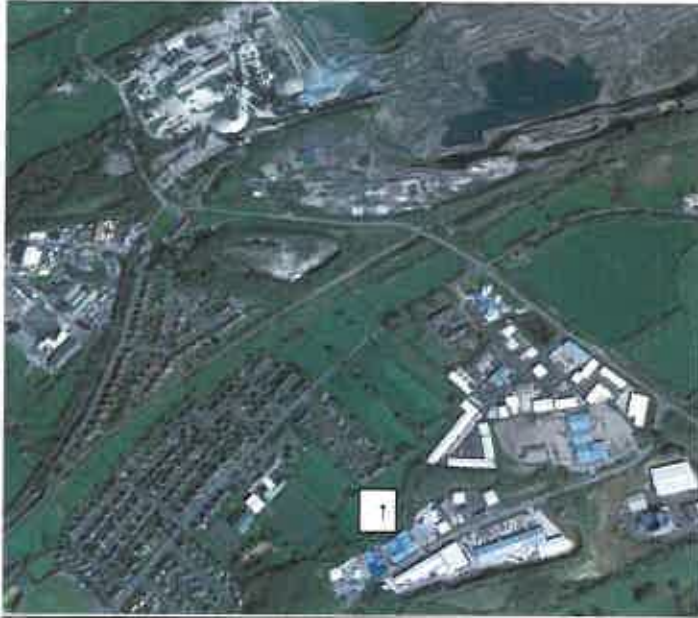
The property is located on a housing estate which consists of houses of a similar type and age all of which line either side of a single road with gardens to the front and rear. The rear gardens are adjacent to the playing fields of the Grammar school, with the Salthill industrial estate and Salthill quarry local Nature reserve surrounding the fields.

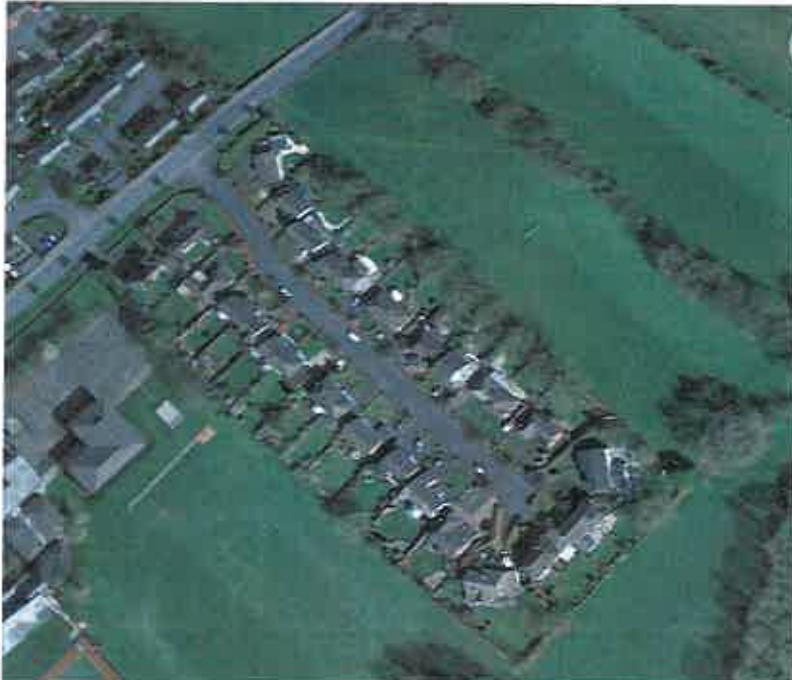
The rear gardens of the properties contain mainly domestic planting but the houses on the N.E side of the road have a line of mature trees on the garden boundary. The playing fields are bordered by mature trees and the dense tree plantation that is the nature reserve is 60m to the S.E of the house. There are no areas of open water within 300m of the house. The location can be considered to provide a medium level of potential habitat for bats.

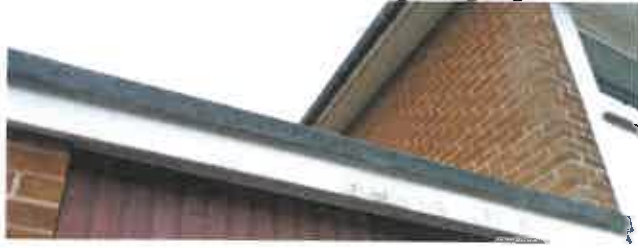
The walls are cavity brick work with sections of render finish. Small section of vertical timber boarding over garage door.

The brick work and render is in perfect condition with no possible access points. The timber boarding is in good condition with no void behind or access points.

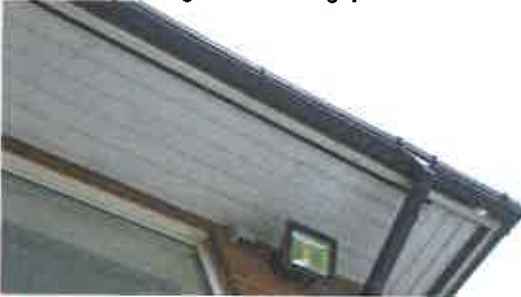
Eaves soffit

The main house roof is a hipped construction with a tile finish. The large eaves overhang has a upvc boarded soffit incorporating a ventilation gap with a mesh cover.

The main roof soffits are in perfect condition and very tight fitting with no possible access points. The roof tiles are in good condition, very tight fitting and with a substantial amount of moss coverage. No access for bats.

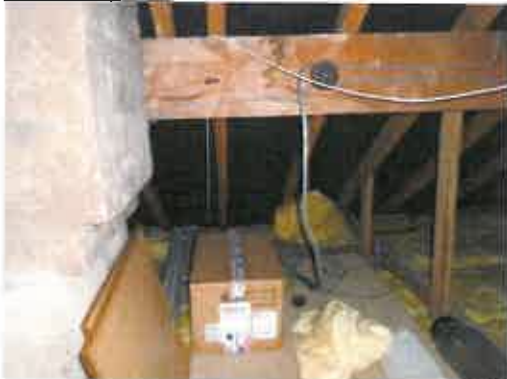
The main roof was accessed and examined paying particular attention to the N.E gable where the extension is to abut the roof. The construction is timber purlins and rafters with felt. There is quilt insulation between the ceiling joists. The space is clean and dry and the timbers and felt are in very good condition. No droppings or insect remains could be found.

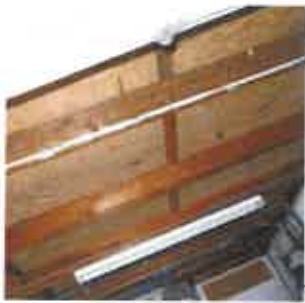
The garage roof is felt laid over treated boarding and joists. All in good condition. The garage is accessed frequently as it is used for storage, the floor was inspected for dropping and insect remains and the underside of the roof was closely inspected, no signs of bats could be found and the space provides sub optimal foraging /roost potential. The conservatory does not provide a suitable habitat for bats.

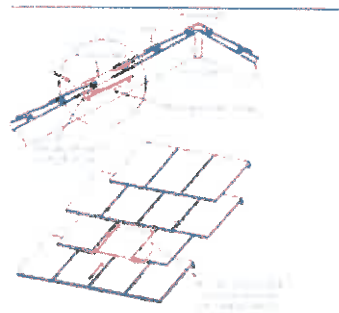
STEP 1 - DETERMINE PORTION OF BAT ACCESS BY MEAN RAINFALL

STEP 2

UP AND REMOVE BAT TILES, 2mm AGC

STEP 3 - PORTION UNIT NOT SECURE BY HAILING THROUGH THE RAUING

STEP 4 - TRIM SLATES AROUND THE COIL ACCESS POINT

However due to the property being located close to good foraging habitat it is recommended that the roost potential be boosted by a couple of bat slates being incorporated in the S.E pitch of the new roof.
