BAT SURVEY

AT
BARN AT TWIN BROOKS FARM
UPBROOKS
CLITHEROE

DATE AND TIME OF VISIT
7th June 2016 9.30 am - Scoping
20th June 2016 9.50 pm - Emergence

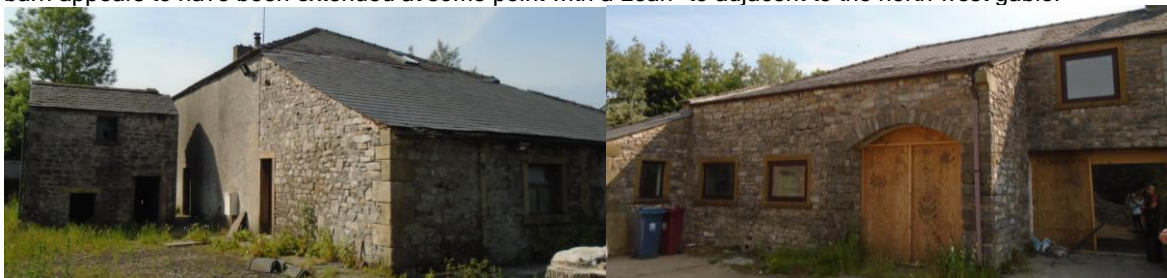
Barn attached to a farmhouse. The house is inhabited and the barn is used as garaging but is mainly empty. The barn appears to have been extended at some point with a Lean-to adjacent to the north west gable.

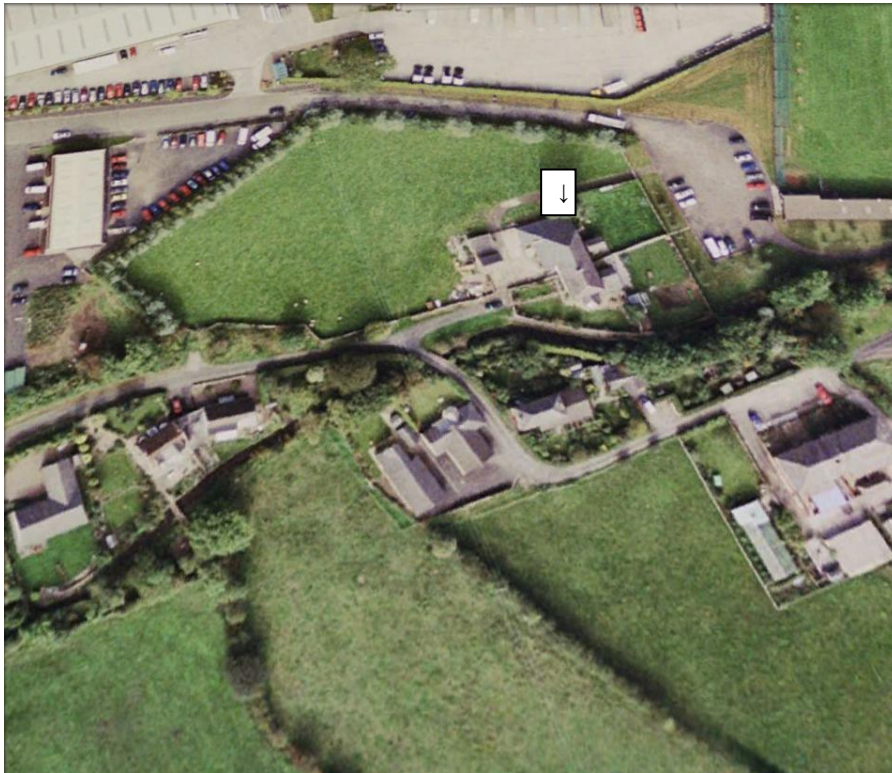
FORAGING POTENTIAL IN THE LOCATION

The house and barn has a small garden to the north east (rear) with paved and tarmac yard area to the front of the barn. There is a small field boarded with a line of trees immediately adjacent to the gable (north west) of the barn which is surrounded on two sides by the car park of the industrial estate beyond. The brook which is lined with trees forms the southern boundary of the house garden. Further to the south there are a couple of houses with gardens adjacent to extensive areas of pastureland.

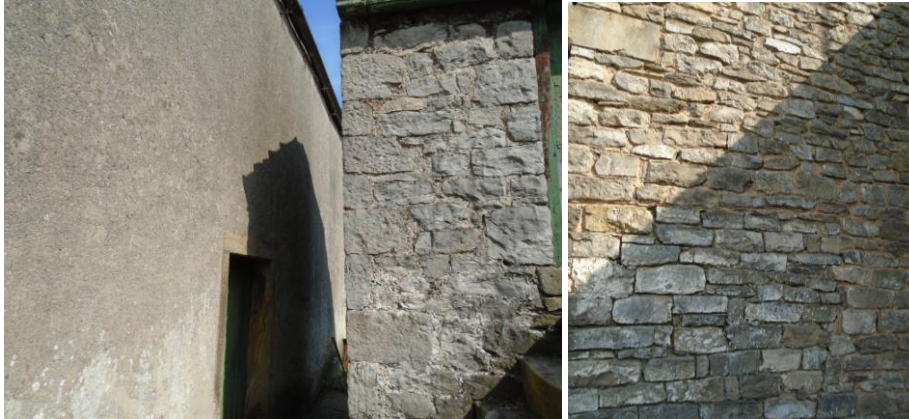
The walls are solid stone construction. The rear (north east) elevation of the main barn has a render finish. The front (south west) and all elevations of the lean -to are random stone with stone surrounds to openings.

The pointing to the walls is in reasonable condition with no cracks or crevices suitable for bats, No Access points were observed.

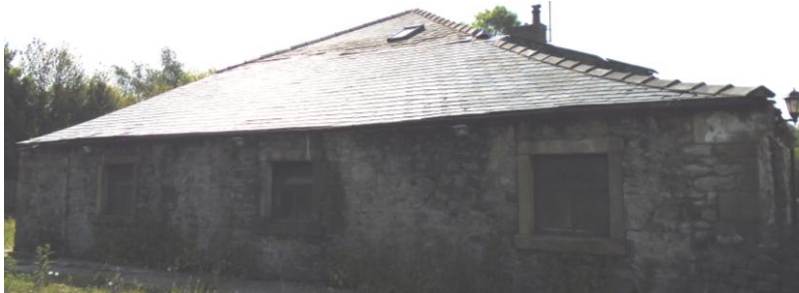
The barn roof is a pitched continuation of the farmhouse roof with a hip at the gable and a cat slide to the front south west elevation. The lean - to which appears to be an addition to the original barn has a mono pitch with a hip to the front elevation. The roof finish is blue slate, the gutters are on hangers and the main roof hip is trimmed out for a roof window.

Lean to and hipped roof to the north west elevation.

The slates are generally in good condition and tight fitting, there are some slightly lifted slates at the abutment of the lean -to with the main roof hip, the hip slates at the eaves level could provide potential crevices for bat use. However it was possible to examine closely any voids at eaves level and no signs of bat use were evident.

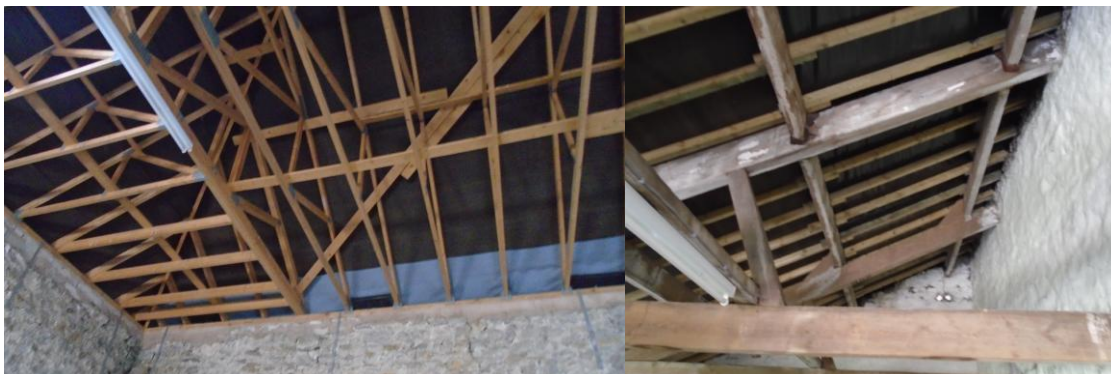
The main roof has been replaced quite recently with a truss rafter roof with felt underlay there is no enclosed roof void. The lean-to section retains its original trusses and purlins but appears to have had the rafters and felt replaced quite recently. All the timbers old and new, were in good condition with no rot ,cracks or crevices.

Main barn roof

Catslide/ lean to roof
