LAND TO THE REAR OF 9 DOWNHAM ROAD, CHATBURN:

HERITAGE ASSESSMENT

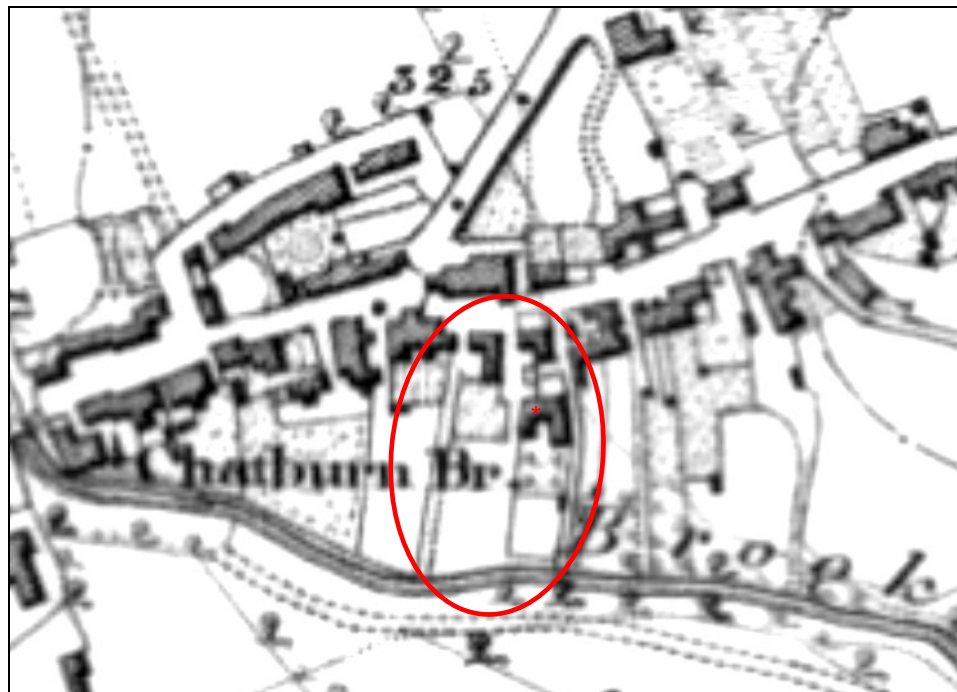
Figure 1: OS 1844 1:10560 map³

- 4.2 There is no previously documented history of the site itself but according to the present owner, historically it was used as a farm, but became used as the base for a haulage business from the mid 20th century.
- 4.3 Historic maps show that there were buildings within the proposed development area from the 1840s and 1850s, and that before the railway was constructed these may have been more extensive. Parts of the site to the south and west of the buildings appear to have been garden or orchard, but otherwise the land seems to have formed part of a paddock or farmland (figure 1).

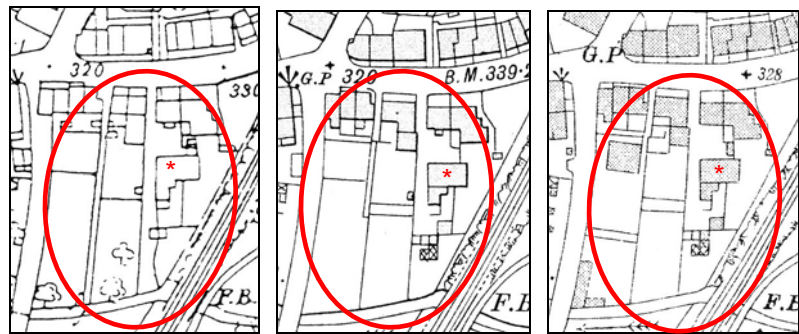
Figure 2: OS 1:2500 maps, published 1886, 1912 and 1932⁴

- 4.4 Maps of 1886, 1912 and 1932 all show an L-shaped arrangement to the buildings within the site, with some very minor structures to the south and west.

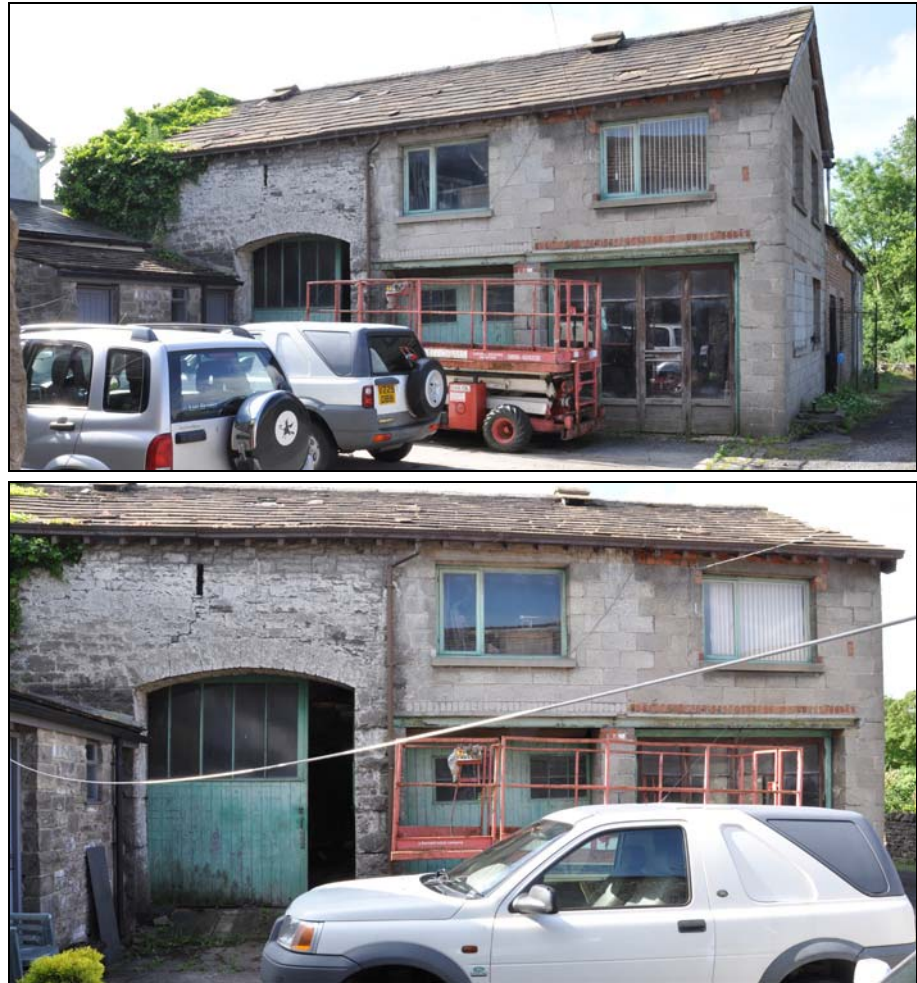
- 5.2 Within the unaltered part of the north elevation, the original arched doorway (with modern doors) forms the main entrance; the surrounding masonry is of squared limestone and incorporates two high level “breathers”, small slits just below the eaves. Modern toilets adjoin to the left of the doorway. Further breathers exist in the original east gable, arranged in a row of three with a fourth near the ridge, although vegetation cover means these are only clear from within the building.

Former barn: north elevation

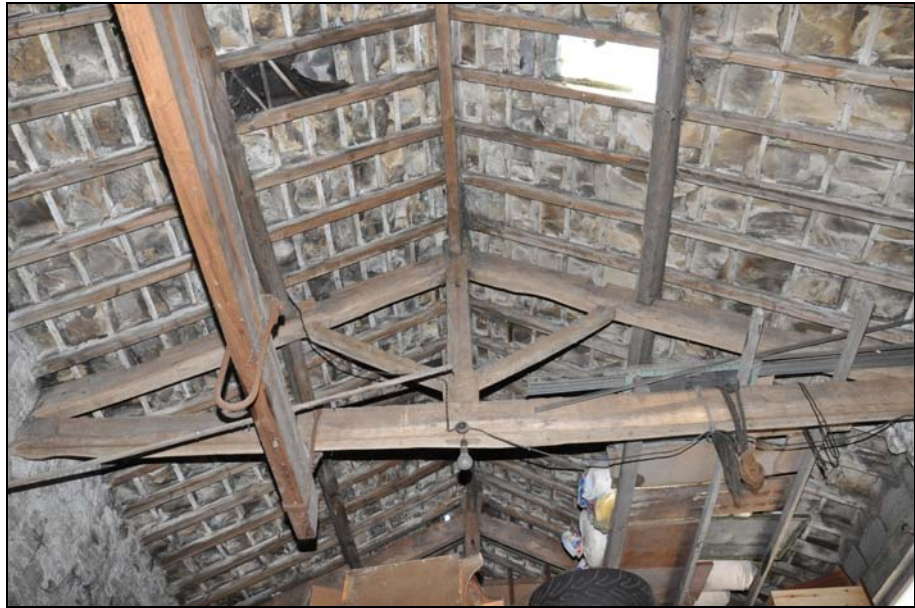
- 5.4 The barn's west gable was entirely rebuilt in the mid 20th century and although it must preserve the outline of the original, it has new fenestration which is most unlikely to replicate it. This is also true of the west half of the north wall, where the two vehicular doorways and large first floor windows are similarly mid 20th century.
- 5.5 The former barn's roof has been left essentially unaltered by the 20th century works and retains its stone slates and sandstone ridge, with roof lights, ridge ventilators and protruding rafter ends.
- 5.6 There are no historic divisions or floors inside the barn: the eastern half is open to the roof while the west end has an inserted floor carried on RSJs. The three king post roof trusses appear original but there are slight variations in their exact configurations.

Former barn: underside of roof

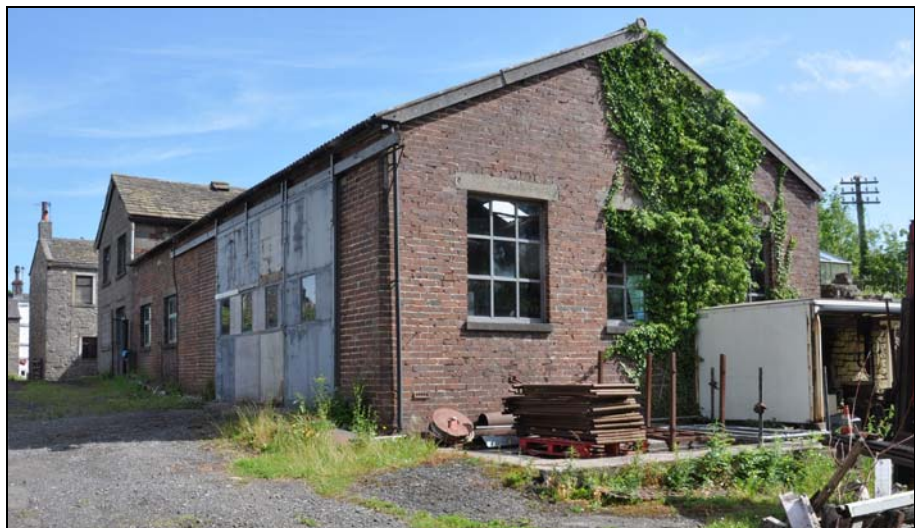
- 5.7 The mainly brick-built workshop at the barn's south-west corner is entirely of mid 20th century date and not of historic interest, although as noted above it, historic maps indicate that it replaced a smaller predecessor.

Mid 20th century workshop: south end
