320160728P

**BAT SURVEY**

**AT  
BARRACLOUGH COTTAGE  
WHALLEY ROAD  
CLITHEROE**

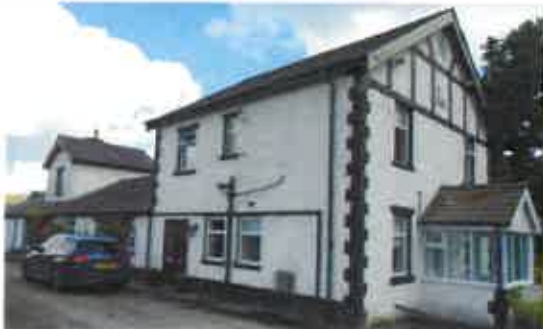
Main house

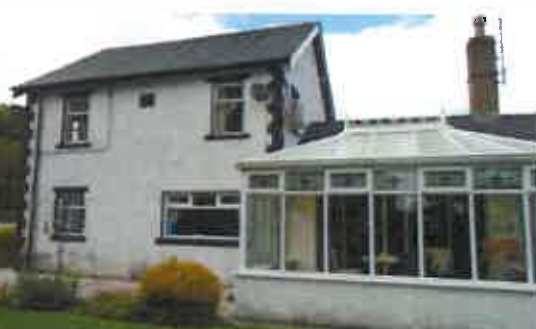
Main house and conservatory attached to the link.

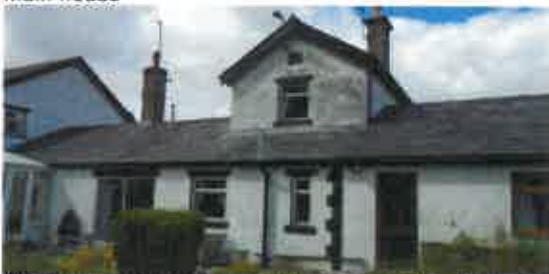
The link constructed around the original detached cottage.

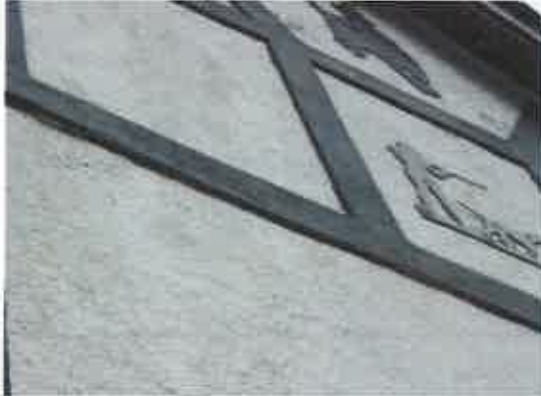
The walls are white painted render with a timbered effect to the east elevation.

The render on the walls is in good condition with no cracks or crevices suitable for bats.

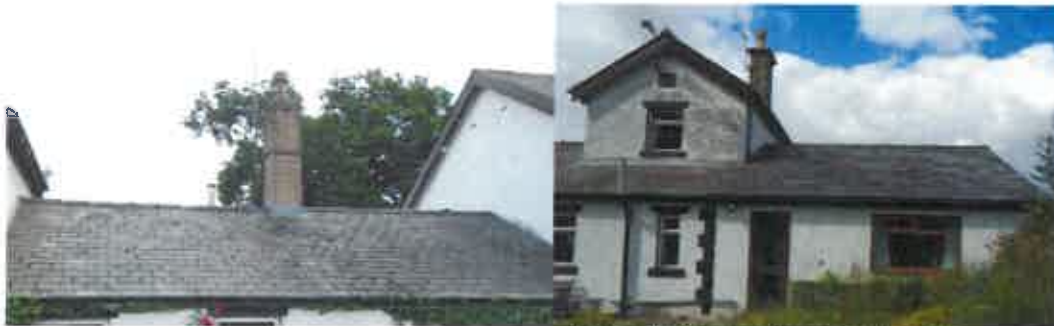
Link roof

Second cottage and garage extension

All the roofs are conventional pitch with a blue slate finish. Overhangs to the eaves and verges with fascias and barge boards.

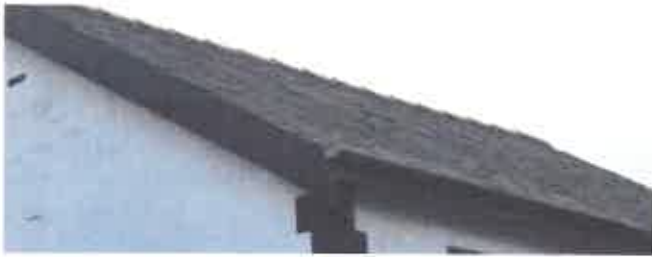
The roof slate and ridge tiles are tight fitting and in good condition with no slipped slates. The eaves were examined with the aid of binoculars on the cottages. Close inspection was possible on the single story link and garage. No access points were evident.

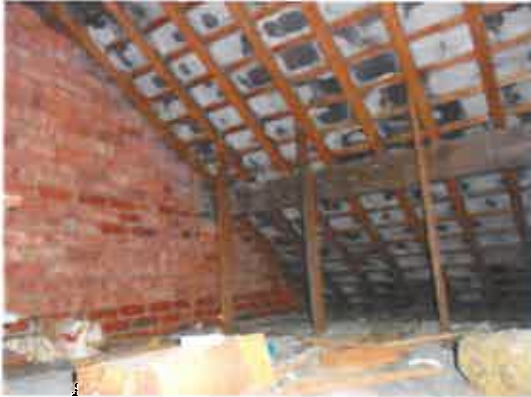
All the five separate roof spaces were accessible via hatches. The two cottage roof spaces were rafters and purlins with battens and slate with no underlay. The slates were mortar fixed over the battens. One small section of the main cottage roof had been plastered out including the underside of the rafters. The link roof was rafters /purlins etc as before but with a felt underlay and insulation quilt laid between the ceiling joists.

Main roof void

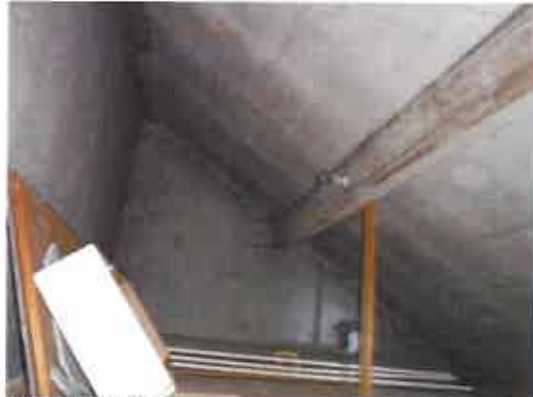
Main roof void.

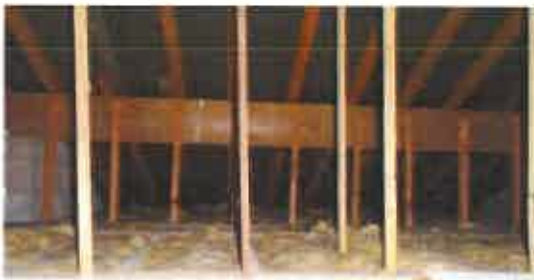
Link roof void

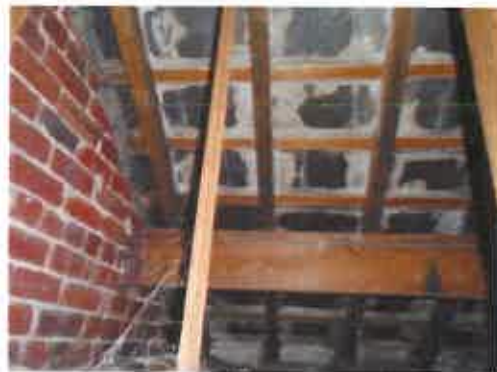
Second cottage roof void.

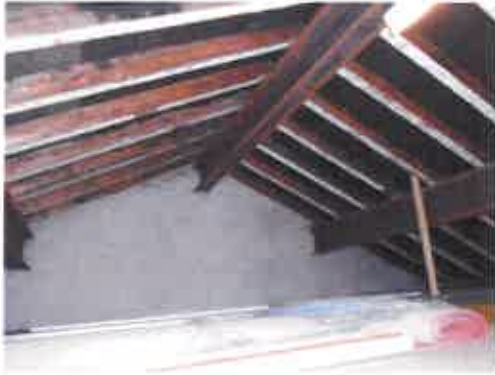
Garage roof void was steel purlins, timber rafters, and felt underlay. The ceiling joists were boarded.

All the roof spaces were relatively clean and dry. The floor surfaces were clean and free from any dropping or insect remains. All the timbers were in good condition and free from rot. The felted areas were in perfect condition, the spaces generally provided sub optimal roosting and foraging potential.

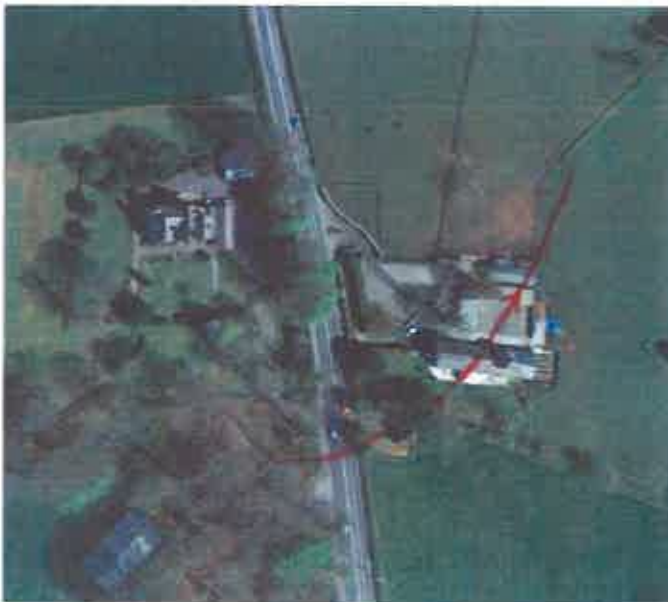
The evening emergence survey was carried out in perfect foraging conditions. It commenced at 9.30pm, no activity was recorded until 9.50pm when a single bat emerged from the trees surrounding the entrance of the Roman road (off Whalley road) to the S.W of the house, it travelled as indicated on the photo below. The survey continued until it was too dark to see (around 10.40pm) during this time minimal activity of 3no bats all flying singularly with long intervals between each bats appearance, all from the same S.W direction and commuting towards the N.E over the house. There was no emergence from the house and no foraging activity was recorded in the immediate locality.

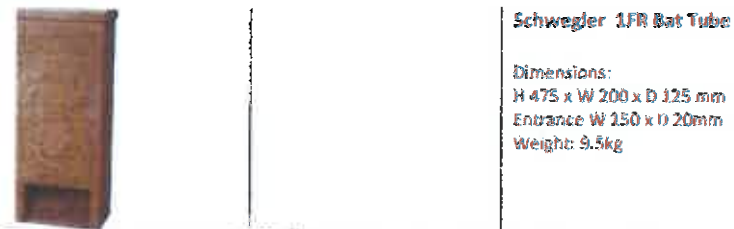
Schwegler 1FR Bat Tube

Dimensions:  
 H 475 x W 200 x D 125 mm  
 Entrance W 150 x D 20mm  
 Weight: 9.5kg

STEP 1 - DETERMINE POSITION OF BAT ACCESS BETWEEN RAFTERS

STEP 3 - POSITION LINE MARKED BY NAILING THROUGH THE SLATE

STEP 2 - CUT AND REMOVE BATTEN (25mm WIDE) REMOVE 6 1FR SLATES AS SHOWN (SEE NEXT SLATES)

STEP 4 - TIE SLATES AROUND THE GOMM ACCESS POINT

Bat slates

No mitigation is required, however it is recommended that the opportunity to improve roosting potential in the new house be achieved by the incorporation of a bat tube in the south facing wall and a couple of bat slates be positioned in the new roof south pitch.
