**Buildings and land at Lodematic, Primrose Works, Primrose Road,  
Clitheroe, BB7 1BS**

## **Bat, Barn Owl & Breeding Bird Survey & Assessment**

Ribble Ecology ref: RB-14-147

### **Bat, Barn Owl & Breeding Bird Survey & Assessment Plus Outline Mitigation Method Statement**

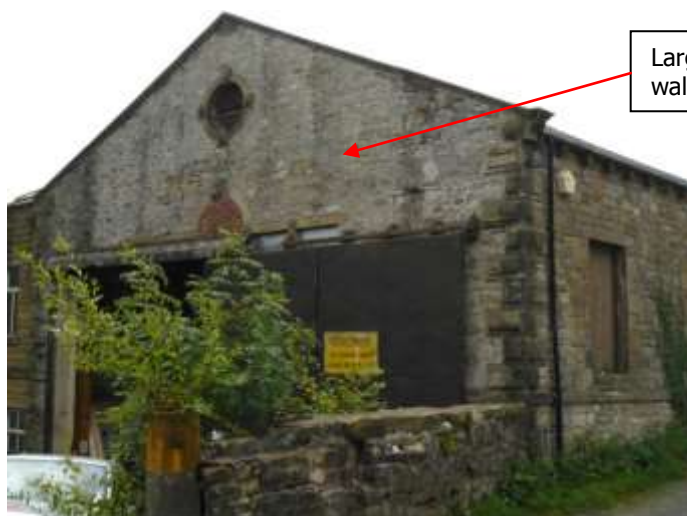
**Photo 1**

Windows overlaid with metal grids along north-west elevation

*There is only low-moderate potential value for crevice-dwelling bats at B1 via possible access under the gutter and onto the wall-tops along the north-west elevation. There is very low or negligible potential value for breeding birds and there is no access and no habitat value for Barn owl.*

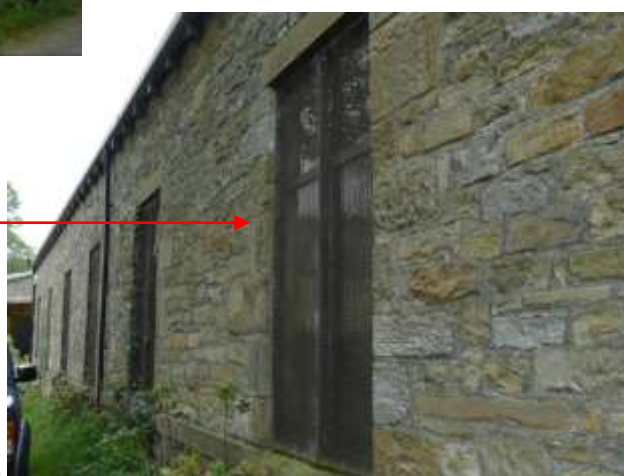
**Photo. 2**

This large and functional factory building has sturdy stone walls, internally whitewashed, but not clad or insulated. Its ridge-line runs south-west to north-east and the roof has a timber and metal frame, finished with corrugated metal sheets that are not lined. There are large sliding doors and a circular window with ventilation grill at the north-eastern gable end, plus a large parapet wall (see **Photo 1**, next page). The long north-western elevation has many windows that are covered with

metal grids, as shown in **Photo 2**. The south-eastern and south-western aspects meet with building components B2 and B6 respectively. The mortar and stonework is in good condition.

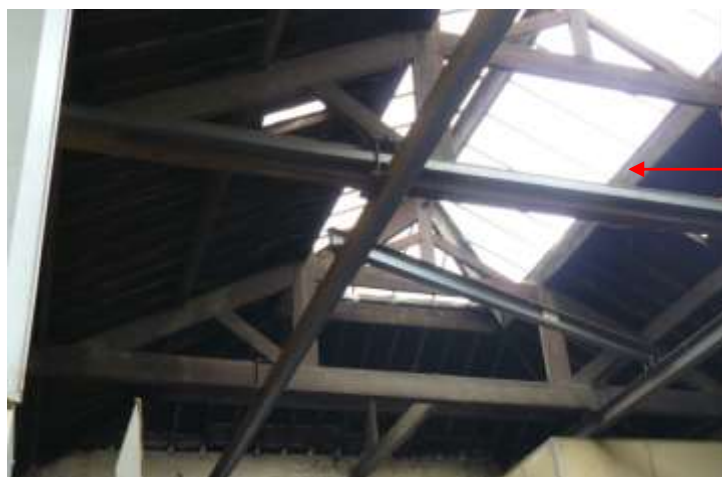
**Photo 3**

This is another elongate, large and functional factory building, again with a south-west to north-east aligned ridge-line. It is flanked by B1 and B3 along its elevations, so only its gable end walls are externally visible. The roof is pitched and externally finished with slates, laid onto bitumen felt and a traditional timber frame, but with a large expanse of skylights along the ridge (see **Photo 3**).

Interior timber roof frame, bitumen under slates and skylights along ridge line

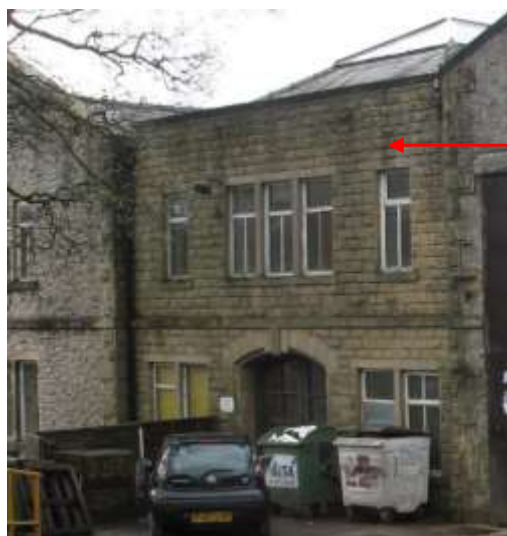
**Photo 4**

The roof of B2 finishes with a gable at the south-west end, but it is hipped at the north-east end, as exemplified in **Photo 4**. Here there is a small parapet wall concealing the edge of the roof, below which there are many intact windows, still with glass panes, plus one set of large old doors. There are also many windows at the south-western gable end, but all upper windows have been sealed with breeze-blocks and mortar, as shown in **Photo 5**.

North-eastern end, with hipped roof & many intact windows

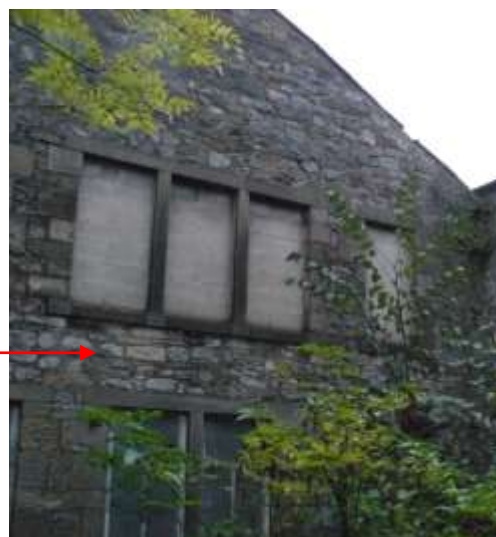
**Photo 5**

South-western end, with blocked up windows

Again, mortar and stonework associated with B2 is intact. Additionally there are no visible access gaps for bats or birds around the window frames. There is moderate potential value for crevice-roosting bats under slates and ridge tiles on the roof, but there is negligible potential value for hibernating bats, due to a lack of frost protection at such locations. There is also no visible access and no potential value for Barn owl or other breeding birds.

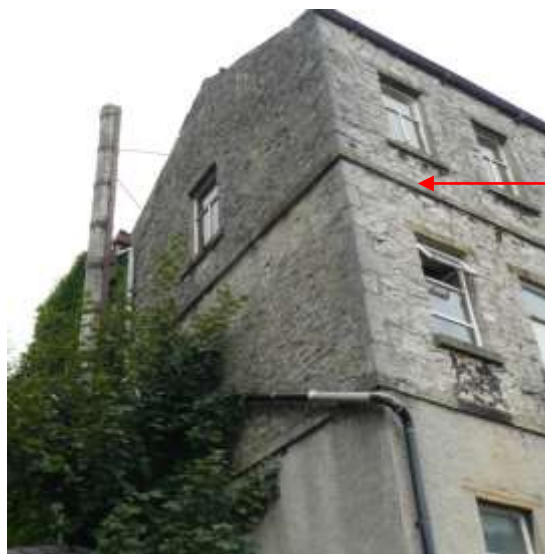
**Photo 6**

This is the largest of the factory buildings, displaying substantial height, a double pitched roof with valley gutter and also a former factory chimney attached at its south-western end, as illustrated in **Photo 6**. Its south-western gable supports very few windows and no parapet walls, whilst approx. 50% is clad with Ivy, as exemplified below. By comparison, the south-eastern elevation has very many intact and functional windows (see **Photo 7**) and the north-eastern gable end has multiple glass-paned windows, one personnel door and also one circular window with ventilation grill near the apex. The north-eastern gable end also has a parapet wall.

South-western end, with high stone walls and chimney

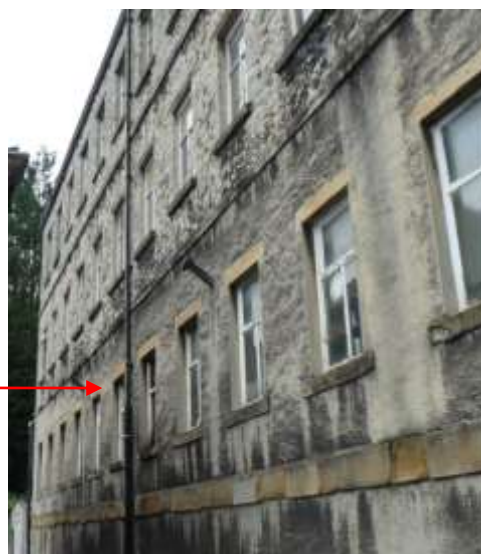
**Photo 7**

South-east elevation, with many windows

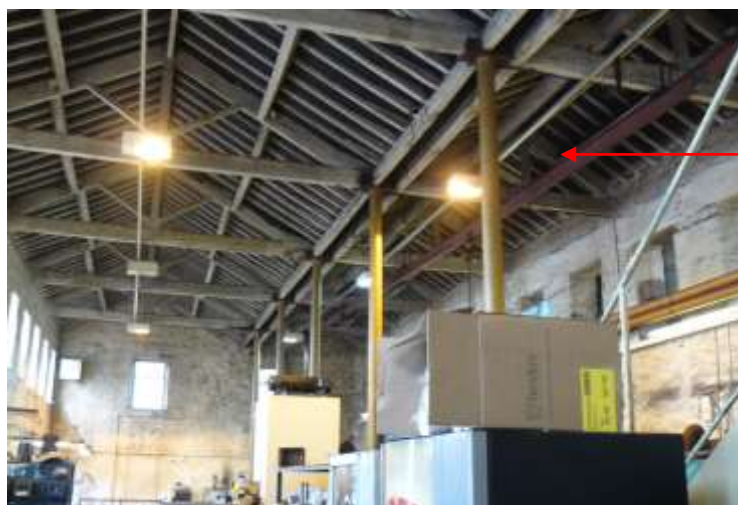
**Photo 8**

Inside, as shown in **Photo 8**, B3 is mostly open from floor to ridge, except for an enclosed office area, plus a lower-ground floor area, which is another functional part of the factory. The roof comprises traditional timber frames, overlaid with bitumen and then slates and ridge tiles. There are no skylights and there is no internal cladding or insulation to the roof or walls.

Interior of B3, open from floor to ridge, the same as B1 and B2

Mortar and stonework associated with B3 is predominantly intact, but to the exterior there are occasional deep gaps where mortar is missing. Additionally it is possible that there will be access to the wall-tops along the elevation walls. There is also potential habitat value for crevice-roosting bats to the rear of the dense Ivy at the south-western end. It is assessed that aforementioned gaps/features afford low-moderate potential value for crevice-dwelling bats. There is also moderate-high potential value for crevice-roosting bats under slates and ridge tiles on the large double-pitched roof of B3, but there is negligible potential value for hibernating bats, due to a lack of frost protection at such locations.

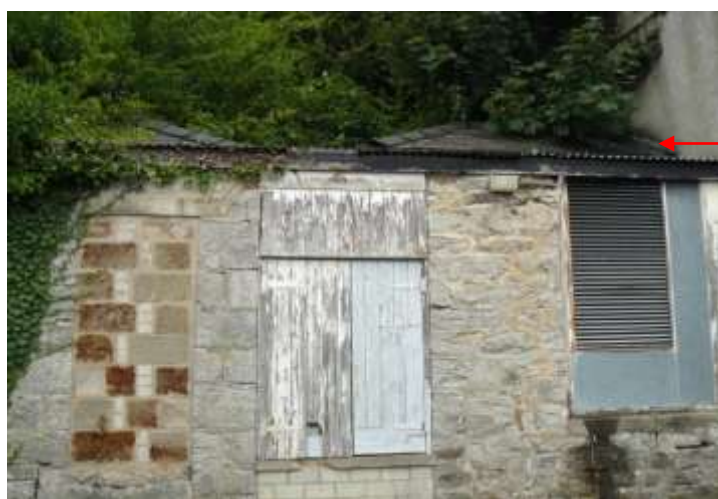
**Photo 9**

B4 is single-storey, stone walled and has two small hipped roofs that are finished with slates and ridge tiles. These are connected by a small section of low single-pitched roof of corrugated plastic sheets, plus a section of this single-pitch roof extends in front of the hipped areas (see **Photo 9**).

Two small hipped roofs, both with a narrow section of corrugated sheet roofing in front of them, at the south-east elevation

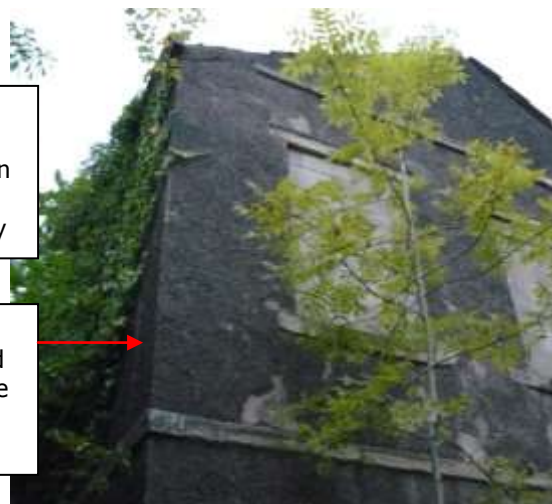
**Photo 11**

Blocked up windows and also evidence of missing roof slates

Although it was not possible to undertake an internal inspection of B5, it appears there is low-moderate potential value for crevice-roosting bats in association with gaps behind Ivy cover and gaps under roof slates. There is also low-moderate potential value for small nesting birds, again in association with Ivy and potentially under slates or within the roof space where missing slates have facilitated access. It is assessed that there is negligible potential value for Barn owl.

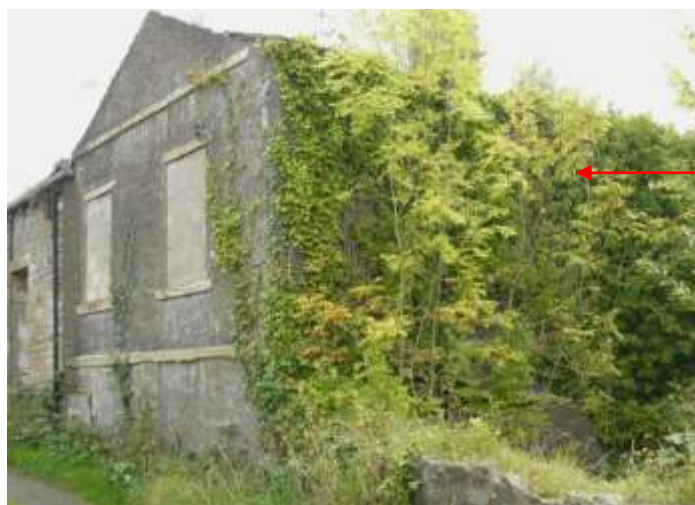
**Photo 12**

This is a derelict and burnt-out former house. Its rendered walls are still largely intact and its windows are sealed with breeze-block, as illustrated in **Photo 12**, but its former pitched roof has predominantly collapsed so there are only a few remnant stone tiles visible at the wall-tops. There is abundant Ivy along the south-western elevation wall.

The south-west elevation overgrown with Ivy. The roof above is mostly missing

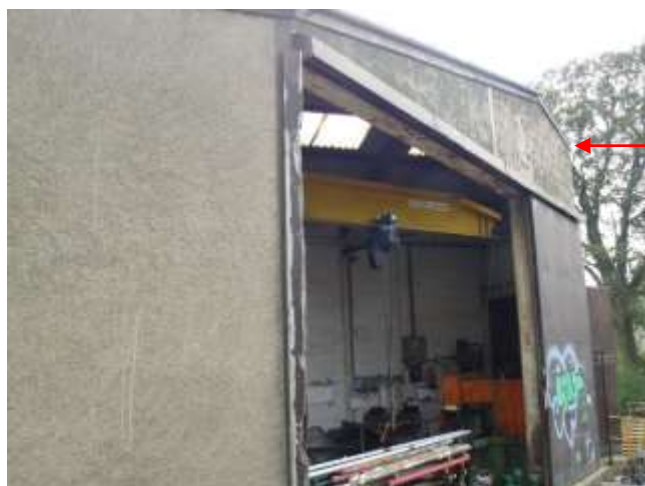
**Photo 13**

This is a detached and more modern structure, comprising breeze-block walls that are externally rendered and internally whitewashed (see **Photo 13**). The roof is pitched, with a metal frame and corrugated concrete-asbestos type sheets, plus plastic skylights. The interior is open from floor to ridge and the walls and roof are not lined or insulated. There are concrete-asbestos type verge caps at both gable ends, behind which there are small gaps.

Rendered breeze-block walls, plus concrete-asbestos verge cap

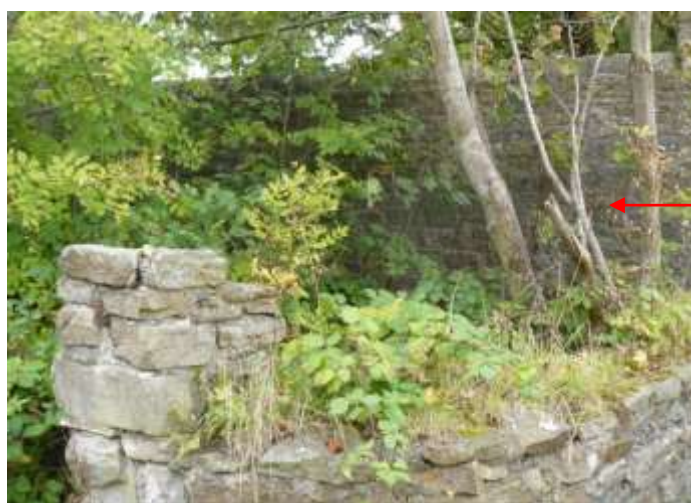
**Photo 14**

An array of stone walls (these in the photograph are at the south-western end of the Site)

The largest wall displays mortar that is in good condition. The lower walls have many mortar gaps, but being only 1 – 1.8m high they are judged to have very low or negligible potential value for bats. The largest gaps have low potential for use by nesting birds.

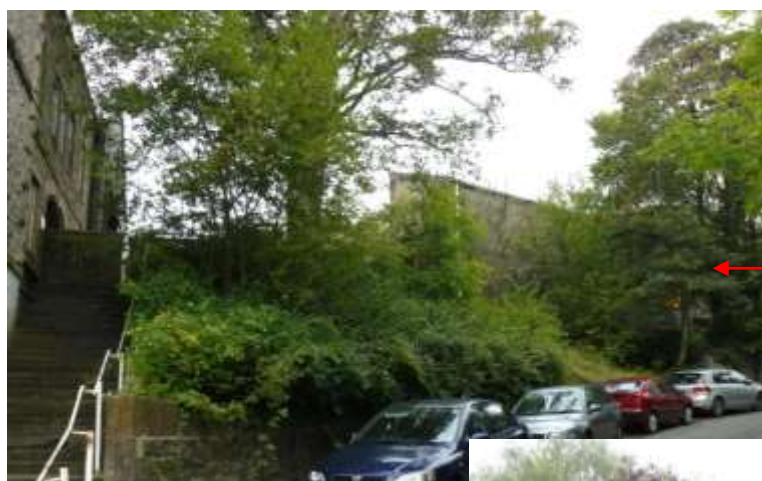
Beneath trees T2 – T8, the elevated ground to the east of buildings B1, B2 and B3 also supports a shrub layer and ground cover, as illustrated in **Photo 15** (next page). This comprises abundant Bramble and Snowberry, plus locally frequent Ivy and occasional ruderal 'weed' species such as Common nettle and Yorkshire fog. This vegetation appears to comprise a combination of landscape planting and natural colonisation. It does not represent an NVC community or a rare or fragile plant composition. This vegetation is not botanically noteworthy.

North-east  
part of the  
Site

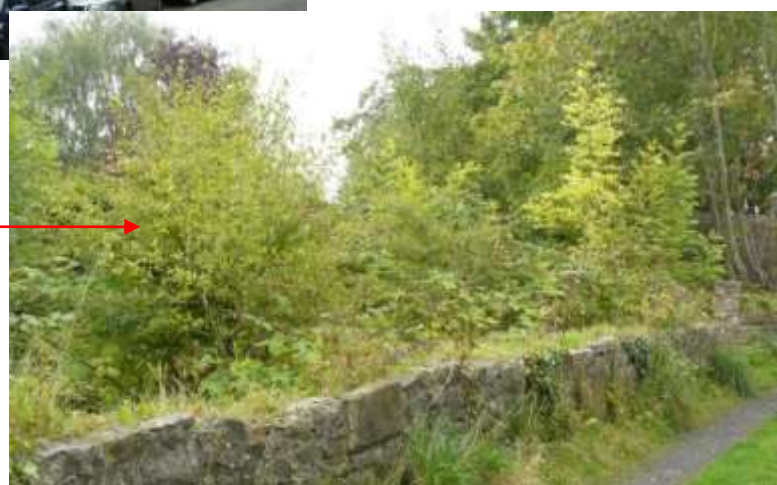
**Photo 16**

To the west of the buildings there is a shrub layer and ground flora associated with tree groups G1 and G2. Here there are mixed ruderal plants, ferns and grasses that appear to have naturally colonised (see **Photo 16**). Bramble, Ivy, mosses and Male fern occupy the most shaded areas and common grasses, Rosebay willowherb and Dandelion are prominent in the areas that are not

shaded by woody vegetation. There are no rare plant species, there are no examples of an NVC community and again the vegetation is not botanically noteworthy.

South-  
western part  
of the Site

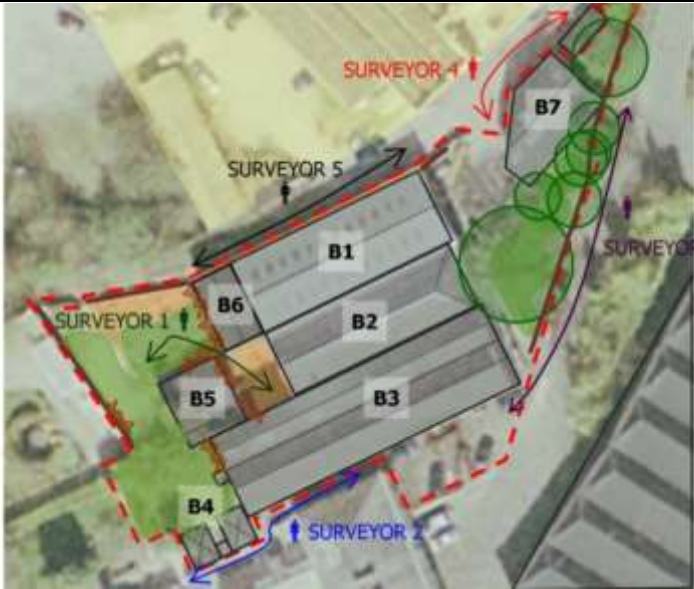
| Pre-dawn re-entry survey: Date: 15 <sup>th</sup> September 2014 | |
|---|---|
| <b>Surveyor locations:</b> | |
| Surveyor 1 | <p>05:35hrs = 1x Common pipistrelle feeding overhead, audio-only detection.</p> <p>06:05 – 06:07hrs = 1x Soprano pipistrelle, regular passes around trees south-west of surveyor.</p> <p>06:10hrs = 1 x Common pipistrelle pass east, up and out of sight over the roof of building B3.</p> <p>06:15 – 06:21hrs = 3 – 4x Soprano pipistrelles individually entering air-space over the surveyor and in the 'courtyard' framed by B2, B3 and B5, with <u>1x bat investigating the roof of B2 and with all then passing east /south-east up between B2 and B3, presumed to a roost on the roof of B3</u> because Surveyors 2 and 3 did not detect them re-emerging from the roof.</p> <p><u>In summary there was a likely Soprano pipistrelle roost high on the roof of the eastern half of B3, but roost entry was not visible due to height and this would remain the case for future surveys unless substantial scaffolding or a large elevated platform was to be made available.</u></p> |
| Surveyor 2 | <p>05:12 – 05:57hrs = Occasional Common and Soprano pipistrelle passes detected, audio-only, with two occurrences of possible faint <i>Myotis sp.</i> detections.</p> <p>06:07hrs = 2x bats flying high at tree tops and near south-west gable of building B3. Unsure of species, owing to limited echo-location and substantial height.</p> <p>06:32hrs = <u>1x bat (likely pipistrelle, but limited echo-location) re-entered a roost</u> high in the south-west gable end of building B3, on the section located south of the chimney.</p> <p>06:33hrs = <u>1x bat (again, likely pipistrelle, but limited echo-location) re-entered a roost</u> in a mortar gap high in the south-east elevation wall of building B3.</p> <p>Flight observation suggested that these bats were pipistrelles, though <u>it remains uncertain as to precisely which species. The precise roost entry locations were also very difficult to discern because of the height and angle of observation.</u></p> |

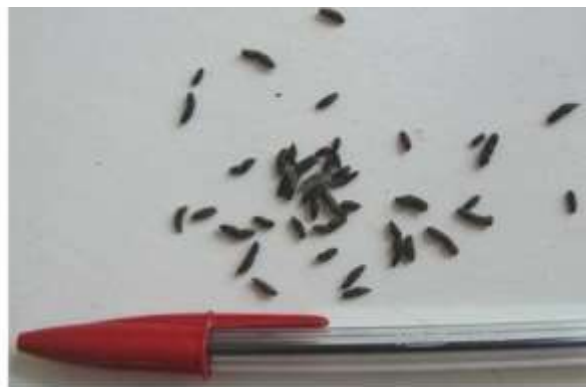
Pipistrelle bat droppings, which look like mouse droppings, but crumble to dust when squashed between the fingers (comprising tiny, glistening bits of insect wings etc.)

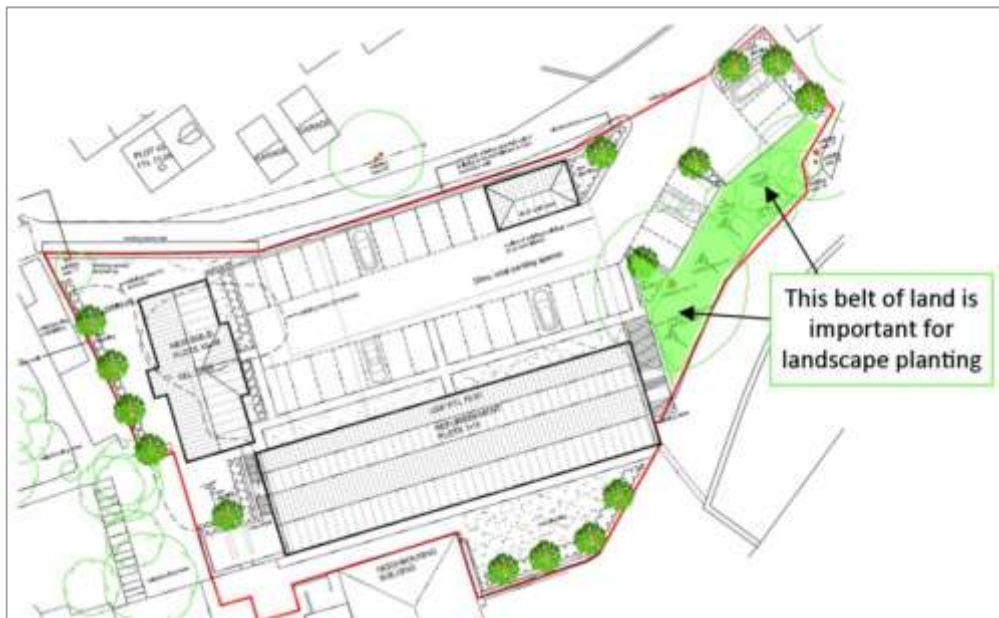
Additionally, good quality landscape planting is required, so that there is future foraging and commuting habitat for the bats in the vicinity of the buildings and roosts. Where there will be removal of trees T2 – T4 from the belt of land to the east of building B3, the landscaping will demonstrate replacement planting of mixed shrubs and trees, as indicated below:

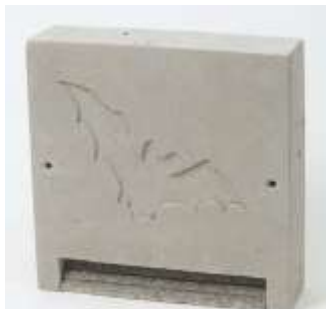
**Ibstock**

**Bat roost boxes or access bricks** can be built into upper walls. This is subtle but provides high quality roost habitat.

Position them to avoid locations above windows or doors.

Height=265mm Width=180mm  
Depth= 240mm

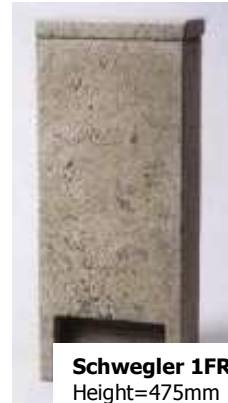
**Schwegler 1FR**

Height=475mm  
Width=200mm  
Depth= 125mm

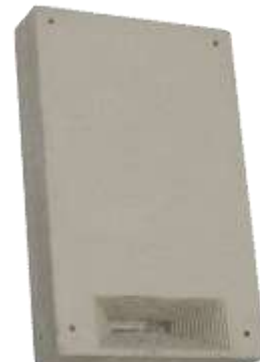
**Schwegler 1WI**

**Schwegler Summer and Winter Box**

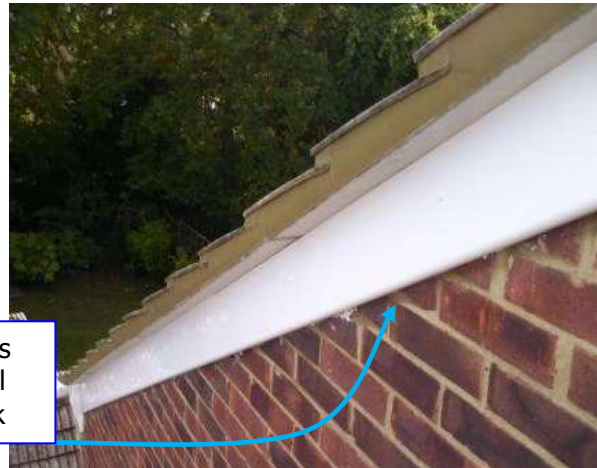
**Fascia boards and barge boards** provide valuable bat habitat, provided they are offset from the wall by about 20mm (3/4 of an inch)

Allow a gap for bats to gain access behind this board, where they will roost against the outer stonework

This should allow the bats two options:

- a) Roosting directly between the wall and the fascia board
- b) Access to the tops of the walls (see separate recommendation).

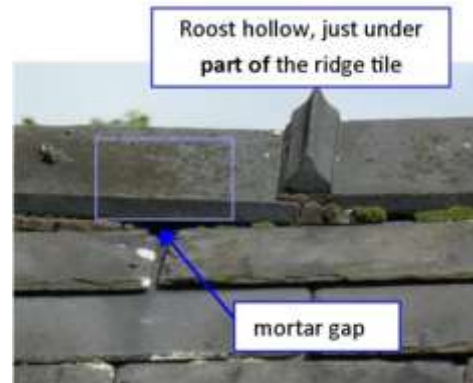
Access **under ridge tiles** can be achieved with no loss of water-tightness. Small gaps are left out of the mortar of certain ridge tiles and the hollow under the ridge tile is not filled with mortar at these locations, so there is a roost hollow, as shown.

NOTE: It is important that a layer of **bitumen felt** is used under the roost tiles, though breathable membrane can be used elsewhere. Research shows that breathable membranes can be prone to fraying when bats use them for roosting, which is a major hazard to the bats and also degrades the membrane. There is no means of the bats getting into the roof void provide the layers of bitumen and membrane do not have gaps in them.

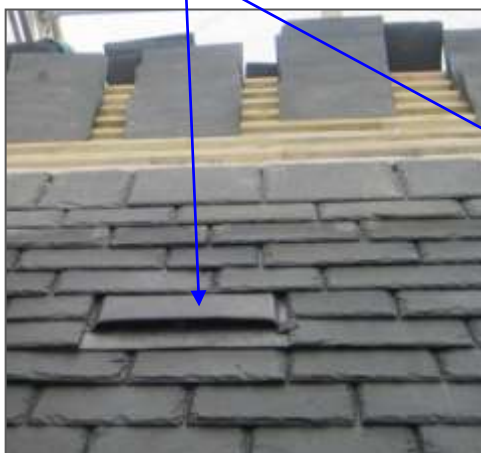
- 2) Create 'lead saddles' (i.e. mould pieces of lead, like shown below).

NOTE: again, **bitumen felt** has to be used under these slates, with breathable membrane elsewhere.
