KILN LANE BARN PRELIMINARY BAT ASSESSMENT

Bat and Barn Owl Survey; Kiln Lane, Clitheroe

- 1.1. BK Ecology was commissioned to undertake an assessment for bats at Kiln Barn, Kiln Lane, near Paythorne, Clitheroe (SD 83102 51581), see Figures 1a and b. Plans involve conversion of a barn into a residential property.
- 1.2. The aim of the assessment was to establish potential for bat use and record evidence of any bat use through a daytime inspection.

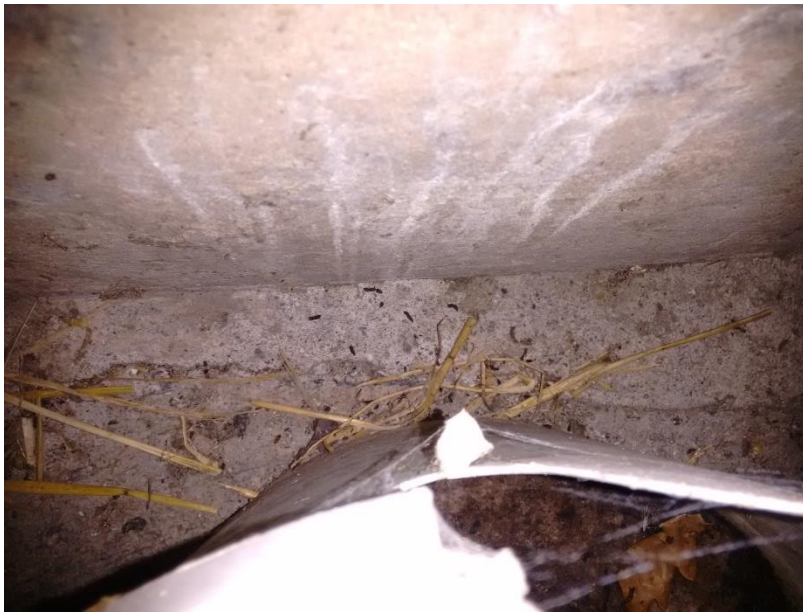
Plate 1 shows droppings on the floor behind a bucket and against the northern wall.

- 3.10. Several butterfly wings and droppings were noted internally on the floor (and in a bucket) next to a set of three windows on the north western aspect of the building. In addition droppings were found on the wall itself above the windows, apparently dropping down between the upper floor and the wall.

- 4.2. Due to the evidence of bat use noted during the inspection, and previous recorded use the barn should be subject to further survey in order to confirm and / or determine the type of roost, status and any species present prior to any works. This should inform any licence application before work commences.

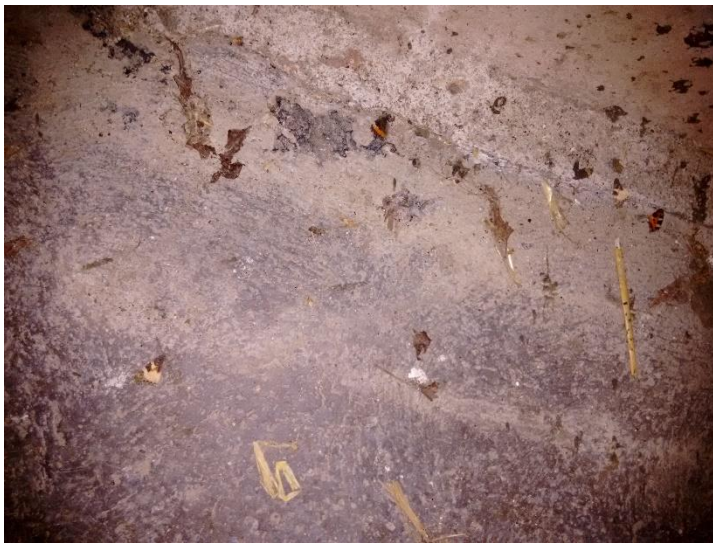
Plate 2 Shows butterfly wings on the floor and against the wall.

- 3.11. Additional butterfly wings were found in two places on the floor and droppings next to stairs leading to the upper floor. The presence of butterfly wings indicates the potential for brown long eared bats, either using the timber internal framework as a feeding perch or feeding in a more substantial roost (e.g. maternity roost).
- 3.12. Externally, there are numerous points of potential access including gaps in mortar, air vents, missing and broken window panes, gaps behind stone and timber lintels above doors and windows and behind steel fascia at the two ends of the barn. There are also frequent small gaps in the mortar along the roof ridge line and large cracks in the wall on the south east corners.

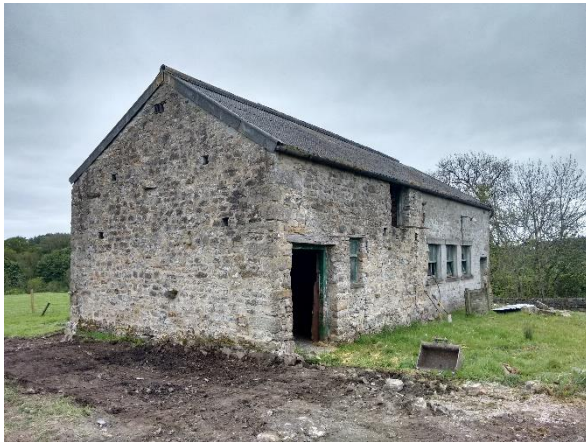
3.5. The building (see Appendix 1 for photographs) has high potential for roosting bats. It is a stone barn with a pitched, corrugated asbestos roof. There are numerous opportunities for access including an open lower barn door, gaps in stonework, broken glass in windows and vents in stonework. Torching is loose and degraded, which may present some opportunities.

Photograph 1 shows the north eastern aspect of the building.

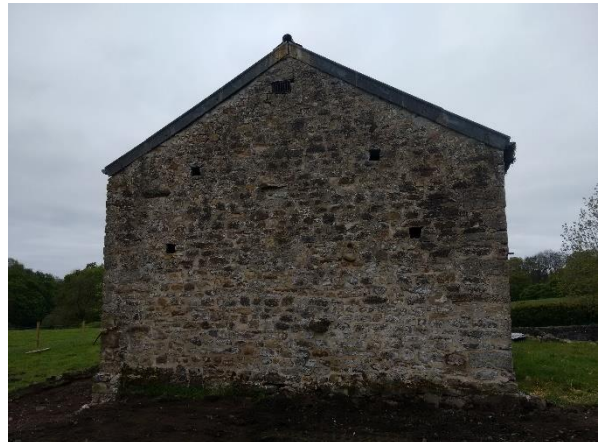
Photograph 2 shows the eastern aspect of the building.

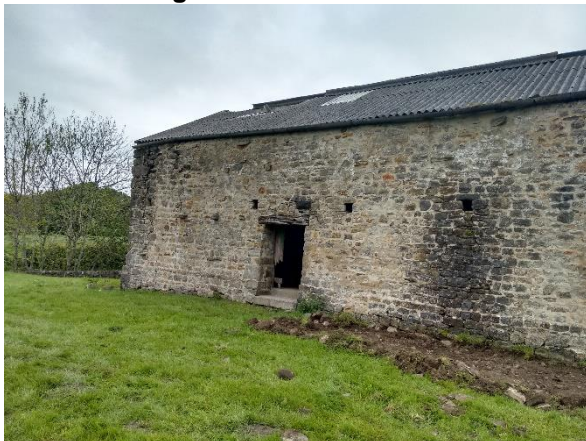
3.6. The end wall of the barn is suffering subsidence and is gradually coming away. Anecdotal evidence suggests this end of the barn (specifically the south east corner) is where bats are roosting.

Photograph 3 shows the south eastern aspect.

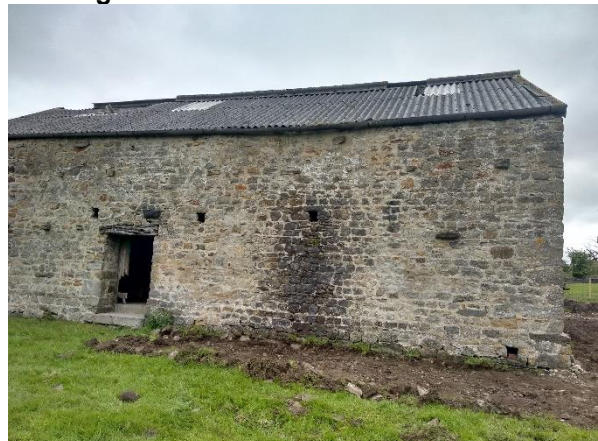
Photograph 4 shows the south eastern aspect.

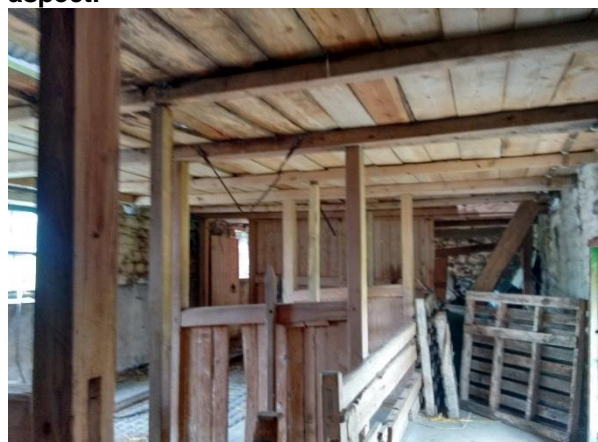
Photograph 6 shows the internal structure of the barn.

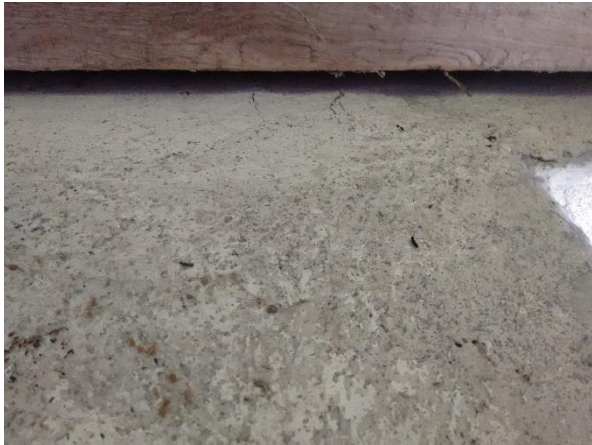
Photograph 7 shows droppings below the upper floor and between lower floor windows

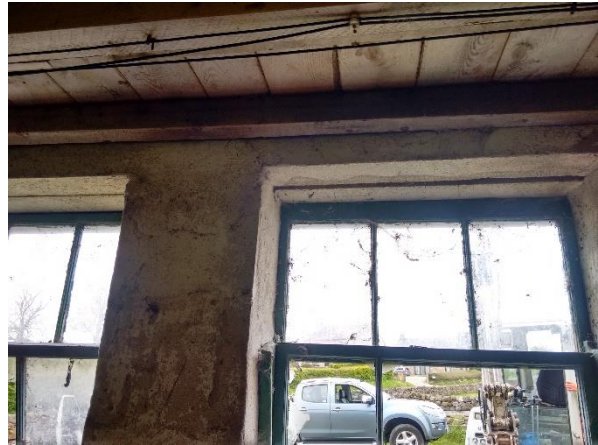
Photograph 8 shows the structure of the floor above the windows.

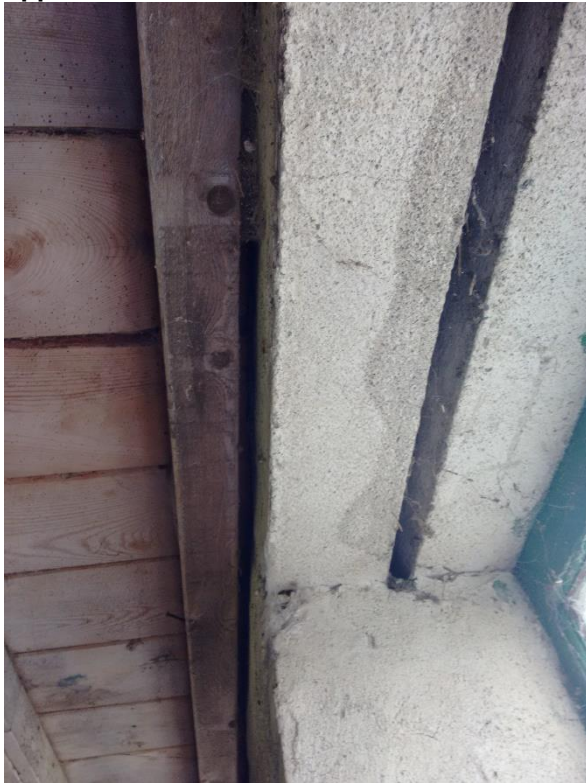
Photograph 9 shows the gap in the lintel and also between the upper timber floor and the lintel.

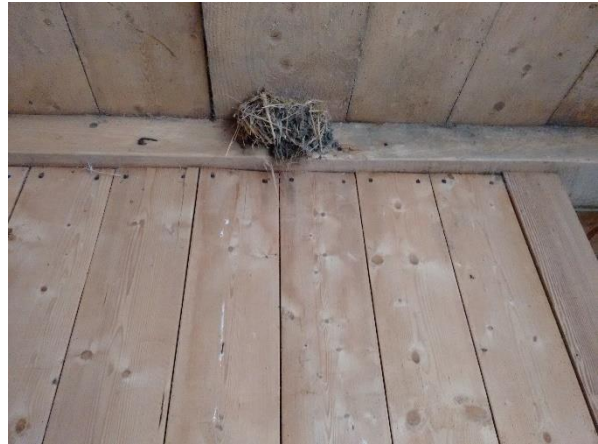
- 4.7. During the survey it was noted that the building has evidence of recently nesting swallows. In addition, a jackdaw nest and another active nest with young were noted during the survey.

Photograph 10 shows swallow nest.

- 4.12. The Wildlife & Countryside Act (1981, as amended) gives general protection to all wild birds from killing, injuring or taking; destroying, damaging or taking nests in use or being built; and taking or destroying eggs. Further, as the swallow returns to the same site each year, it is recommended that some provision is made for these birds within the new development. This should take the form of;

- An access points to be included in the building.
 - Nesting sites or nests; an example of which can be found in Appendix 2.
