Standen Hall, Clitheroe, Lancashire BB7 1PR

## LICENSED BAT SURVEY AND ASSESSMENT

November 2015

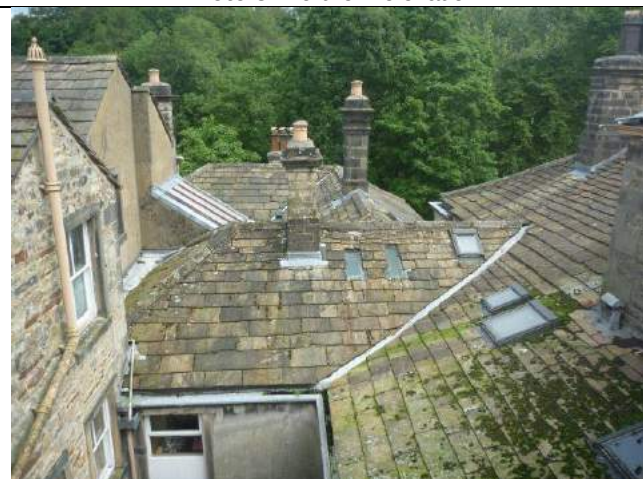
**Photo 5:** Complex rooftop, from southern end looking north (view from bat activity survey position 3)

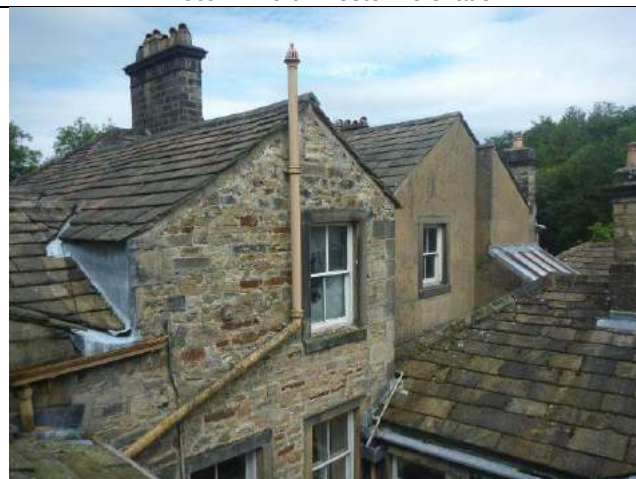
**Photo 6:** Complex rooftop, from south-eastern end looking north-west (view from bat activity survey position 2)

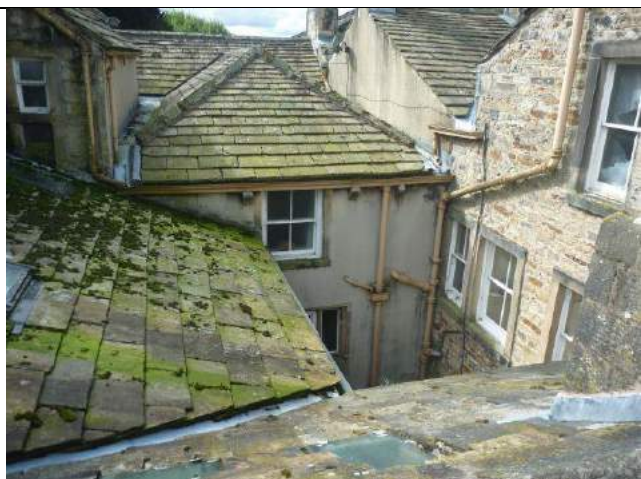
**Photo 7:** Complex rooftop, from northern-end looking south

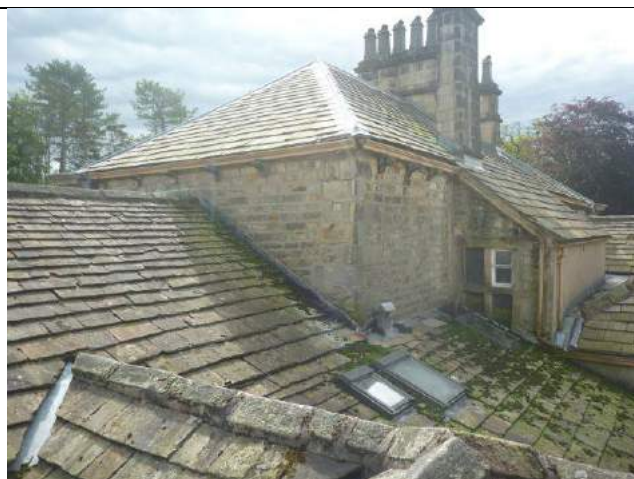
**Photo 8:** Complex rooftop, from north-western end looking south-east (view from bat activity survey position 1)

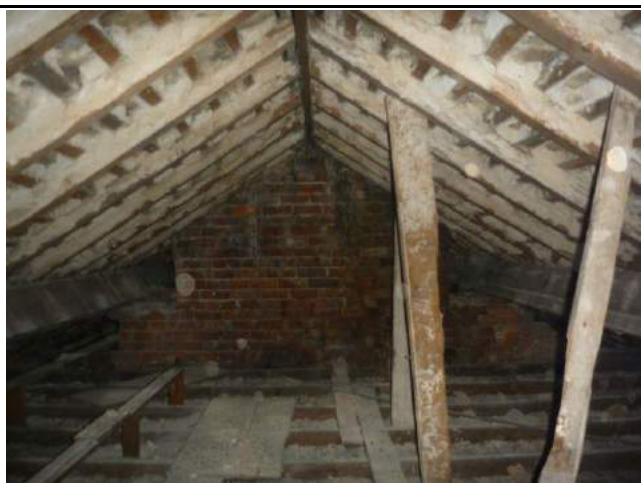
**Photo 9:** Roof Void A

Slates are lined with degraded horsehair parging. Floor is uninsulated.

No bats or signs of bats detected within void.

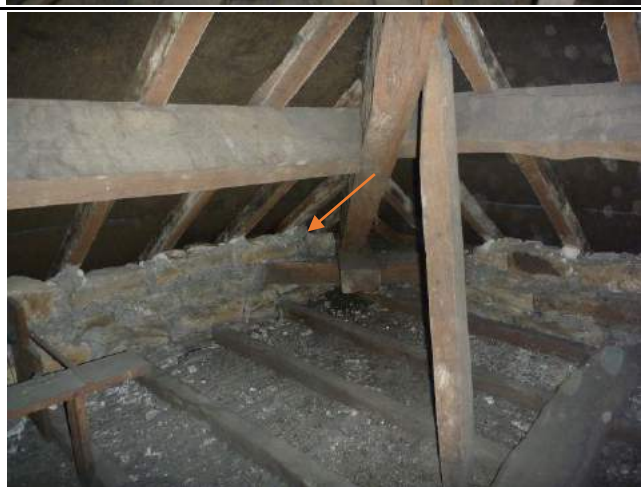
**Photo 10:** Roof Void B1 (northern end)

Pipistrelle bat species observed roosting at crevice between internal 0.3 metre high mortared stone wall and roof (see arrow).

**Roosts 1, 2 and 3. Refer to Photos 24 to 27 Table 8.3.**

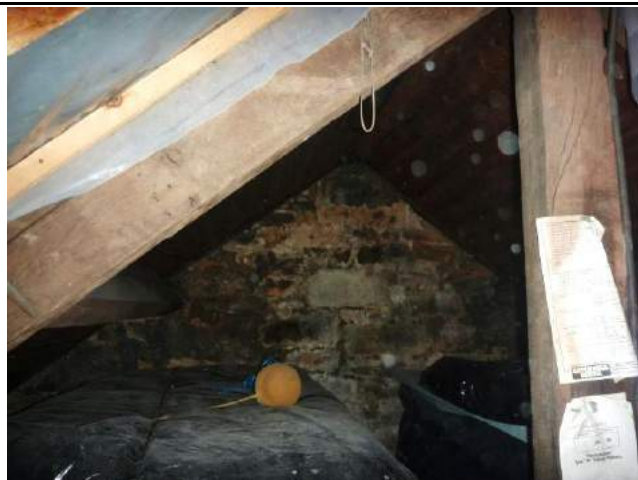
**Photo 11:** Roof Void B2 (middle/northern end)  
Separated from Roof Void B1 via plastic sheeting.  
*Dimensions:*  
2.5 metres tall, 7.5 metres wide by 5 metres long.  
*Construction type and materials:*  
As per B1. Covered water tanks are present. The roofing is lined by timber planks.  
*Signs of roosting bats*  
Occasional scattered droppings, indicative of bats in flight present. No bats or signs of roosting bats present.

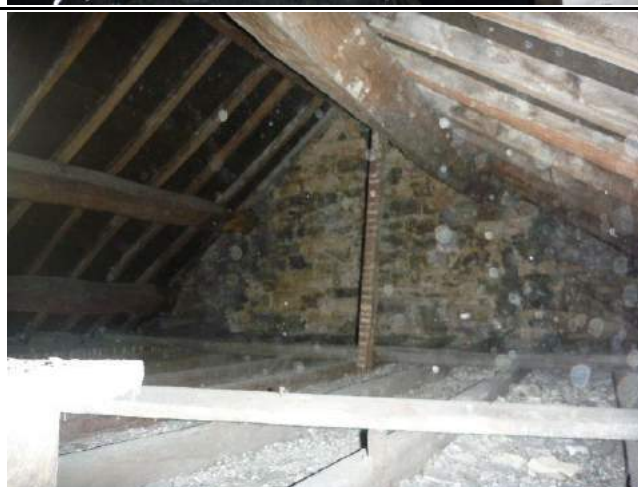
**Photo 12:** Roof Void B3 (middle/southern end)  
*Dimensions:*  
2.5 metres tall, 7.5 metres wide by 5 metres long.  
*Construction type and materials:*  
Constructed from traditional timber purlins and rafters.  
Roofing slates lined with bitumastic roofing felt.  
Floor is uninsulated.  
*Signs of roosting bats*  
100's of droppings (of a size and shape indicative of *pipistrelle* species) distributed under the ridge line.  
No bats detected.  
**Roost 4, refer to Photo 28, Table 8.3.**

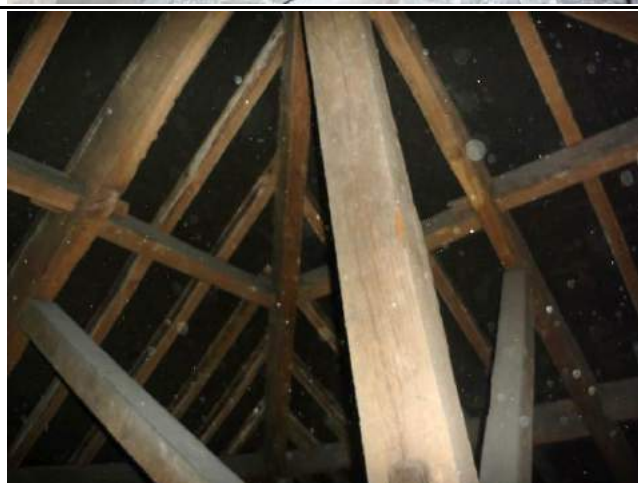
**Photo 13:** Roof Void B4 (southern end)  
*Dimensions:*  
2.5 metres tall, 7.5 metres wide by 5 metres long.  
*Construction type and materials:*  
Hipped end. Constructed from traditional timber purlins and rafters.  
Roofing slates lined with bitumastic roofing felt.  
Fibreglass insulation present at floor.  
*Signs of roosting bats*  
10's of droppings detected scattered within void, indicative of bats in flight. Cluster of 50+ droppings present under ridge-line.  
**Roost 5, refer to Photo 29, Table 8.3.**

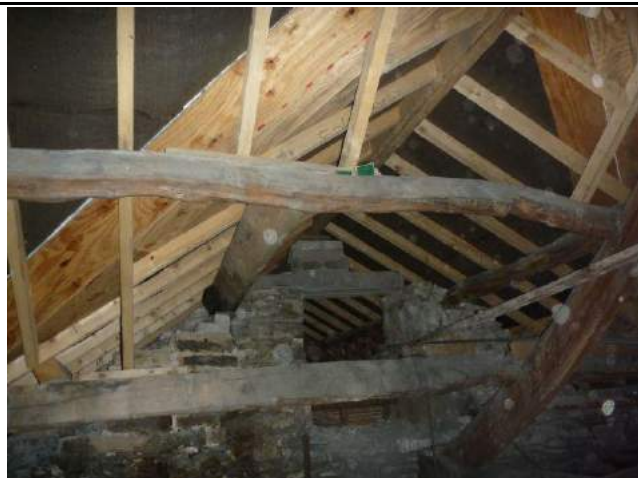
**Photo 14:** Roof void C

1000's droppings (indicative of a pipistrelle species) under ridge beam

**(Roost 6, refer to Photo 30, Table 8.3).**

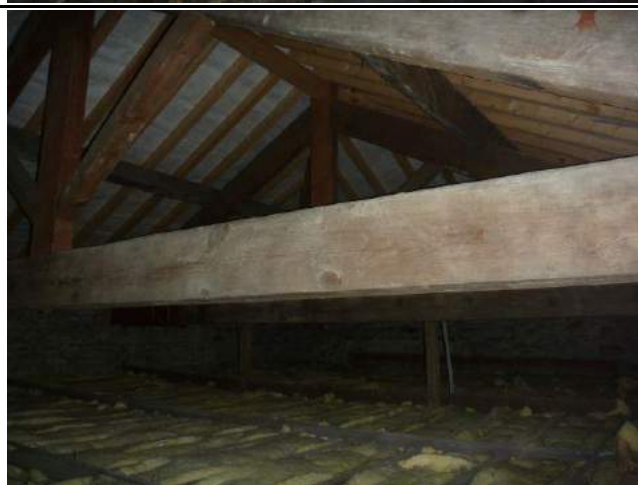
**Photo 15:** Roof Void D

Droppings scattered throughout, more indicative of bats in flight than in specific clusters which could indicate a roost. Droppings a mixture of smaller, thinner droppings indicative of a pipistrelle species and larger droppings split into three clear sections, indicative of Brown Long-eared bats.

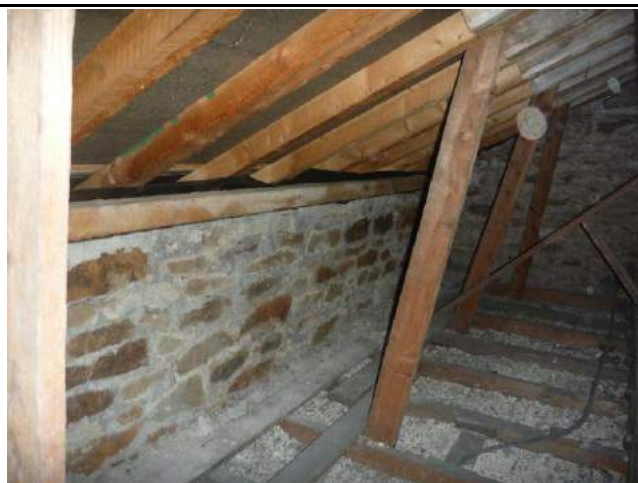
**Photo 16:** Roof void E

No bats or signs of bats were detected within the void.

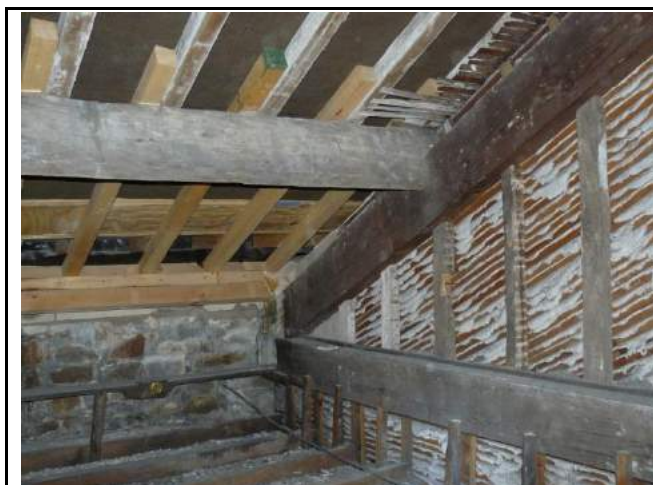
**Photo 17:** Roof void F

No bats or signs of bats.

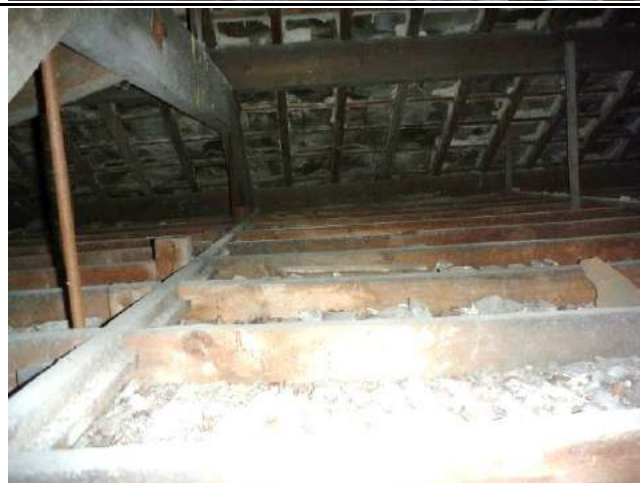
**Photo 18:** Roof void G

Degraded horse-hair parging is present under the roofing slates. No insulation is present.

1000's of droppings are located under the two ridgeline along the length of the void, with clusters (100's) at the two south-east facing gables.

**Roosts 7 (north) and Roost 8 (south), refer to Photos 31 to 33, Table 8.3**

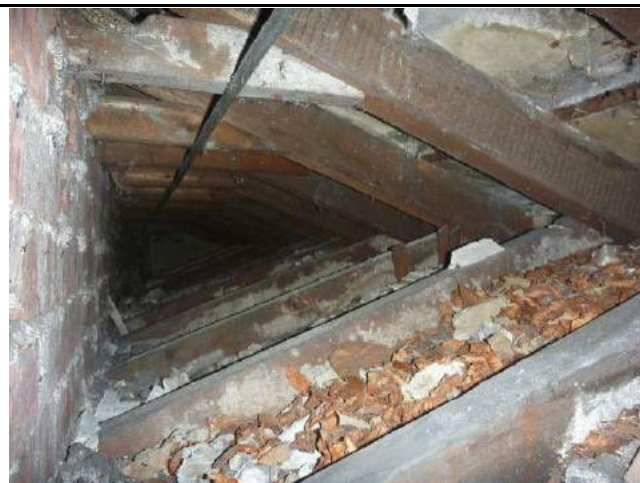
**Photo 19:** Roof void H

No bats or signs of bats were detected.

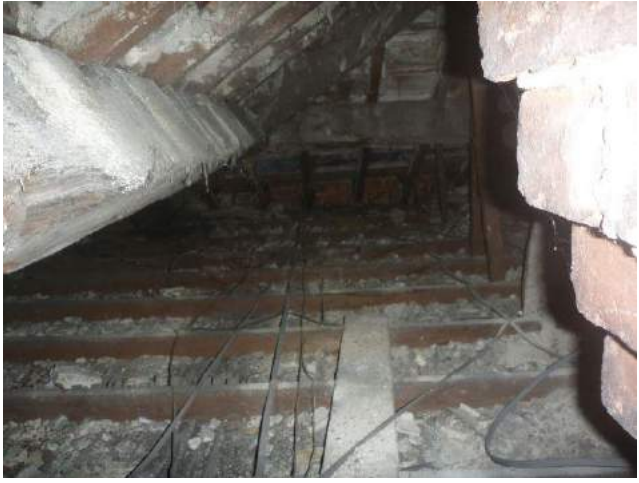
| | <p><b>Photo 20:</b> Roof void I1, (south-western end) inaccessible</p> <p><i>Dimensions:</i><br/>2.5 to 3 metres tall, 3 metres long and 4 metres wide with a hipped end at the north-western elevation.</p> <p><i>Construction type and materials:</i><br/>The void is supported on traditional timber purlins and rafters.<br/>The roofing slates are unlined and the void is uninsulated.</p> <p><i>Signs of roosting bats</i><br/>No access could be gained directly into the void, however examination from the narrow opening between the chimney wall and roof did not reveal any clusters of bat droppings; no bats or signs of bats were detected via the examination which was possible.</p> |

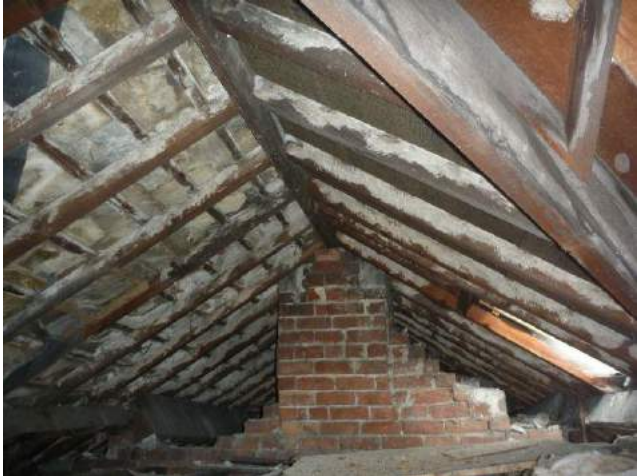
| | <p><b>Photo 21:</b> Roof void I2 (southern middle),</p> <p><i>Dimensions:</i><br/>1.5 metres high by a maximum of 5.5 wide and 4 long.</p> <p><i>Construction type and materials:</i><br/>Supported on traditional timber purlins and rafters.<br/>The roofing slates are unlined and the void is uninsulated.</p> <p><i>Signs of roosting bats</i><br/>A cluster of 30 old droppings, indicative of a pipistrelle bats are present at the southern end of the void</p> <p><b>Roost 9, refer to <i>Photos 34 and 35, Table 8.3.</i></b></p> |

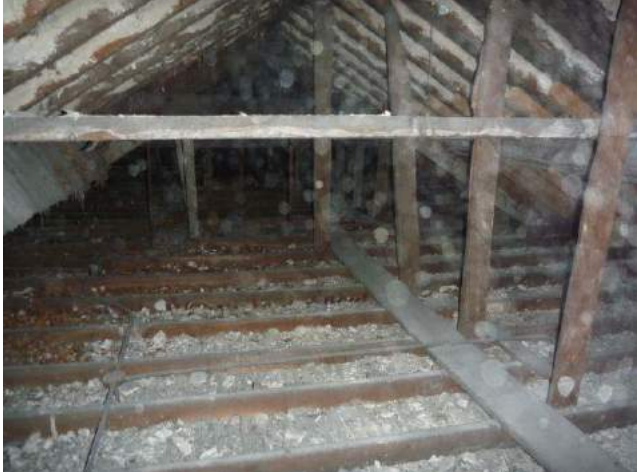
| | <p><b>Photo 22:</b> Roof void I3 (northern middle)</p> <p><i>Dimensions:</i><br/>1.5 metres high by a maximum of 7 wide and 9 long.</p> <p><i>Construction type and materials:</i><br/>Supported on traditional timber purlins and rafters.<br/>The roofing slates are unlined and the void is uninsulated.</p> <p><i>Signs of roosting bats</i><br/>No bats or signs of bats were detected.</p> |

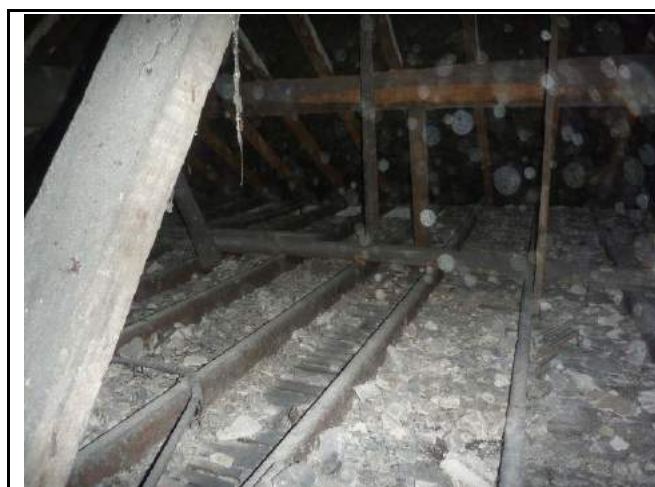
**Photo 23:** Roof void I4, north-western end

**Roost 10, refer to Photo 36, Table 8.3.**

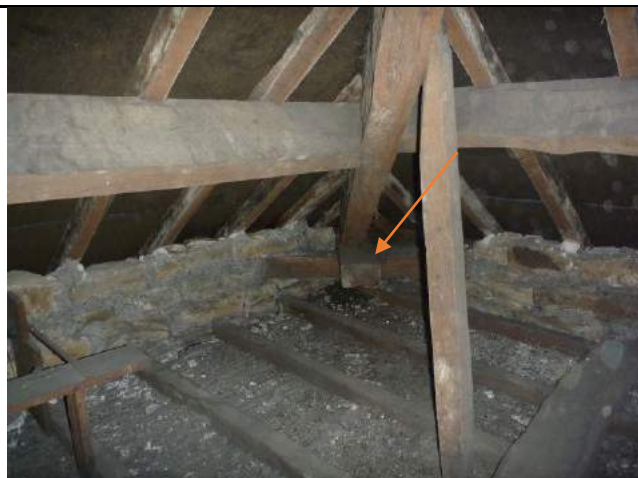
| Reference, Species and Photo reference | Location | Description and Roost Type <sup>1</sup> |
|---|---|---|
| <b>Roost 1</b><br>Soprano Pipistrelle<br><i>Photos 24 and 25</i> | Roof Void B1, north-eastern corner, between wall-top and roofing at eaves | 1000's of droppings within void. Bats observed and large numbers heard active during survey.<br><i>Maternity roost.</i> |

**Photo 24:** Roost 1 location, as indicated by orange arrow. Roost located at south-eastern of Roof Void B1. 1000's of droppings and bats were present

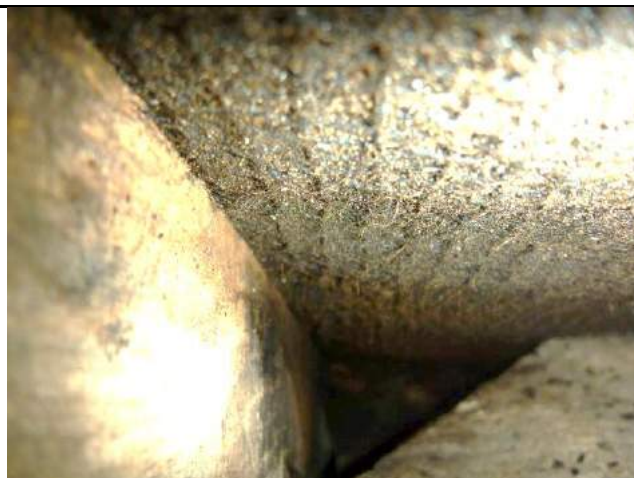
**Photo 25:** Roost 1 roosting location at eaves.

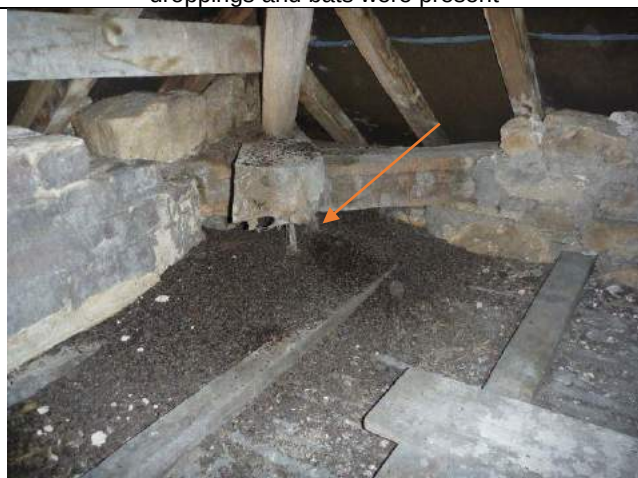
| Reference, Species and Photo reference | Location | Description and Roost Type <sup>1</sup> |
|---|---|---|
| <b>Roost 2</b><br>Soprano Pipistrelle<br><i>Photo 26</i> | Roof Void B1, north-western corner, between wall-top and roofing at eaves | 1000's of droppings within void. Bats observed.<br><i>Maternity roost.</i> |

**Photo 26:** Roost 2, 1000's droppings present at north-western corner of Roof Void B1

- 5.2.3 Points 'a' to 'c' will ensure that the proposals will be timed at a suitable time of year to avoid impacts to roosting bats. Points 'd' and 'e' seek to ensure that the proposals will retain and maintain the current conditions at the Hall for Roosts 2, 3, 7, 8 and 11.

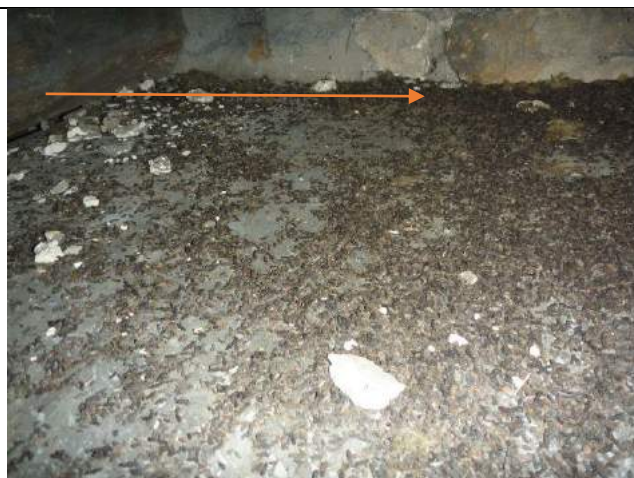
**Photo 27:** Roost 3, 1000's droppings present at south-western corner of Roof Void B1

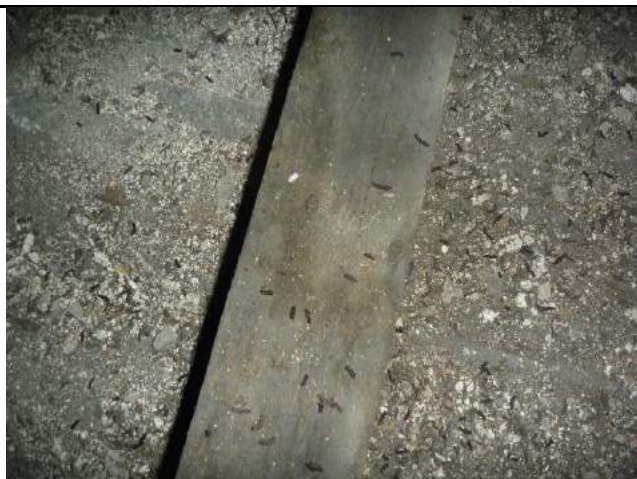
**Photo 28:** Roost 4, 100's of droppings indicative of a *pipistrelle* species along length of ridge beam of Roof Void B3

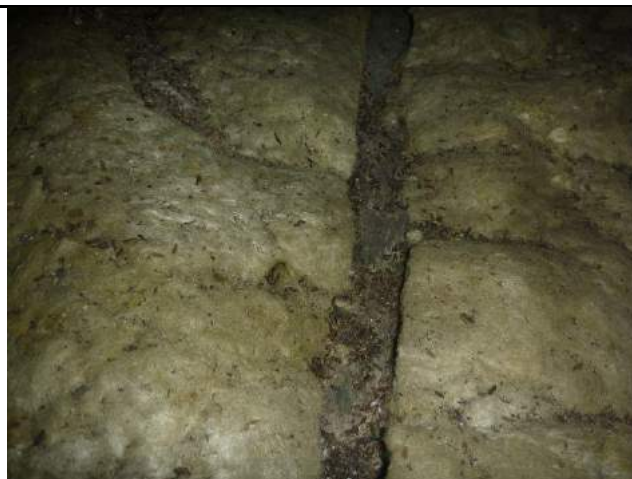
**Photo 29:** Roost 5, 50+ droppings along length of ridge beam of Roof Void B4

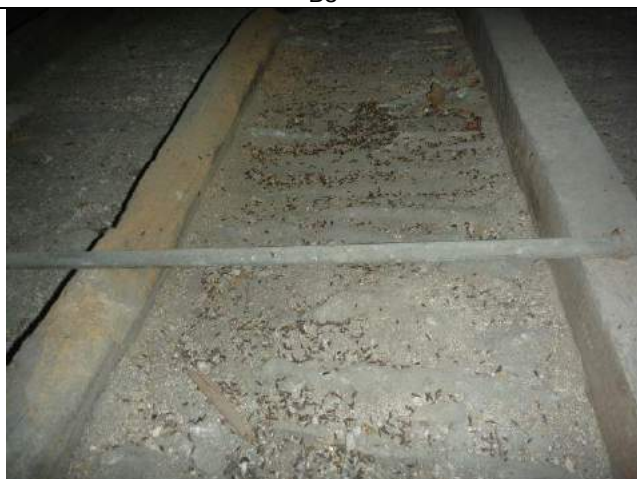
**Photo 30:** Roost 6, 1000's of droppings along the length of the ridgeline

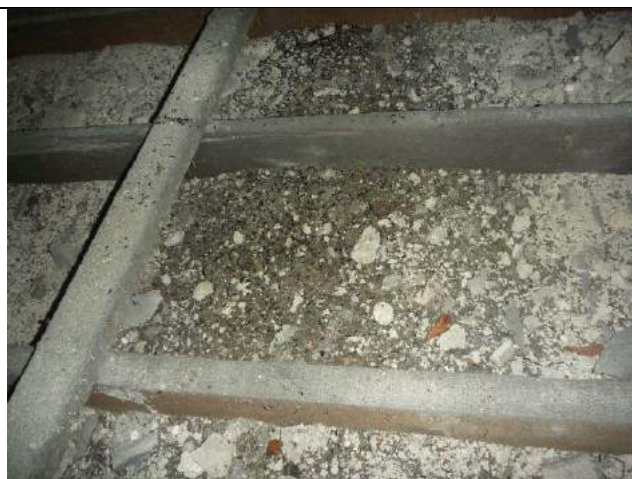
**Photo 31:** Roost 7, 1000's droppings under the ridgeline, with clusters of droppings located at the south-east facing gable

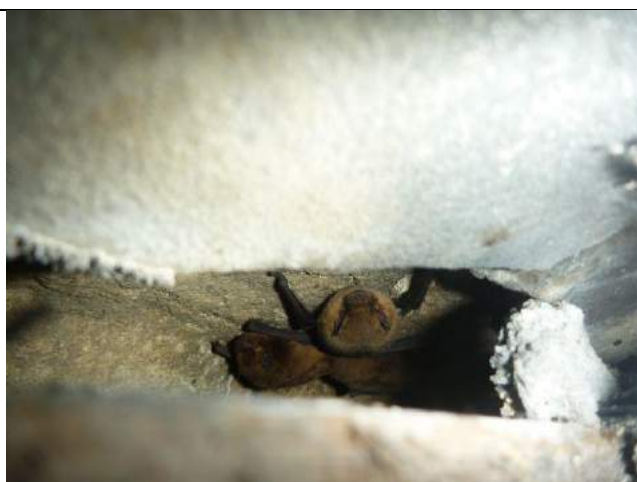
**Photo 32:** Roost 7, Soprano Pipistrelle roosting above ridge beam

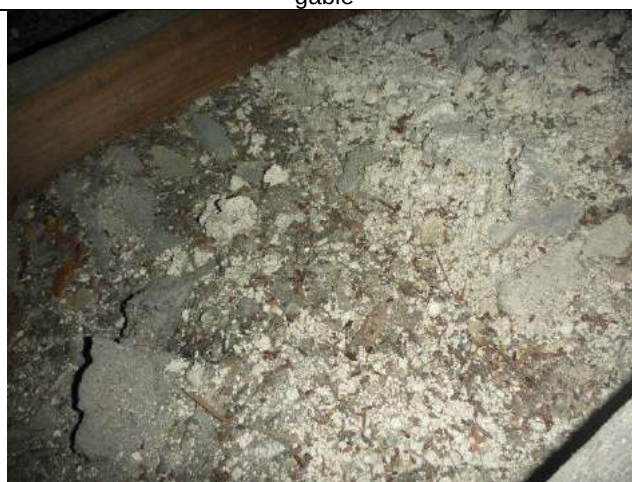
**Photo 33:** Roost 8, 1000's droppings under the ridgeline, with clusters of droppings located at the south-east facing gable

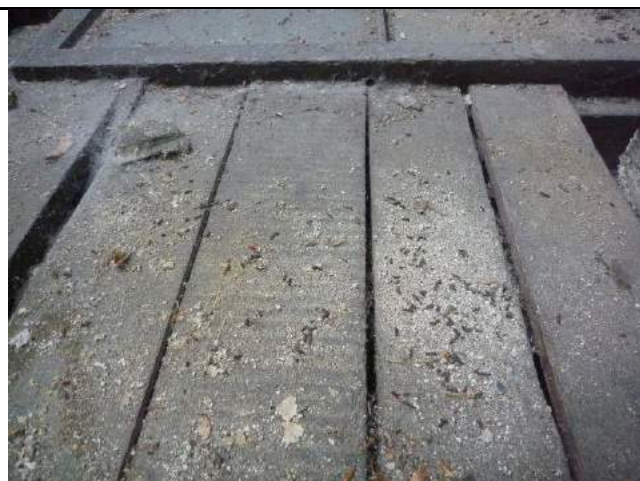
**Photo 34:** Roost 9, 30+ droppings indicative of a *pipistrelle* species, located within Roof Void I2

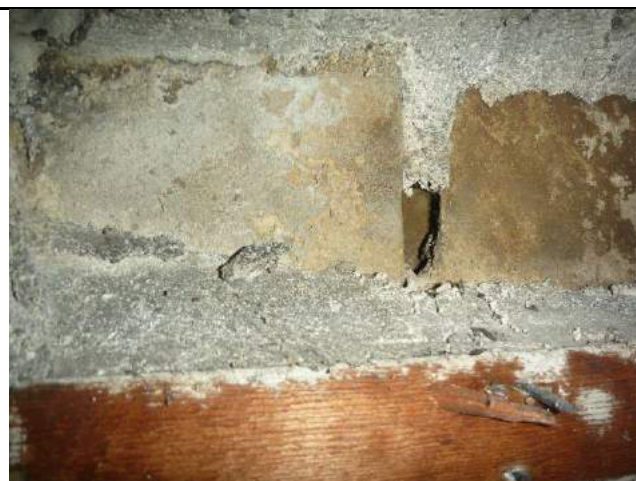
**Photo 35:** Roost 9, gap in stone slates through which droppings have fallen (directly above droppings)

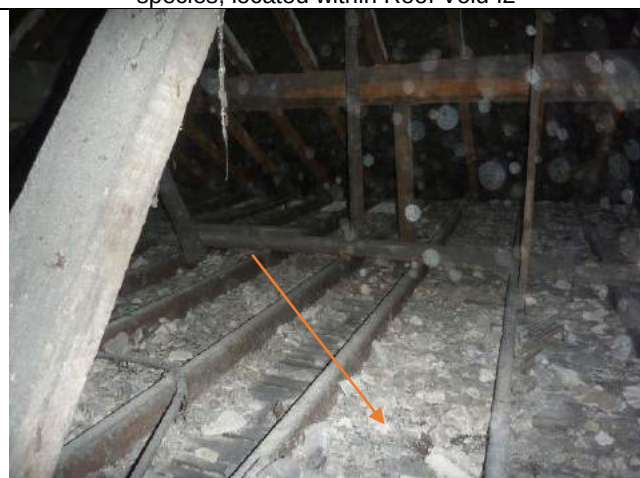
**Photo 36:** Roost 10 as indicated by the orange arrow, 30+ old droppings, indicative of pipistrelle bats, located within Roof Void I4.

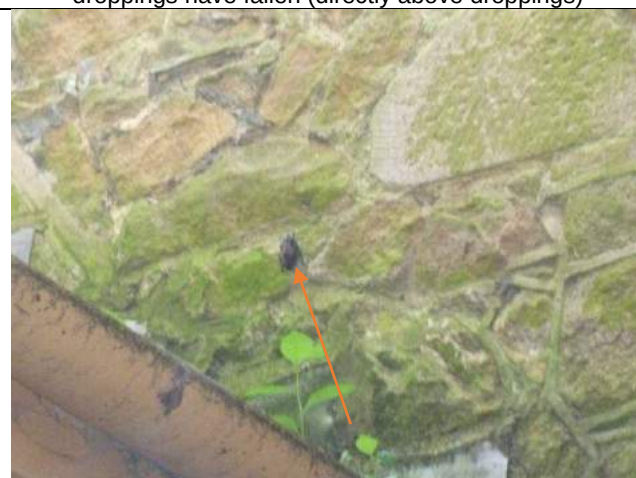
**Photo 37:** Dead Whiskered / Brandt's bat

- 3.2.8 The daylight assessment additionally found the presence of three dead juvenile Soprano Pipistrelle<sup>1</sup> bats within the living areas of the Hall and one dead Whiskered / Brandt's bat on an external wall (**Photo 37, Table 8.3**). The bat was in too far an advanced stage of decomposition to reliably determine to species, although the features were most indicative of a Whiskered bat.
- 3.2.9 The building supports a large maternity colony of Soprano Pipistrelle. The colony is spread across several locations within the building. The building is additionally likely to be used by Soprano Pipistrelle (and other bat species) throughout the year, with smaller day roosts present. The building supports features suitable for use by hibernating bats.
- 3.2.10 The results of the two activity surveys are presented below.

4.2.3 A dead Whiskered / Brandt's bat, found on an external wall, and large droppings indicative of Brown Long-eared bats (found at Roof Void D) indicate that further species may also roost at the building.

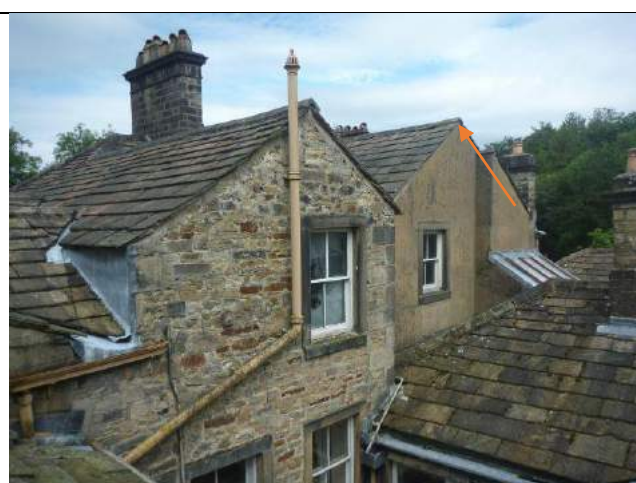
**Photo 39:** Roost 7 emergence and re-entry location

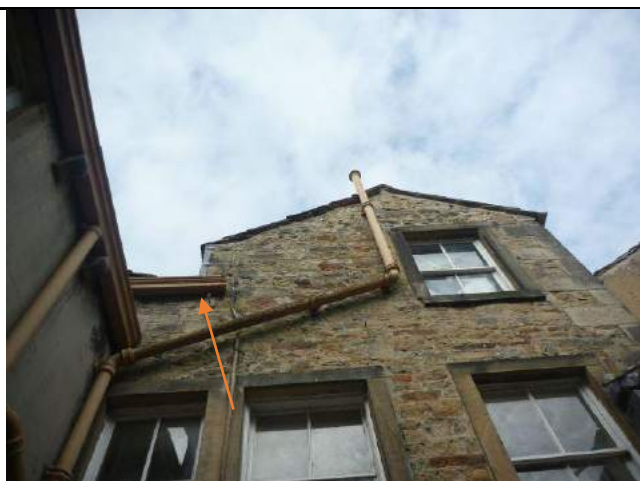
4.2.2 One confirmed instance of a day roost of Common Pipistrelle has been detected at Roost 11, and further field signs indicative of a day roost of pipistrelle species has been noted at Roosts 9 and 10.

**Photo 40:** Roost 11 re-entry location
