**STANDEN HALL  
CLITHEROE  
LANCASHIRE**

**Historic Building  
Assessment**

*Colin Briden  
Historic Buildings Archaeologist  
October 2015*

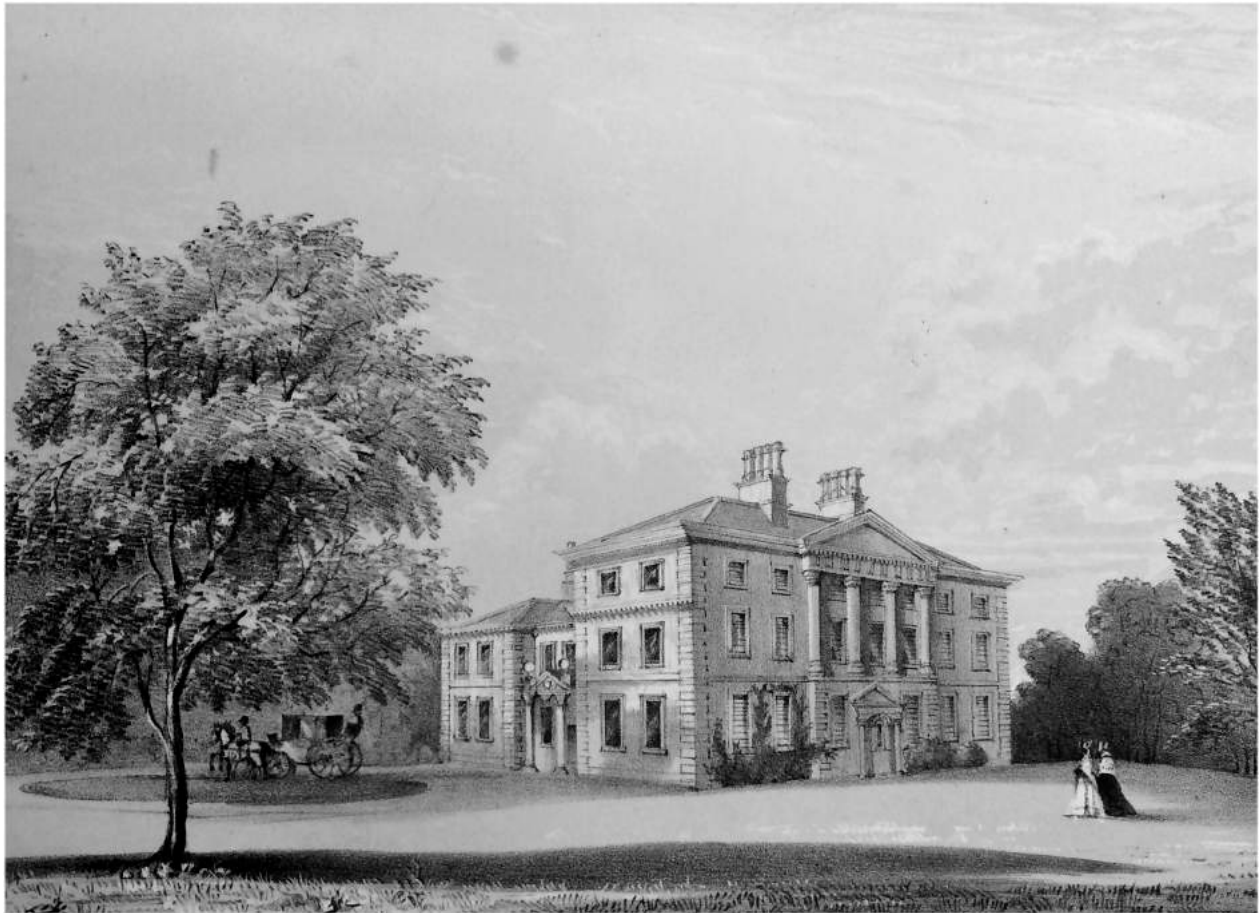
Fig 8                      1847 Lithograph by Twycross for *Mansions of Lancashire*

The west range was also rebuilt. The south end wall is seen in elevation in the Twycross lithograph [Fig 8]: in contrast to the more imposing east range it was only two storeys high although like the east range it was two windows wide. However at second-floor level on the west re-entrant wall of the east range there are projecting blocks on the line of the south wall of the South Hall: a detail which demonstrates a clear intention to raise both the South Hall and the west range to a full three storeys at some future time. This plan was eventually superseded by the demolition of the south bay of the west range and the construction in its place of the larger dining-room block, with its much greater floor-to-ceiling heights, after 1856.

The 1847 engraving shows no buildings at the north end of the C18 east range [Fig 8]. That this may have been merely poetic licence in the interest of providing a more picturesque view, however, is strongly suggested by the OS sheet of the same published date in which the east front is shown carried across to meet the east end of the Phase I north range [Fig 9]. That could only have been the case if the present Phase III service building already existed. A date in the first half of the C19 is in any case confirmed by the roof structure and by brickwork details visible in the roof space.

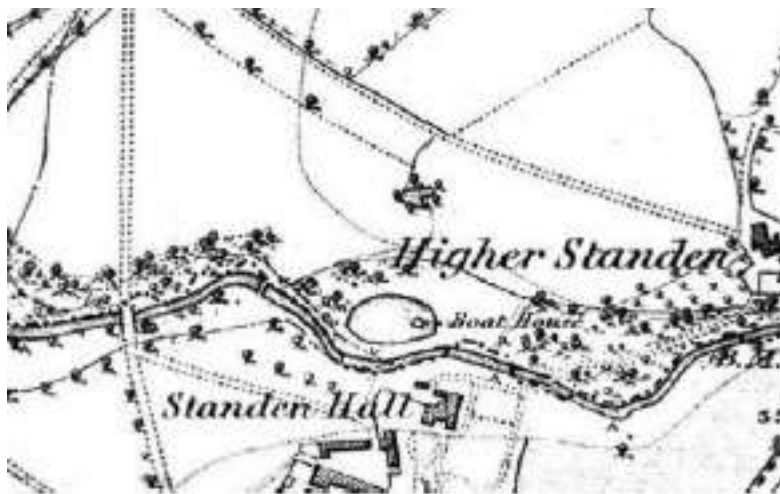
Fig 9                      1847 OS

Minor ranges, however, do not make a hall: it must be asked where the rest of the C17 house was. The clear implication of the 1847 OS [Fig 9] and the Twycross lithograph of the same date [Fig 8] is that it must have lain beneath the present C18 east range and the C18 and C19 west range to create the H-shaped plan as described in the 1911 Victoria County History. The southern surviving C17 range will therefore have been part of a transverse range in the early house, and the north range a service range over basements, with its own surprisingly grand doorway at basement level in the east gable end. Between the ranges was a small open yard; now reduced to what is known today as Bell Tower Yard.
