**BAT SURVEY AT -
73 RIVERSIDE
LOWMOOR
CLITHEROE**

**DATE AND TIME OF VISIT
30TH Sept 2016 5.30pm**

Two storey extension to the front elevation.

No 4 Terraced house in a row of 4 built in 1970's.

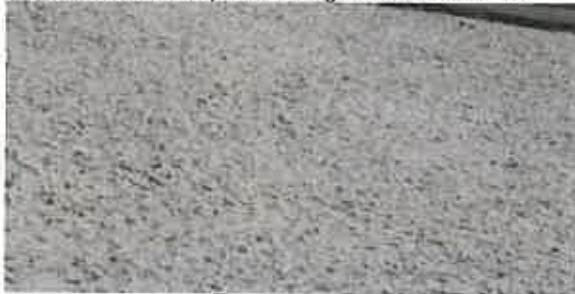
The walls are white painted rough cast render finish

No access points or cracks and crevices in the walls.

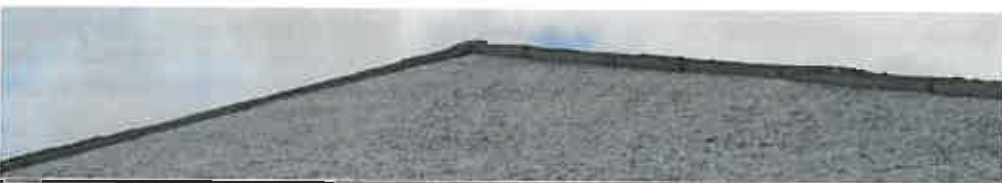
The slates are in reasonable condition and tight fitting with no slipped slates. There is a vent at the ridge but the opening has mesh to prevent any access. Bats cannot enter via the roof finish.

The gable verge has no cracks or crevices, there are no access points for bats

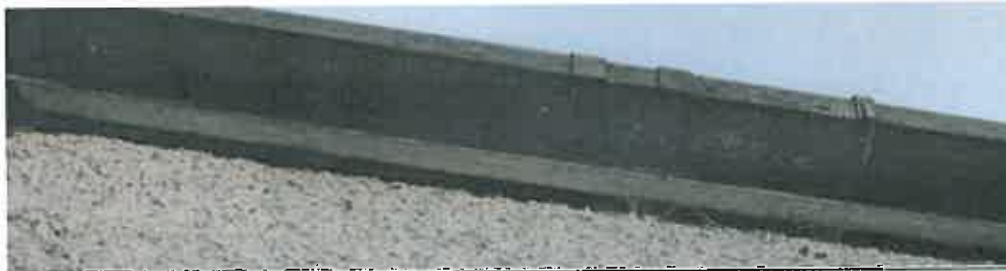
The timber fascia is fixed flush against the wall however on the rear (west) elevation the board between the windows has slightly warped forming a gap which could potentially provide a suitable crevice for bats. However close inspection revealed cob webbing and no evidence of any staining or grease marks adjacent. The nature of the render finish being so rough with sharp edges is not ideal for bat usage.

The fascia to the front (east) elevation being affected by the extension is in reasonable condition and the small gap between wall and fascia is heavily cob webbed.

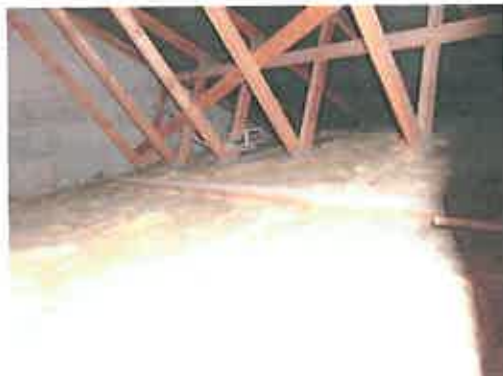
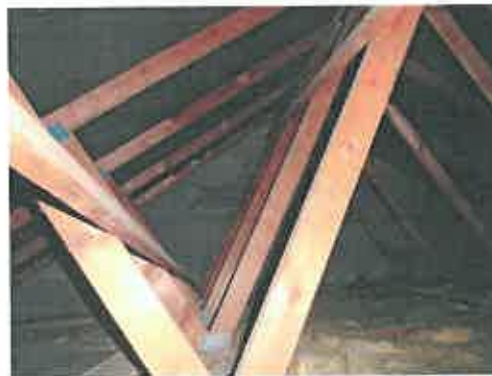
The trusses and felt are in good condition with no cracks or crevices suitable for bats. The detector result was negative . The quilt is clean with no evidence of dust, insect remains or droppings.
