**BAT SURVEY AT -
TROUT BECK
EAVES HALL LANE
WEST BRADFORD**

**DATE AND TIME OF VISIT
3rd Oct 2016 12.30 pm**

REFERENCE NO. 5205

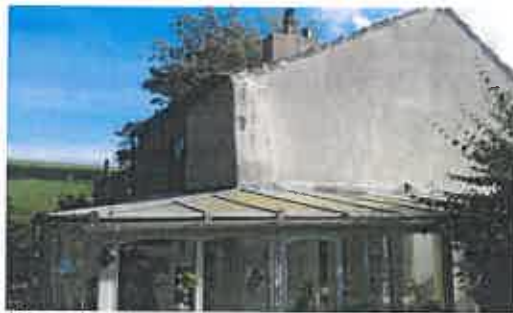
West elevation

The building is a detached period dwelling which appears to have been constructed originally as a row of cottages, the buttress walls on the west elevation indicate that part of the original building may have been removed. There is a single storey wrap around conservatory to the west and north elevation.

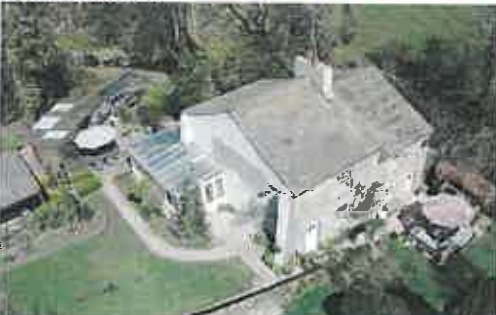
Wrap around conservatory to west and north elevation

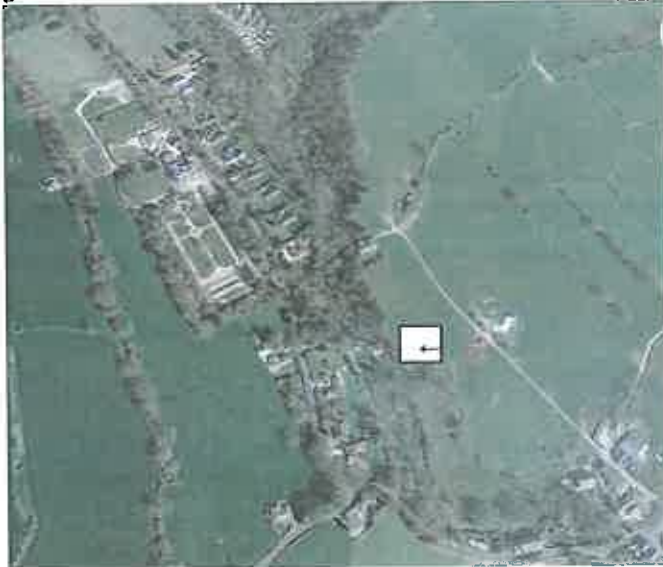
LOCATION SD: 741 447 90m elevation

The property is located to the east of Eaves Hail Lane separated from the road by a 1960's /70's property and its garden. The house is in a semi rural position approx 300m from the main settlement area of West Bradford.

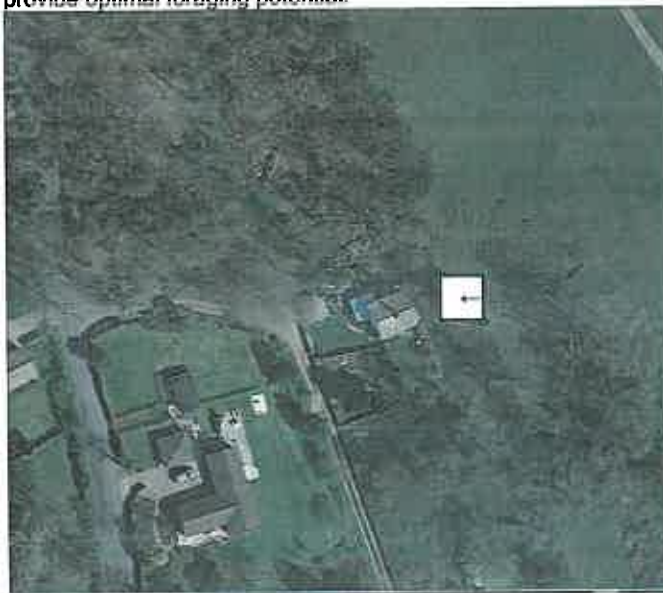
The house is located in a garden which extends to the front (south) Side (west) and to a lesser extent to the rear(north). Immediately adjacent to the east of the house is West Bradford Brook with large acreage pastureland on the east bank.

Mature trees and hedge row line the lane and the house is immediately adjacent to significant wooded areas to the north, lining the banks of the brook and which continues in a northerly direction. The location is considered to provide optimal foraging potential.

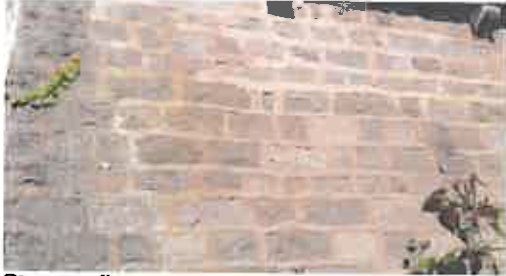
The front and rear walls are coursed natural solid stone with strap pointing. The west elevation and buttress walls are white painted render.

Stone walls

The render is in good condition with no access points or cracks and crevices. The stone and pointing is in perfect condition. There are no access points for bats in the walls.

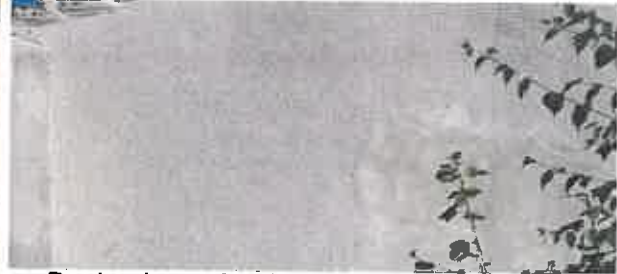
Rendered west elevation

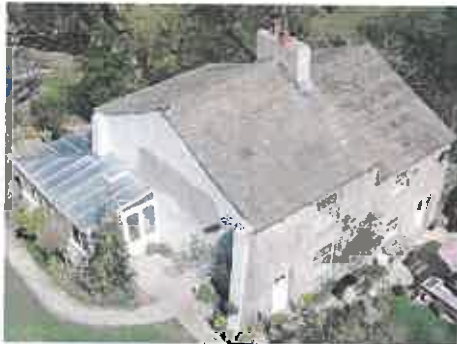
The roof consists of two separate structures due to the property probably being separate dwellings when originally constructed. The roofs are pitched with the lower section abutting the wall of the higher section, the roof covering is grey slate. The wrap around conservatory has a clear polycarbonate lean to roof which does not provide any roost potential for bats. The survey concentrated on the section of the roof being affected by the extension.

House and conservatory

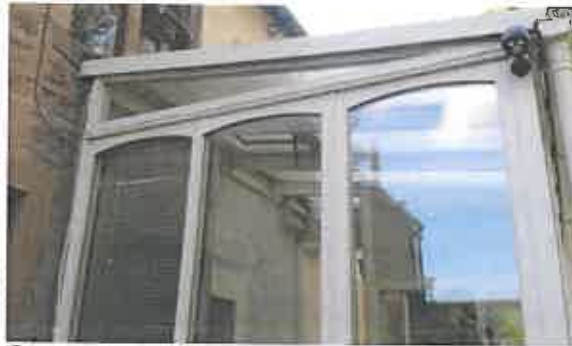
Conservatory roof

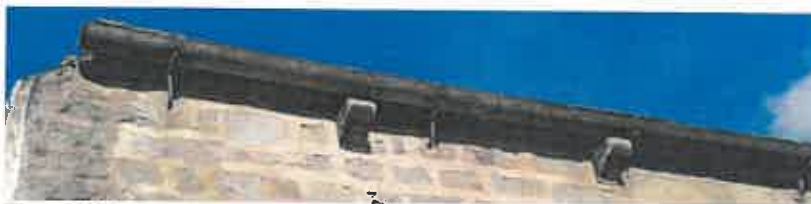
The gutters are mounted on brackets.

As far as it was possible to examine the roof slates externally they appeared to be in reasonable condition with no significant gaps or slipped slates. The eaves were clearly visible behind the gutter, the pointing at the abutment with the slates did not appear to have any gaps or crevices, no access points were visible.

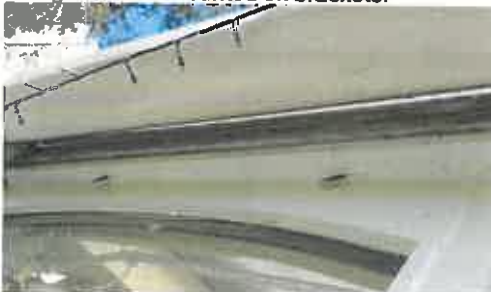
The conservatory eaves, no potential access for bats.

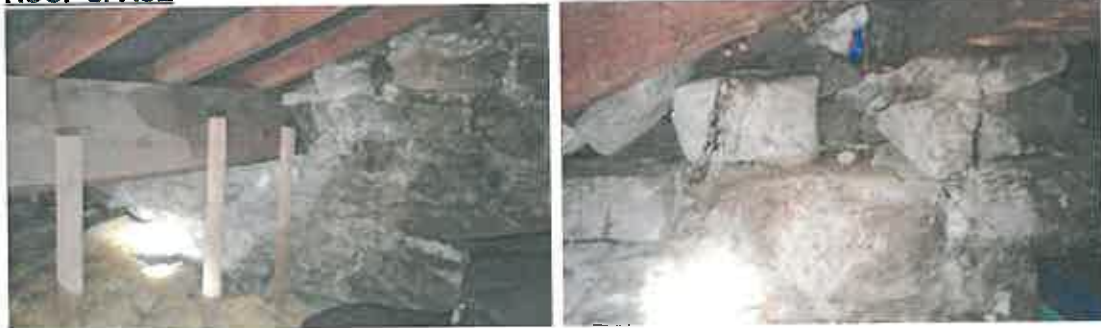
ROOF SPACE

The roof space of the section being adjoined by the extension was accessed via a loft ladder the space has been boarded for use as storage. The boards and insulation quilt had no signs of bat droppings or insect remains. All crevices in the gable wall (which will be affected by the construction of the extension) were carefully examined for any evidence. No signs of current or past bat use were found. The roof void of the lower section of the cottage was not accessed.

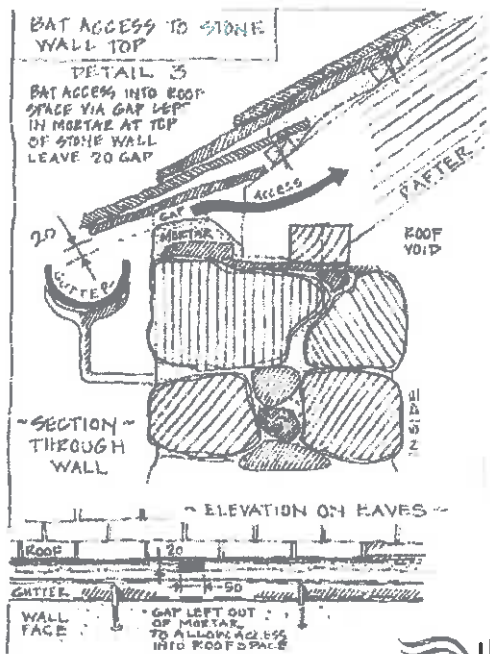
Eaves access

or the bottom cavity of roof space members, we will need to be cut!

However as the house is located in an optimal foraging habitat and it is recommended that roost potential be incorporated in the new structure. See over leaf.

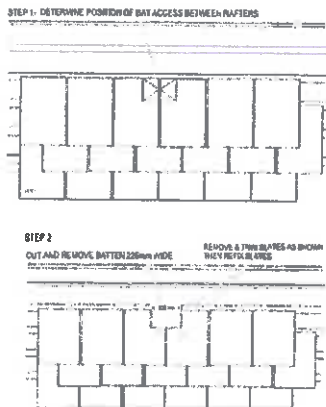
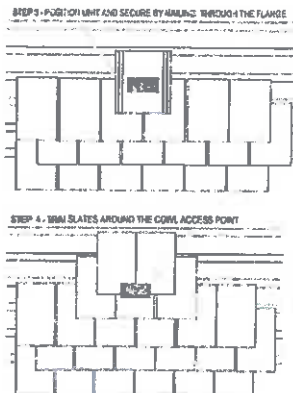
Bat slates
