spa
SUNDERLAND PEACOCK ARCHITECTS

**BAT SURVEY AT -
17 ESHTON TERRACE
CLITHEROE**

**DATE AND TIME OF VISIT
19th Sept 2016 1.30 pm**

REFERENCE NO. 5227

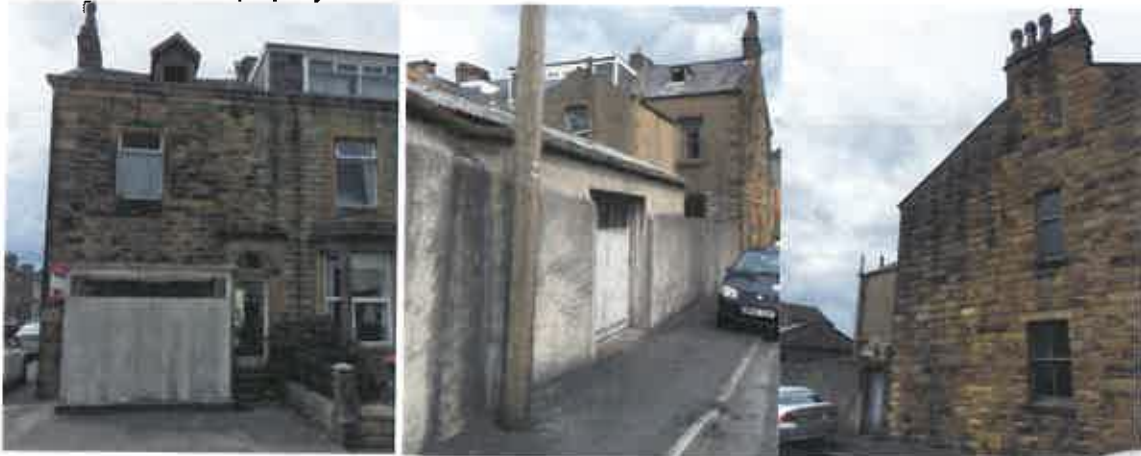
End terrace property originally built as a dwelling but later converted to shop with associated living accommodation. The property was built in 1877

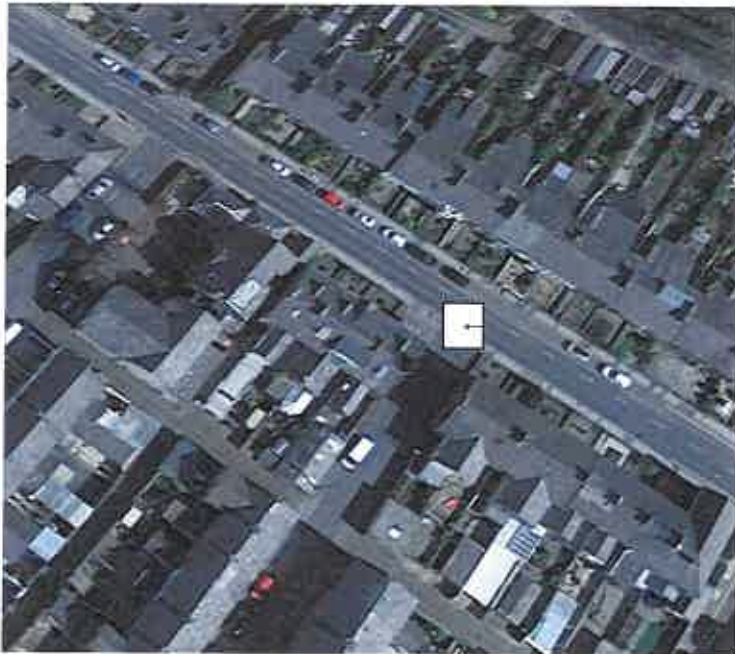
The nearest trees are located min 75m from the property on the edge of the Castle grounds, and the other small group of mature trees lines the weir of Mearly brook at 138 m to the south east. The building has sub optimal foraging potential.

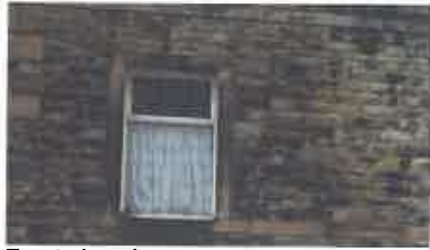
Front elevation

The front and side elevation is coursed stone, the rear elevation and outrigger is random stone with a render finish at first floor level. The garage walls are brick and random stone with a render finish externally.

The pointing and stone work is in excellent condition with no access points for bats nor are there any cracks or crevices in the render.

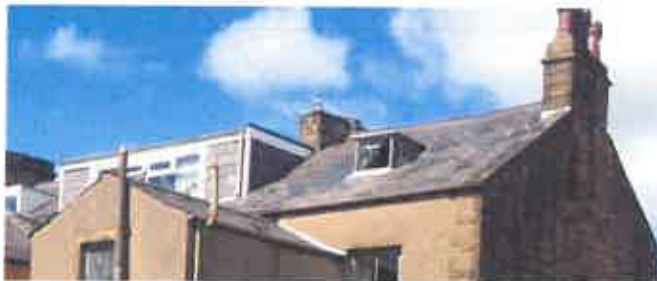
The main roof and outrigger are pitched with a

slate finish and small dormer in the front and rear pitch.

sheet finish with some clear plastic sheets.

The garage pitched has a corrugated fibre cement

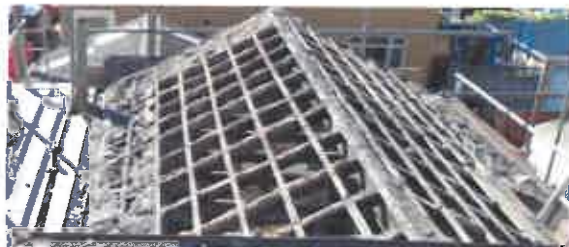
Outrigger roof

The refurbishment has commenced and the roof covering has been removed from the house. No bats were found during the work.

The sheets on the garage roof were tight fitting however access would be possible at eaves level.

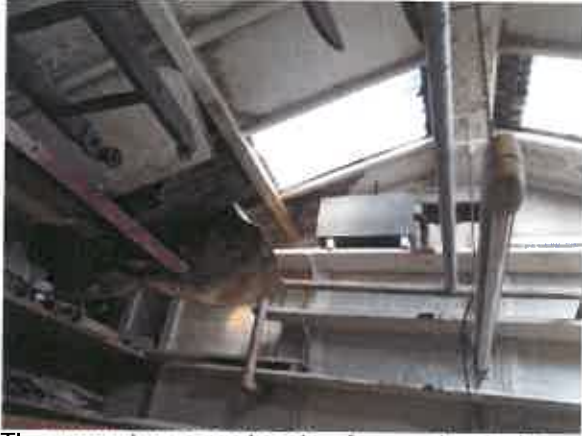
The garage has no enclosed roof space the steel truss and timber purlins are visible. The corrugated sheet has been lined internally with insulation and board. Water ingress has damaged the boards which are in a poor condition. The timbers appear in reasonable condition.

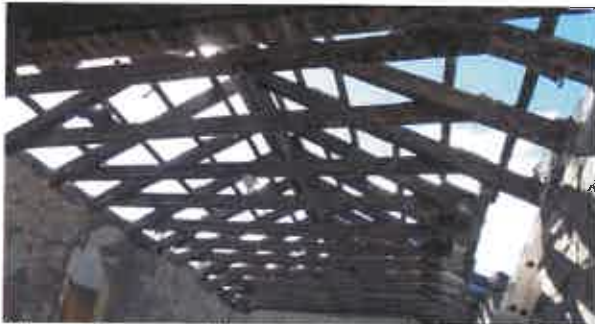
The out rigger would have had an enclosed roof void but the timbers and ties have been exposed.

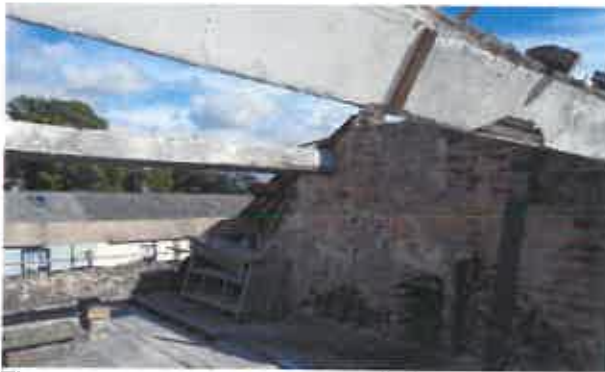
The main roof had an attic space which was accessible via a stair. The rafters, slates etc have been removed. The remaining purlins are in reasonable condition.
