Buildings at Causeway Farm  
Longsight Road, Balderstone, Lancashire:  
Historic Buildings Record

September 2016

# Buildings at Causeway Farm Longsight Road, Balderstone, Lancashire: Historic Buildings Record

### **HISTORIC BUILDINGS RECORD**

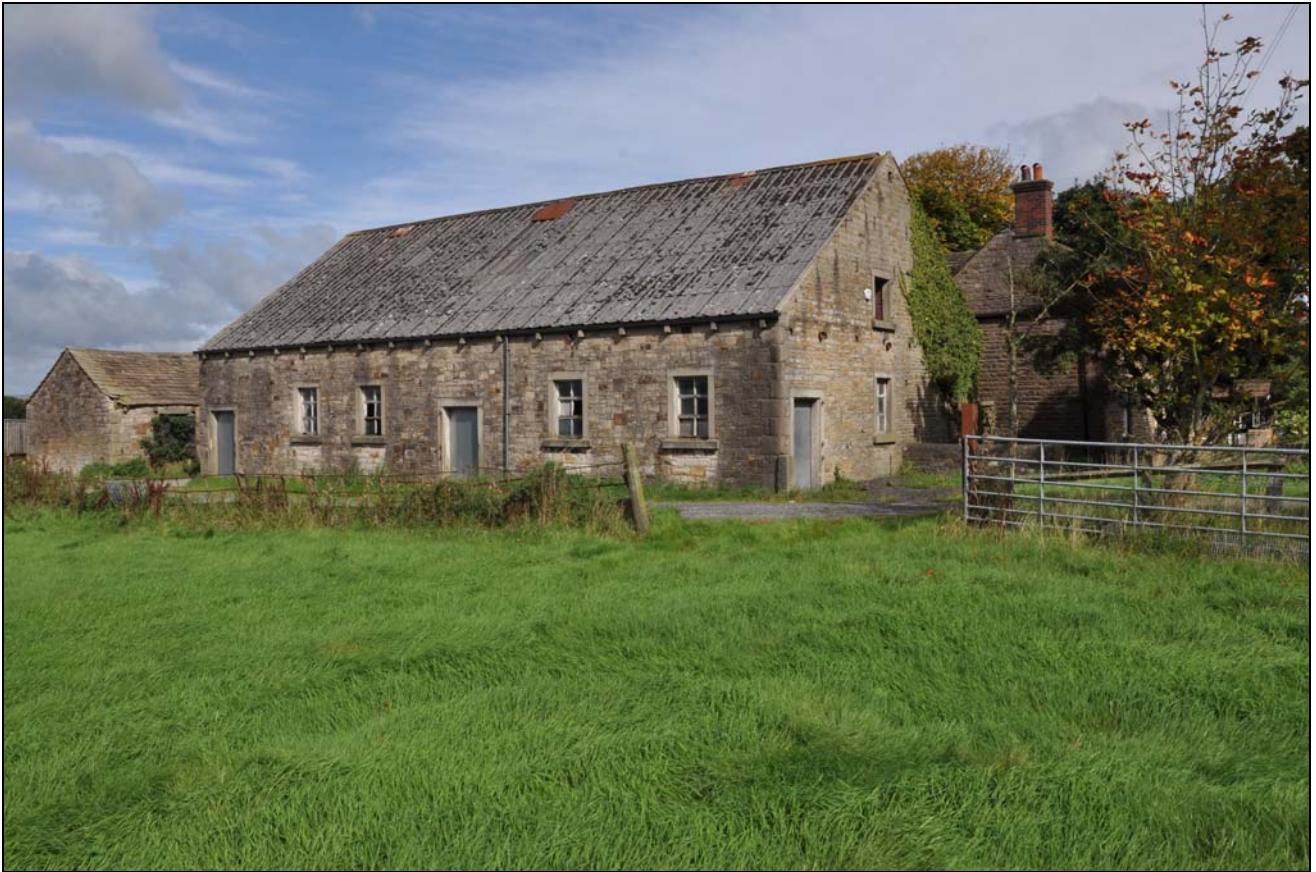
- 7.1 From the approach to the farm from the south-east (**1**), the barn appears to be of relatively modern date with its squared stonework and regular pattern of large doorways and windows, but the south-east gable contains some older fabric of coursed sandstone with vertical breathers, more typical of the eighteenth or early nineteenth century, and this is also true of the adjacent part of the north-east elevation, which faces onto the yard at the back of the farmhouse (**2,3**). In this long elevation, the earlier stonework (also with vertical breathers) is present only to the left of the main entrance, formed by the wide, tall cart doorway with massive, single stone lintel and projecting drip band or tabling (**4**); to the right of the doorway the wall has been rebuilt in different stone, squared but not consistently coursed, and incorporating "jumpers" (**5,6**).

Photo 1: General view of the buildings, from the south-west

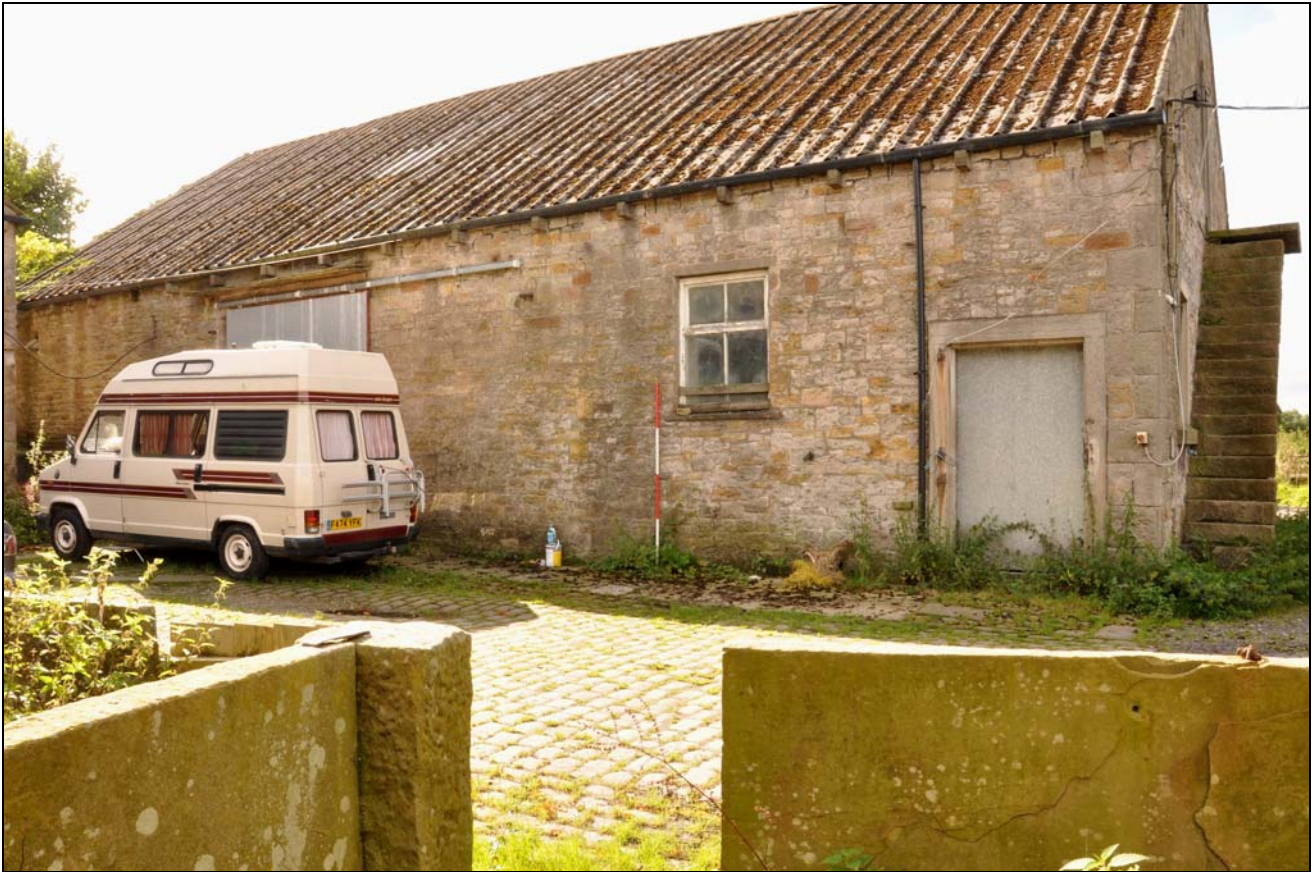
Photo 5: North-east side of barn

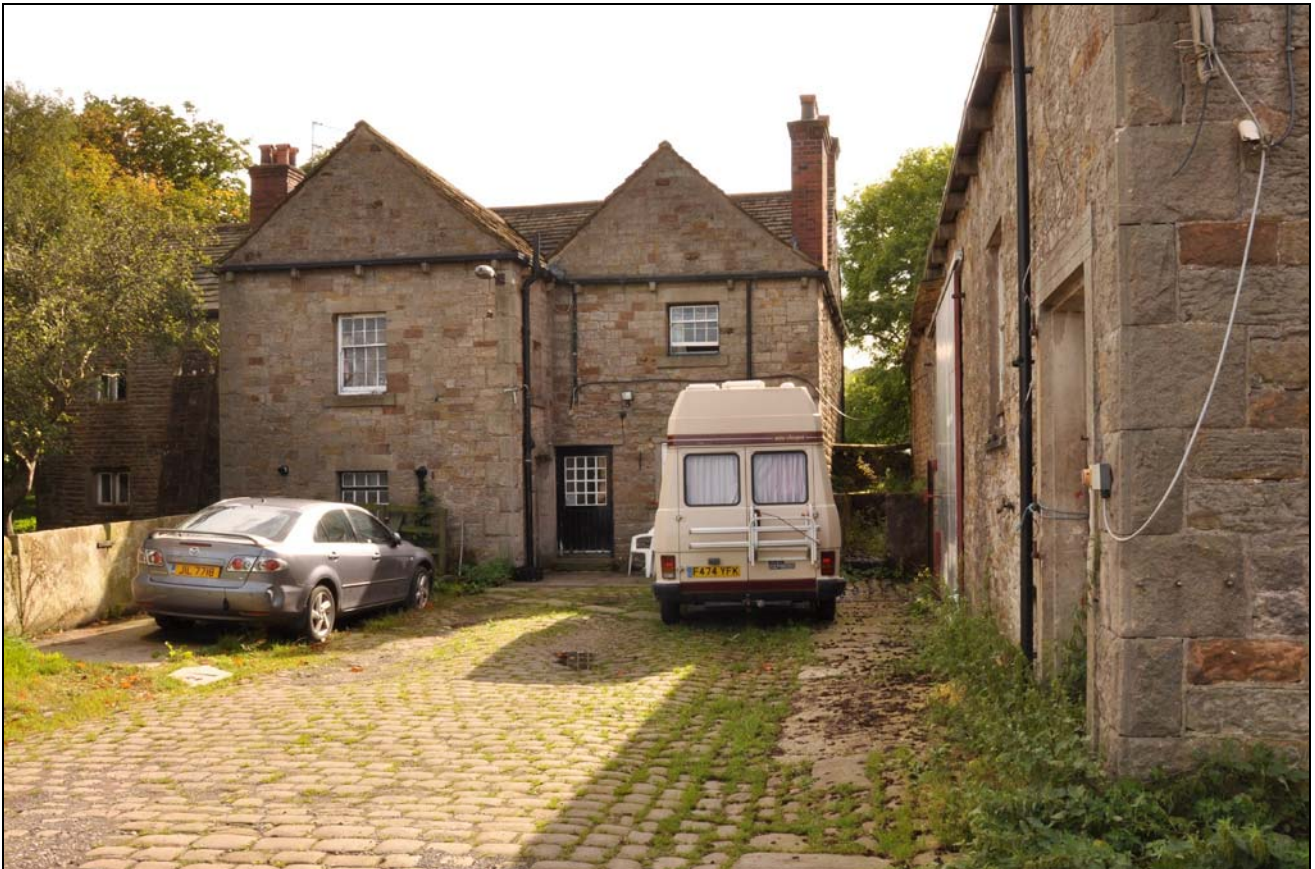
Photo 6: Rear of farmhouse and north-east side of barn

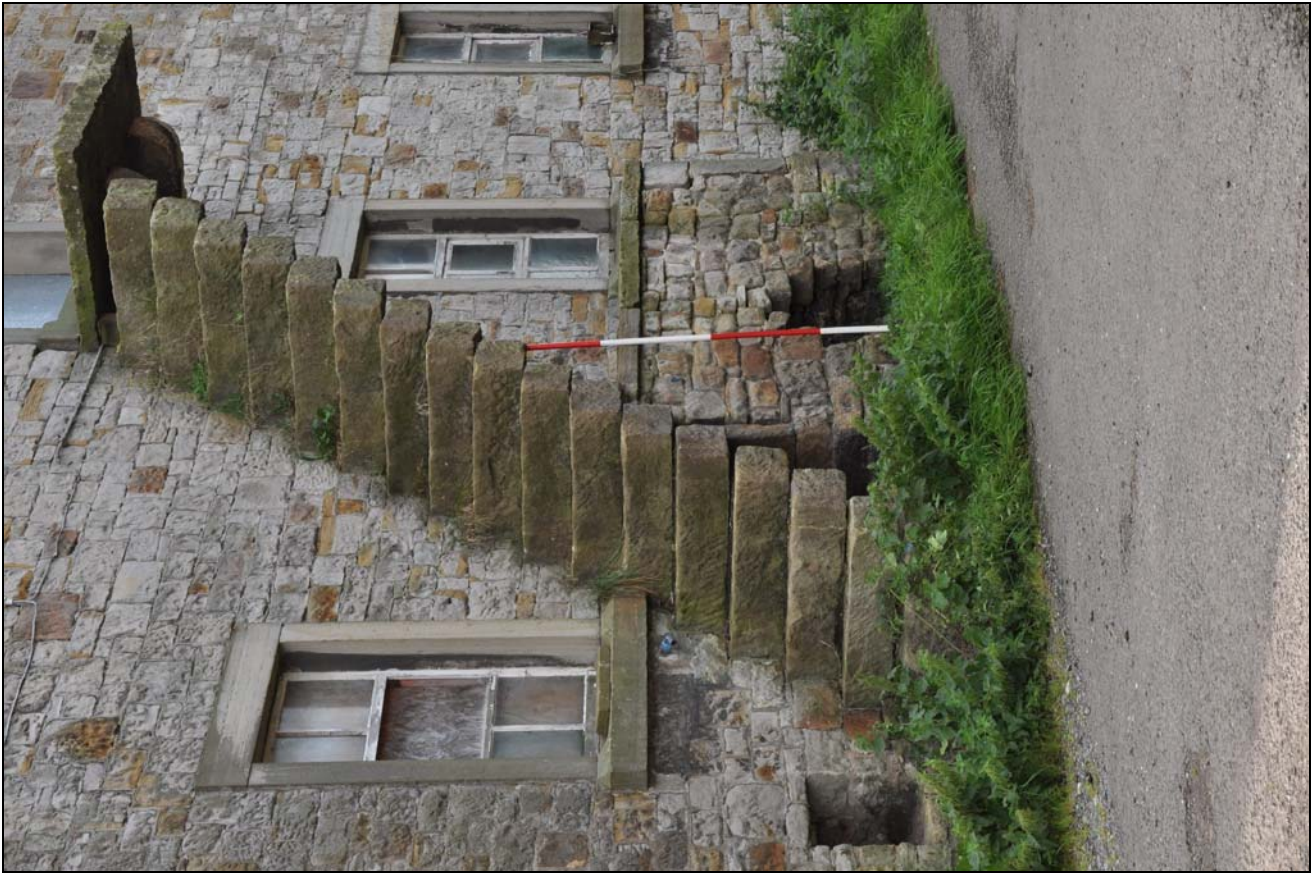
- 7.4 The addition of 1892-1910 was built in squared but not coursed sandstone, with sawn stone brackets for guttering at the eaves, and similar sawn dressings of finely grained sandstone to the large windows and doorways, which are arranged in a regular pattern, in contrast to the more traditional manner in which less generous openings are commonly found in older farm buildings (12-15). The ground floor doorways are provided with narrow rebates for externally hung, two-part doors, though none of these doors survive (16), but the window frames themselves may well be original, and are of six lights, the top two being hopper-opening (17). A steep external flight of cantilevered stone steps is provided in the north-west gable to give access to the high level hay loft, the landing outside the doorway illustrating the quality of building and ready availability of suitable flagstones (18,19).

Photo 18: External stone stairs, north-west gable of barn

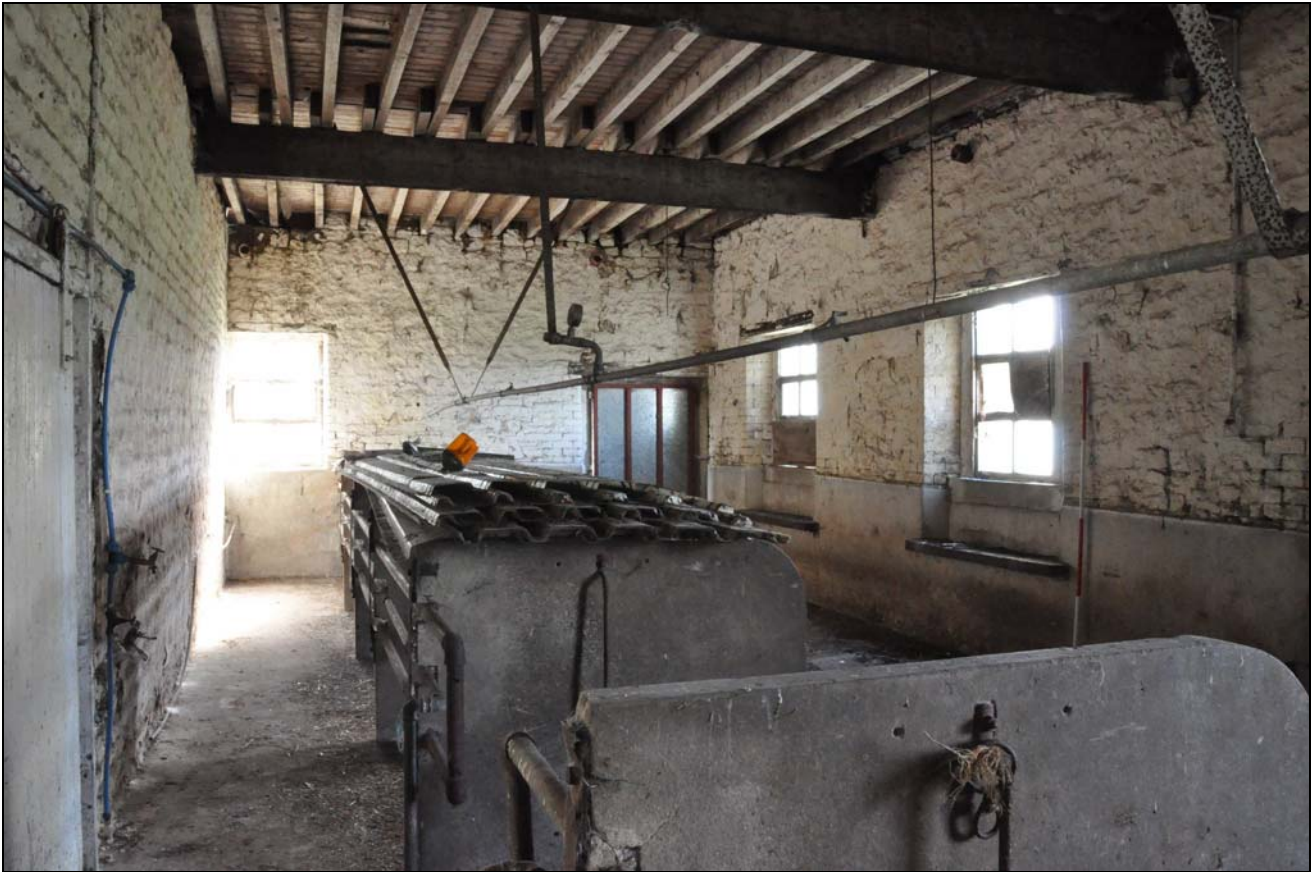
- 7.5 The L-shaped addition to the early barn was built to provide cow housing in two shippens, the larger one with standings for fourteen cows along the south-west side (20-22), and the shorter one arranged perpendicularly at the north-west end of the building with standings for eight (23,24). There was also a separate room at the north corner, probably used as a dairy, but more recently divided into two rooms. The spaces are notable for their light, airy qualities, with many of the windows having wide splays to provide as much daylight as possible (25), and in this respect, the shippens must have been built in keeping with the latest ideas regarding animal husbandry and hygiene. However, both were evidently re-fitted in the mid twentieth century with the present concrete boskins and vacuum milking system, and it is likely that originally they were served by timber boskins of more traditional style.

Photo 20: Large shippon in south-west side of barn, from the north-west

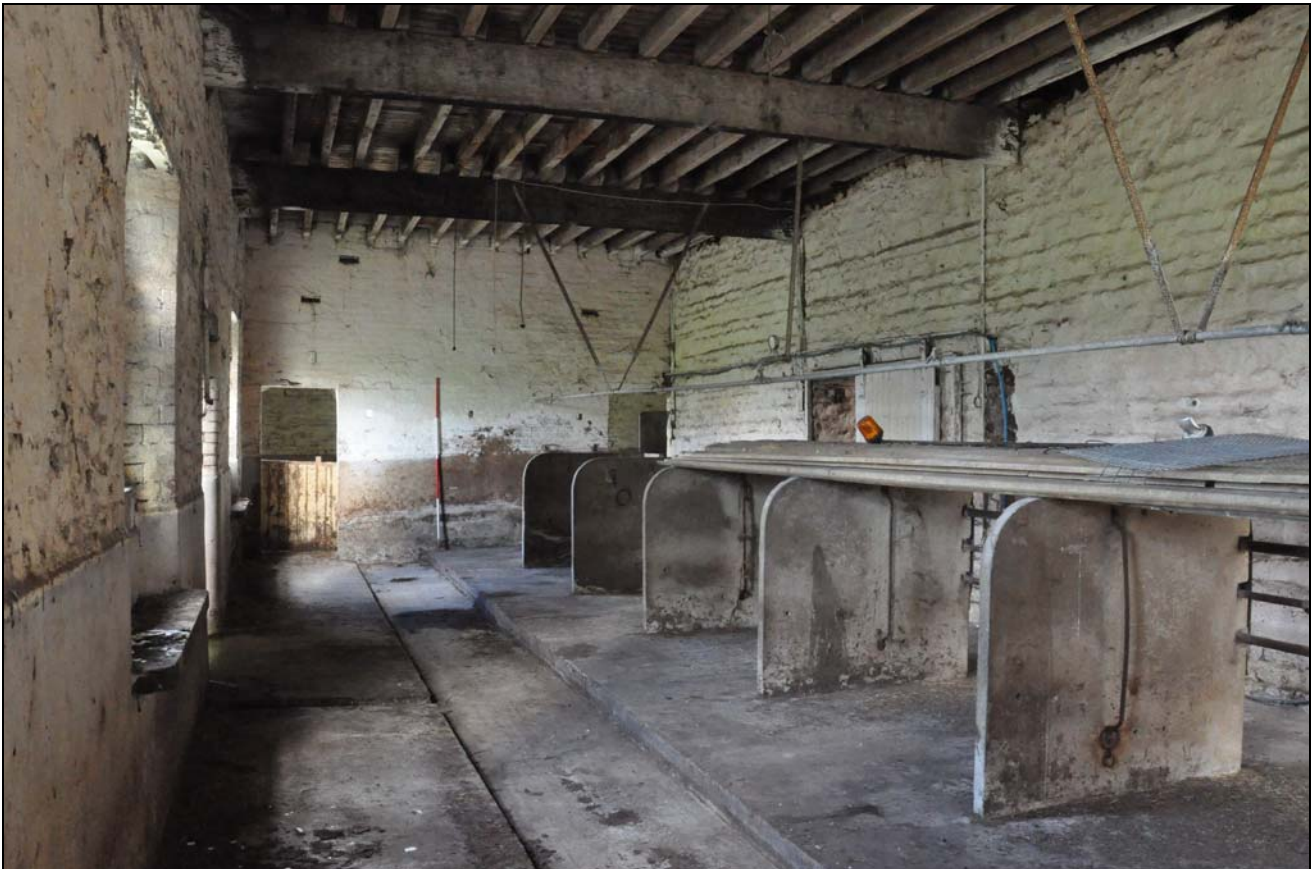
Photo 21: Large shippon in south-west side of barn, from the south-west

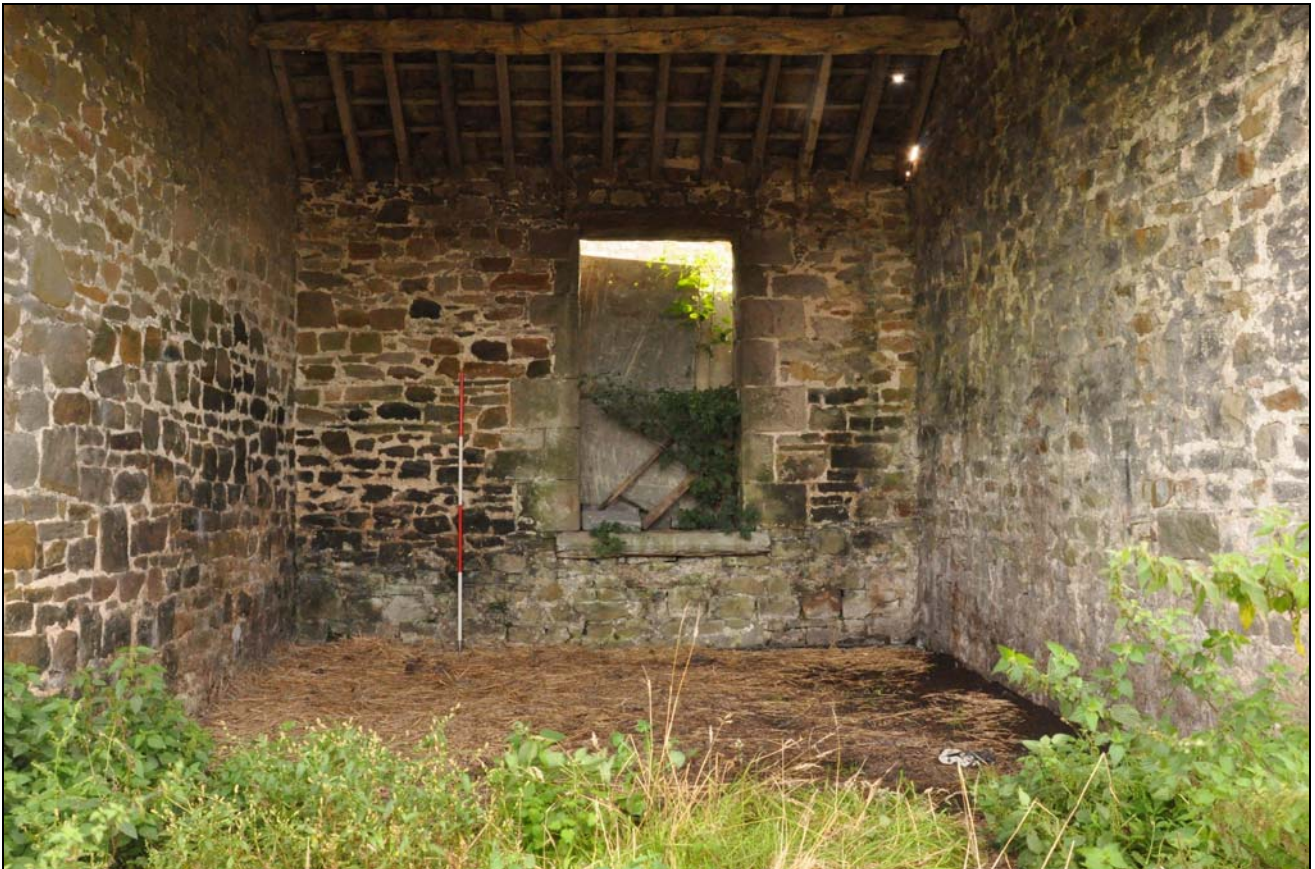
- 8.2 The purpose of the outbuilding is unclear, but the south-west bay is distinguished by its plain doorway, which formerly opened onto a large flagstone set horizontally above the floor level (29,30)<sup>9</sup>. This arrangement suggests it was intended for tipping a laden barrow into the bay, and the space may therefore have served as a covered middenstead. The other two bays have brick walls across them which separate front from back, perhaps for use as stores or loose boxes, leaving areas of shelter to the rear.

Photo 29: South-west bay in outbuilding, from the north-west
