soiltechnics
environmental and geotechnical consultants

The site is centred on national grid reference 360130, 438020 with an area of 7.22ha. A location plan can be found in Appendix A1.

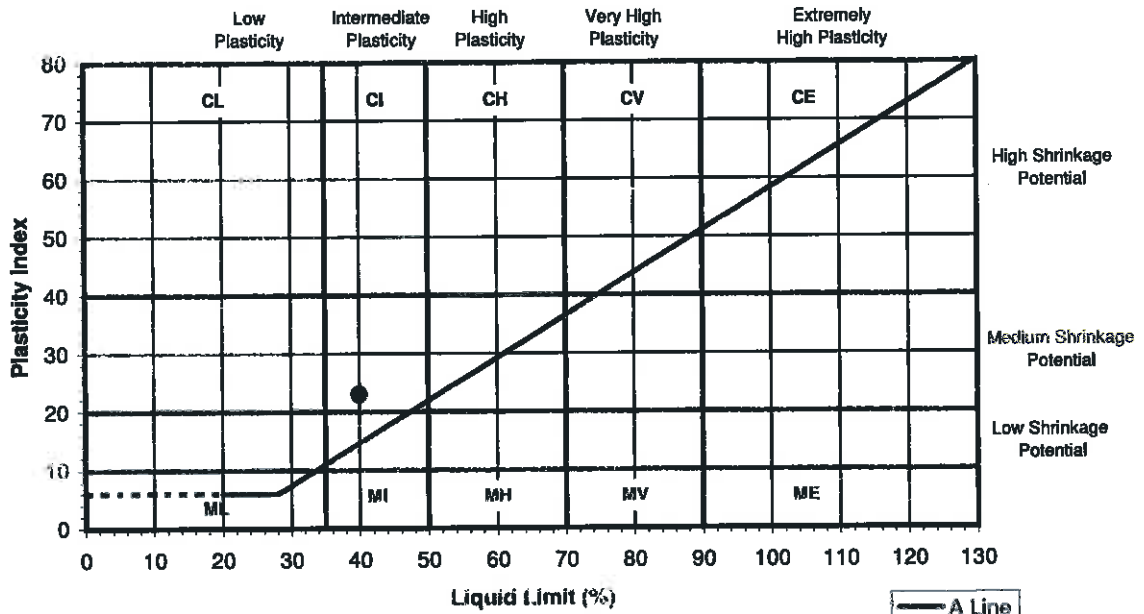
Determination of Moisture Content and Atterberg Limits

Description: Brown CLAY with occasional Gravel

Laboratory Reference	Location	Depth (m)	As Received Moisture Content (%)	Liquid Limit	Plastic Limit	Plasticity Index	% Passing 425µm
45274330	TP124	1.90	N/A	40	17	23	95
