## **Bat Roost Assessment Report Wardsley Farmhouse**

Bowland Ecology Ltd was commissioned by Savills to undertake a building assessment for bats of a site, Wardsley Farmhouse at Leagram near Chipping (NGR: SD 64561 43881).

The purpose of the survey and this report is to make an assessment of the value of the site for bats, and to identify any constraints and requirements in relation to the proposed re-roofing works. The locations of affected buildings are shown on the Bat Survey Plan (Appendix A).

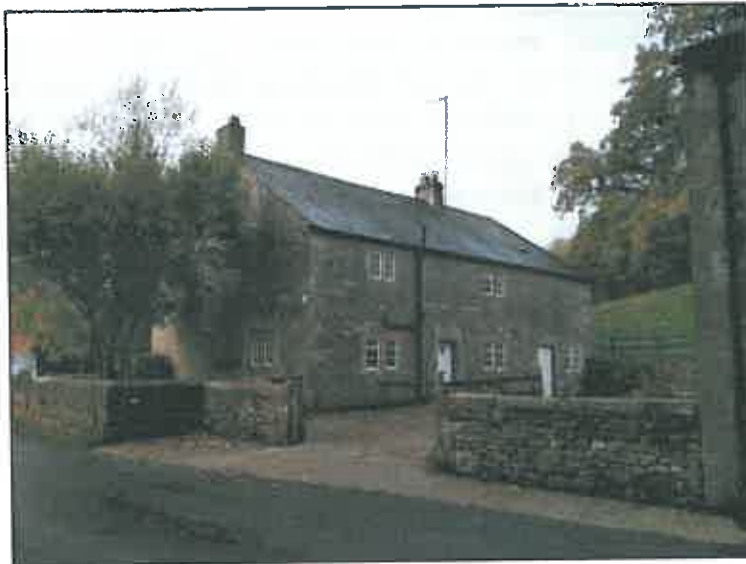
Photo 1: The building B1

**External** – The stonework of the building is in good condition and well-sealed. The roof is pitched and tiled and in fair condition. However there are a number of lifted tiles and gaps under ridge tiles. There are gaps between the top of the walls and the tiles at both of the gable ends. The building has two chimneys with lifted lead flashing around the bases. These features are potentially suitable for use by crevice dwelling bats.

The northern elevation has timber framed windows, plastic guttering and a wooden barge board with a small gap behind it. There may be an access route for bats into the building behind the barge board. There were some cobwebs but not an extensive amount. Bird droppings were recorded at two locations beneath the barge board, indicating that the space there is big enough for birds to roost/nest.

The southern elevation also has timber framed windows and plastic guttering but the barge board is missing. Roof felt can be seen hanging down over the top of the wall. This would indicate that access for bats into the building along this elevation is possible.

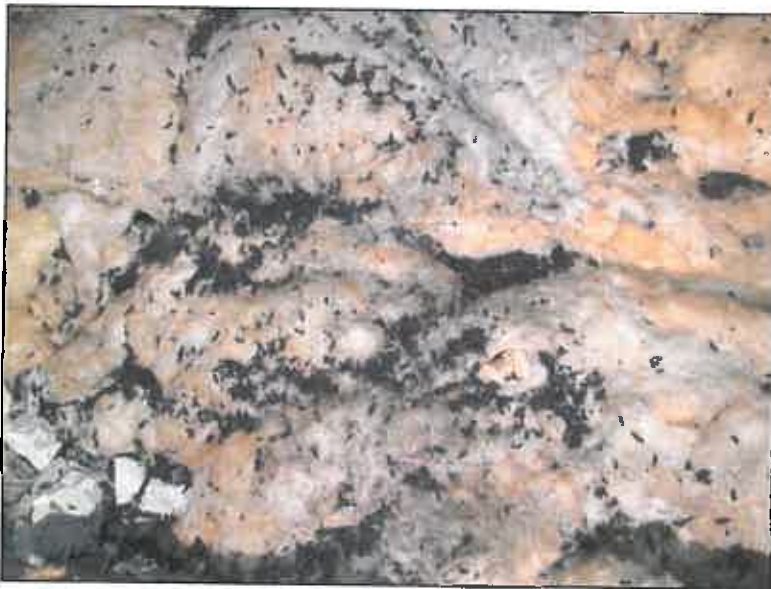
Bat droppings were recorded throughout the building with small quantities in the stairway window on the eastern elevation (D1), under the open loft hatch (D2) on the landing between Bedroom 3 and 4, in the vacant barn on the windowsill (D3), floor below timber beam (D4) and along the southern elevation (D5).

Large quantities of bat dropping were recorded throughout the entire loft space with dropping on apex and internal stone wall, piled up on timber cross beams and covering the floor insulation cover.

*Photo 2: Accumulation of bat droppings in the building loft*

- The roof membrane must be replaced with a **traditional roofing felt**, as it is known that bats become entangled in breathable roof membranes, resulting in the death and injury of bats – **CC**

- Barge boards through which bats access the roost must remain in place, with the hole unobstructed. – **CC**
- The tile above the roost entrance must be slightly raised to allow access by bats into the roost space - **CC**

- Four [Bat Access Tile Set](#) (figure 1; [www.nhbs.com](http://www.nhbs.com)) or Morris Bat Slates are to be fitted (two on each elevation; north and south) to the roof, to allow bats access between the roof tiles and felt liner – the locations to be agreed with the supervising ecologist – **CC**.
