**Little Dudlands Farm, Rimmington Lane,
Clitheroe, BB7 4EA**

Bats: Building Inspection and Night Time Surveys

Simply Ecology Limited

November 2016

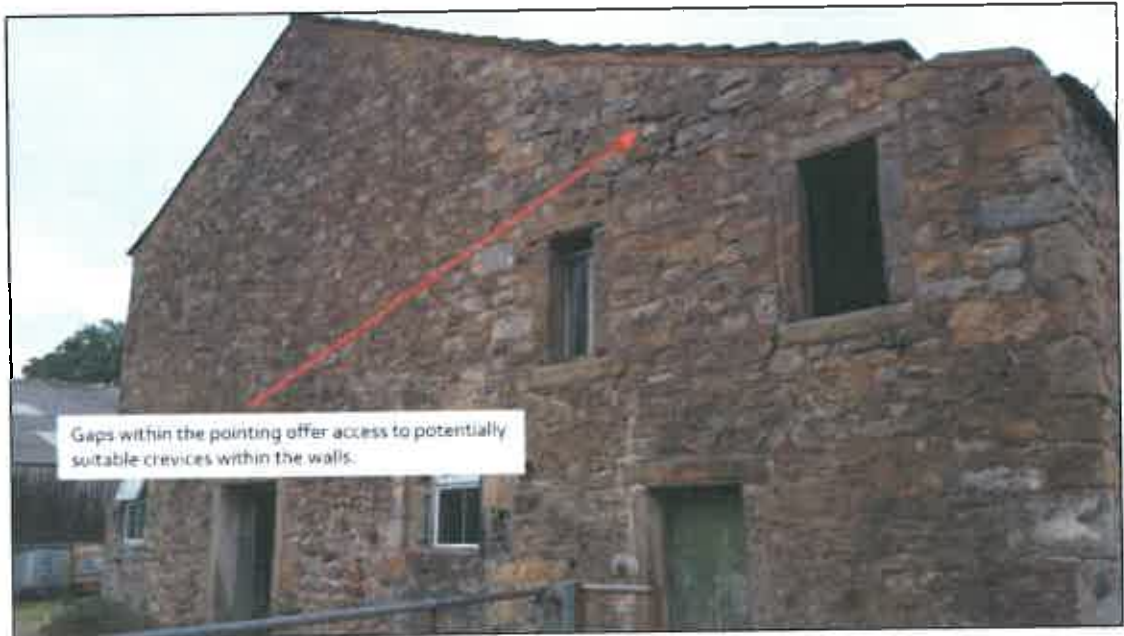
- 3.1.1 Typical of traditional stone/slate barns, the buildings on site had numerous access points that bats could potentially use to possible roosts within. The rooftops had lifted slates under which bats could gain access (see Plate 2). There were multiple cracks and gaps between stones within the walls (see Plate 3). Gaps were present underneath eaves/soffits (see Plate 2) as well as within the roof verges (see Plate 4). Perhaps the most striking was the large open doorways and windows that provided clear easy and permanent access for bats (see Plates 2, 3 and 5).

Plate 3: The southern aspect of the western barn. Abundant gaps in the walls could be found on this aspect and others. In addition, many of the entrance (i.e. windows and door) were completely open to the elements.

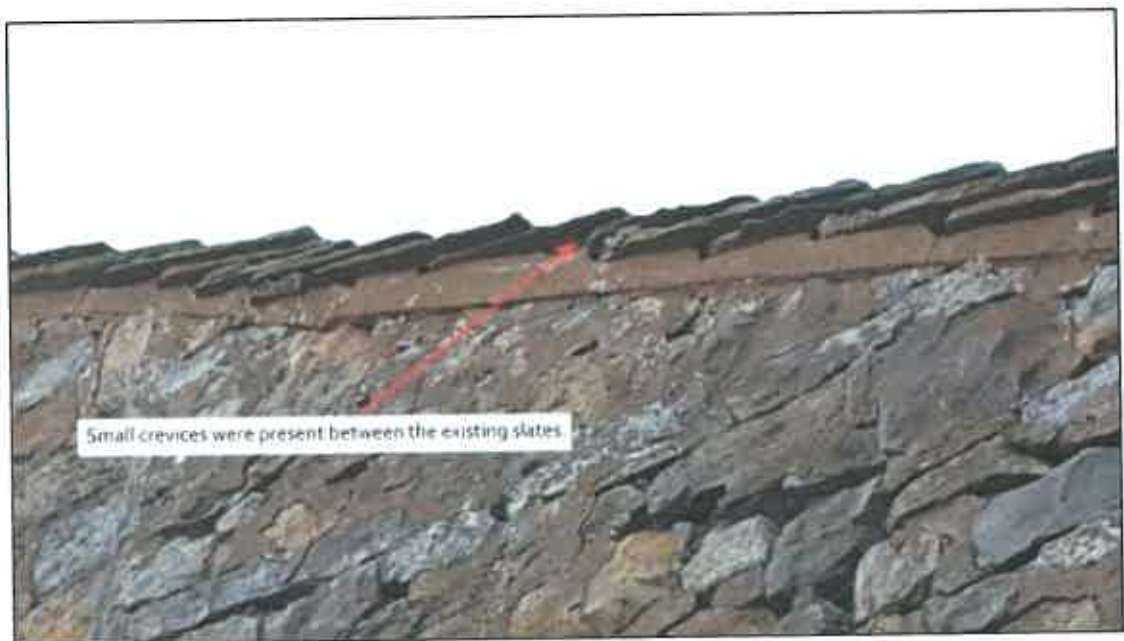
Plate 4: All along the roof verges there were numerous possibilities for bats to gain access to possible bat roosting locations.

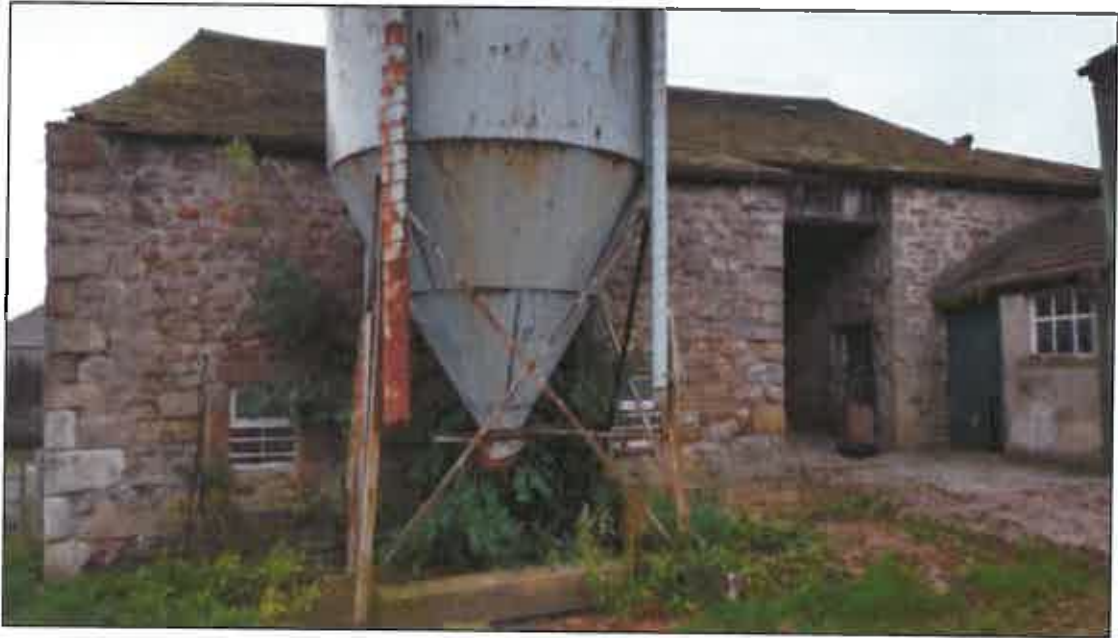
Plate 5: The western barn also had a large open doorway allowing free access to the internal spaces.

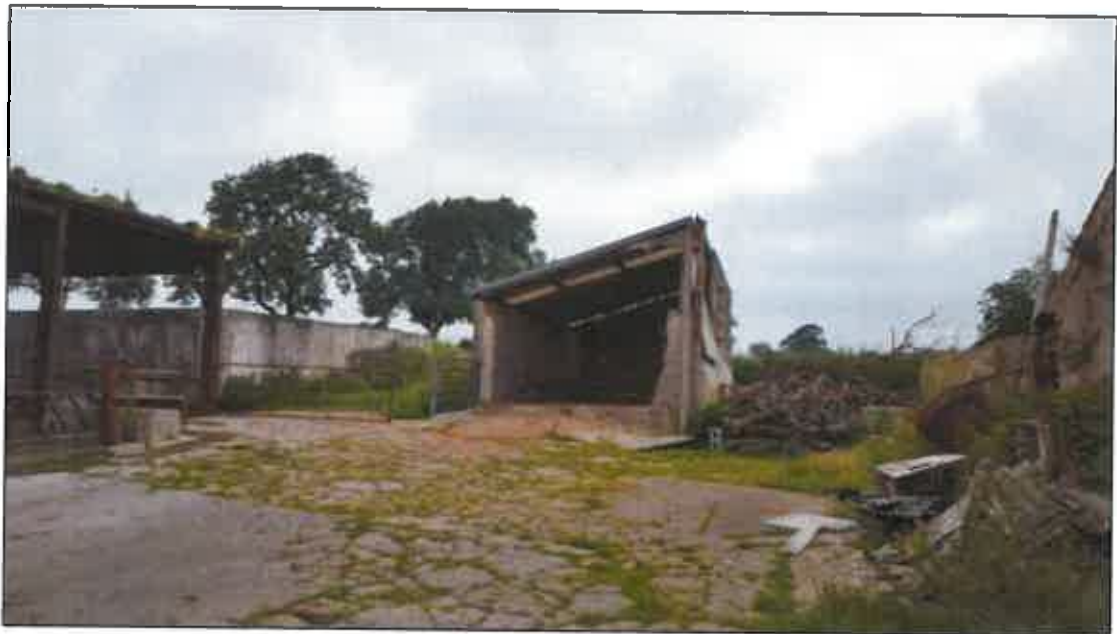
- 3.1.2 On either side (west and east) of the barns there were two outer sheds. Both of these are likely to be affected by the development proposals. The western building was built from breeze blocks and metal cladding with an asbestos roof (see Plate 6). The eastern building was wooden and metal clad with an asbestos roof (see Plate 7). Both buildings were found to be devoid of any external features suitable for bat roosting. However, they both had clear entrances for potential access to the inside.

Plate 6: The western shed had clear open access to the inside of the building.

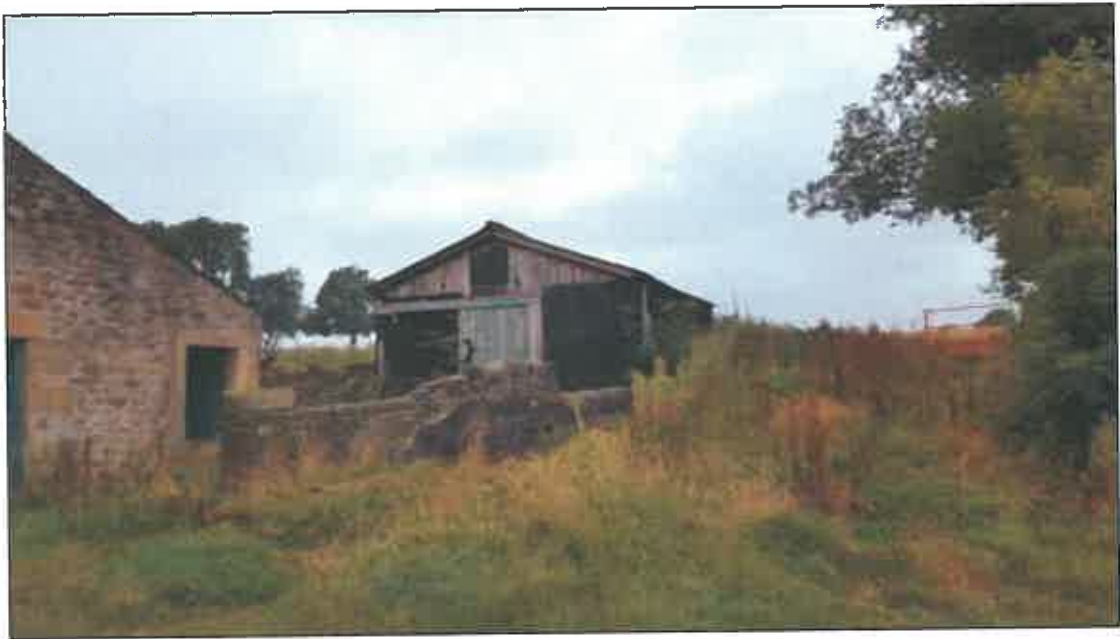
Plate 7: The eastern shed had no features around the outside that were suitable for roosting bats, though access was available for bats to gain access.

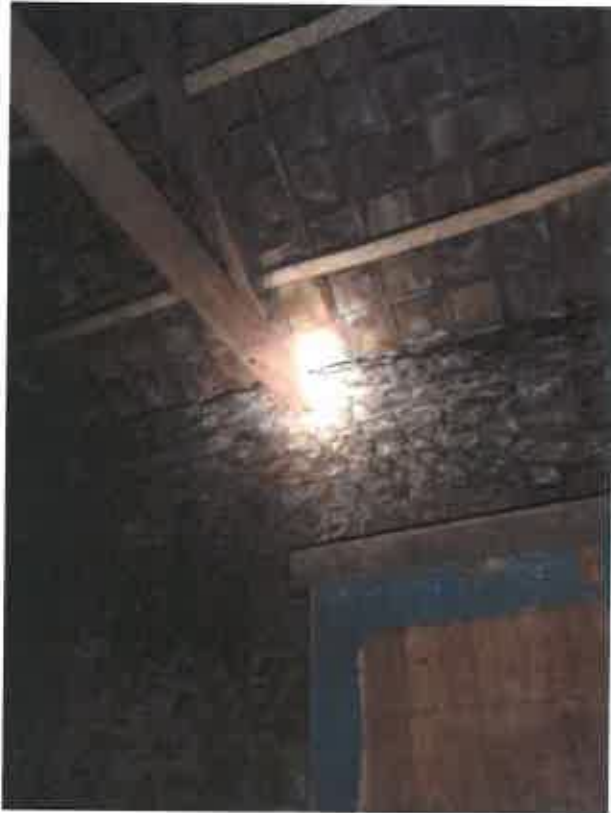
- 3.2.1 The internal inspection revealed similar findings to those during the outside inspection. The old barns had numerous potential bat roosting locations within. Based on previous experience in a multitude of similar structures, bats can be found roosting atop such old stone walls (see Plate 8), within gaps in the pointing (see Plate 9), between the wooden frameworks of the roof (see Plate 10) and where the tie beams and purlins meet the walls (see Plate 11).

Plate 8: Bats can often be found accessing roosts atop or within walls from above.

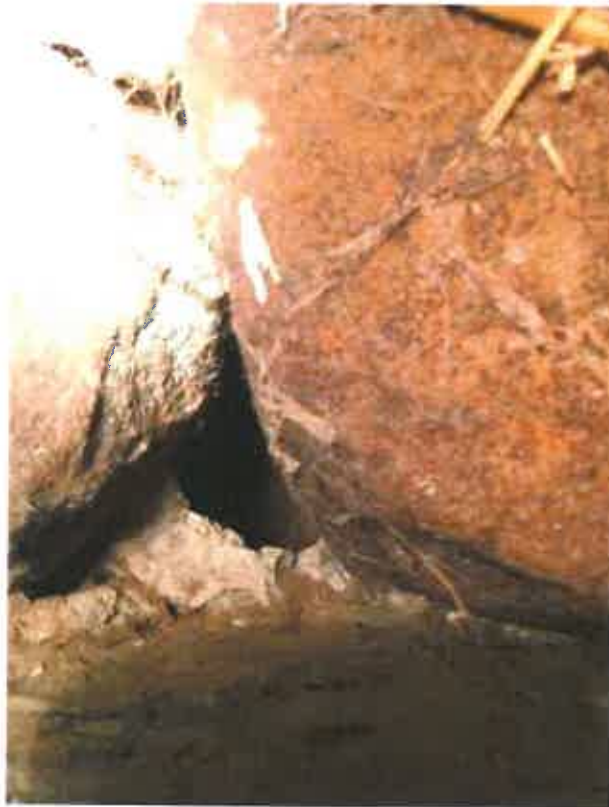
Plate 9: The stone walls had areas of missing pointing allowing access within.

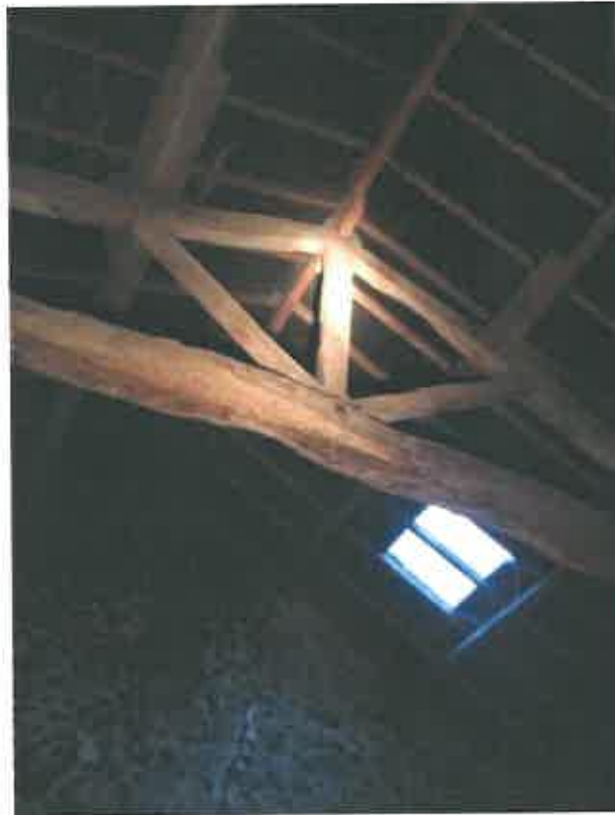
Plate 10: Small crevices between purlins/rafters can be ideal for roosting bats.

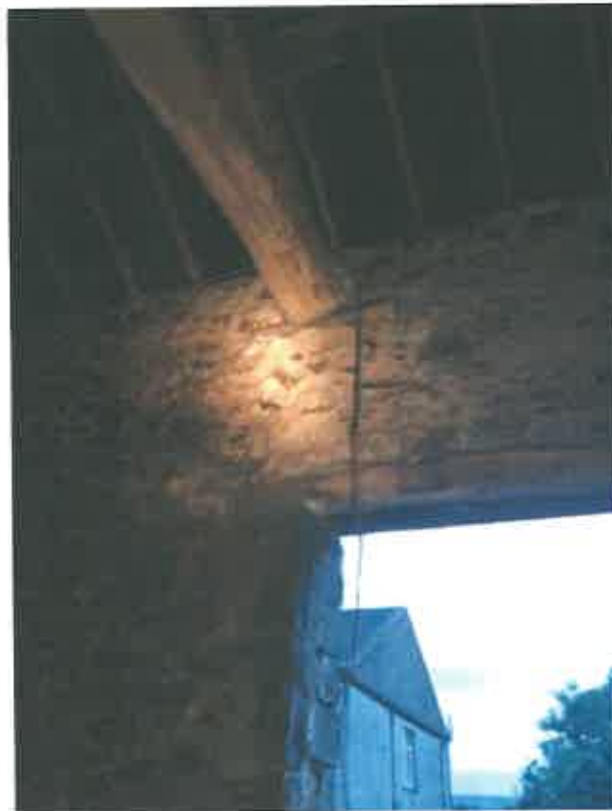
Plate 11: Numerous gaps were present in the walls around the wooden roof frameworks.

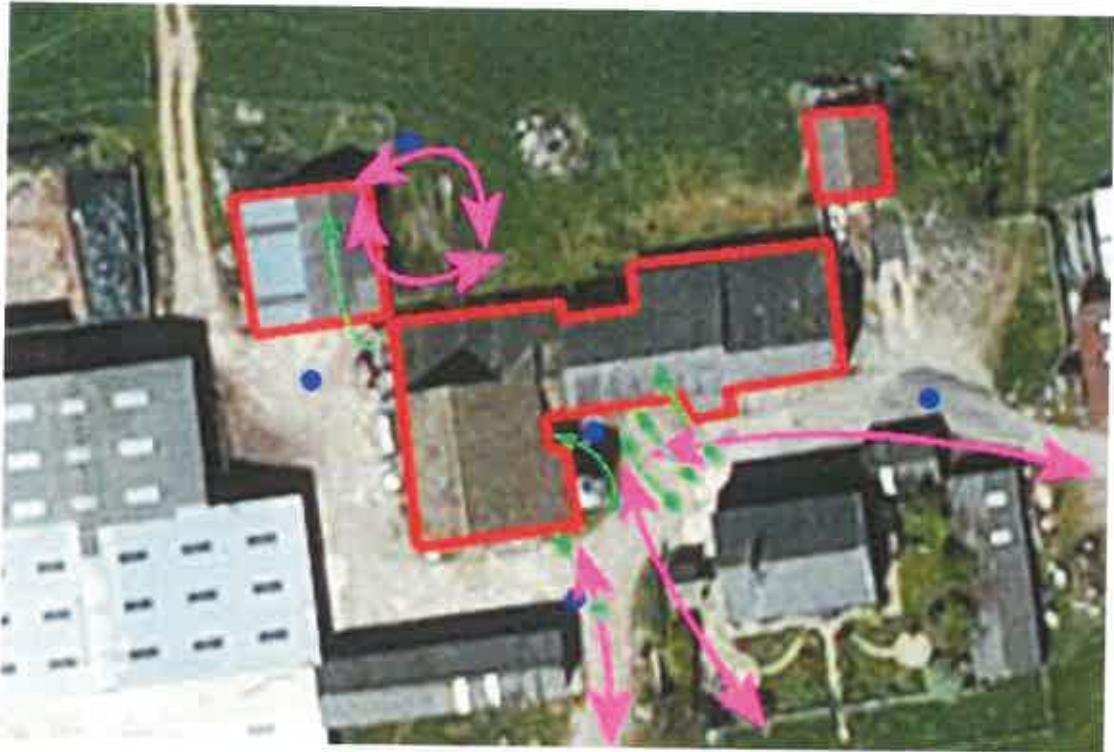
- 3.3.1 Throughout all surveys the surveyors were located around all aspects of the buildings and adjusted during the course of the surveys as required (see Plan 3), based on the movements of the bats. The first night time survey was a dusk survey carried out on the 8th August 2016. The first bat observed during this survey was a common pipistrelle that emerged from the main entrance of the western barn at 21:09. Following this a further 7 common pipistrelles and two soprano pipistrelles were observed collectively exiting the entrance of both the western and the eastern barns. The last of these emergences occurred at 21:30. Throughout this time bats were consistently flying in and around the doorways to the barn. After this period, no bats were seen exiting/entering/around the main doors of the barns. In addition to these emergences 2 common pipistrelle bats were seen emerging from the rear doorway of the western barn at 21:13 and 21:18. General activity patterns around the building other than the emergences comprised occasional common and soprano pipistrelle passes. No common activity trends were observed, other than brief commuting/foraging passes in various directions. The survey was terminated approximately 1 hour and 30 minutes after sunset.

Plan 3: Night time bat surveyor locations around the barns (blue); general flight lines (pink) and emergence/entry points (green).

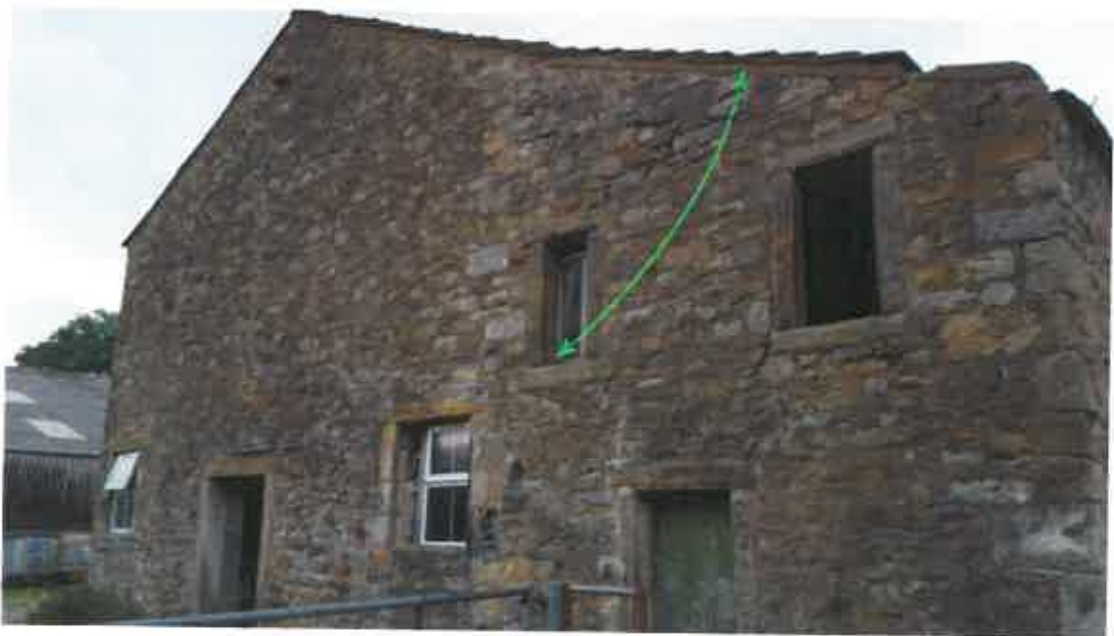
Plate 13: Roost entrance location on the western barn, southern gable end.

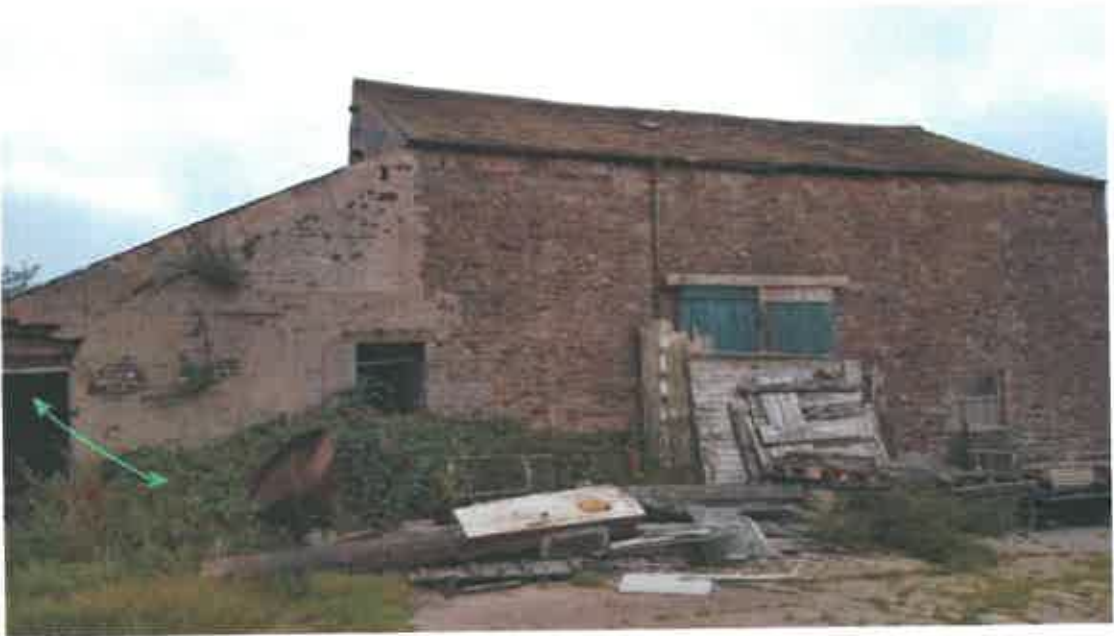
Plate 14: Roost entrance location on the western barn, western aspect.

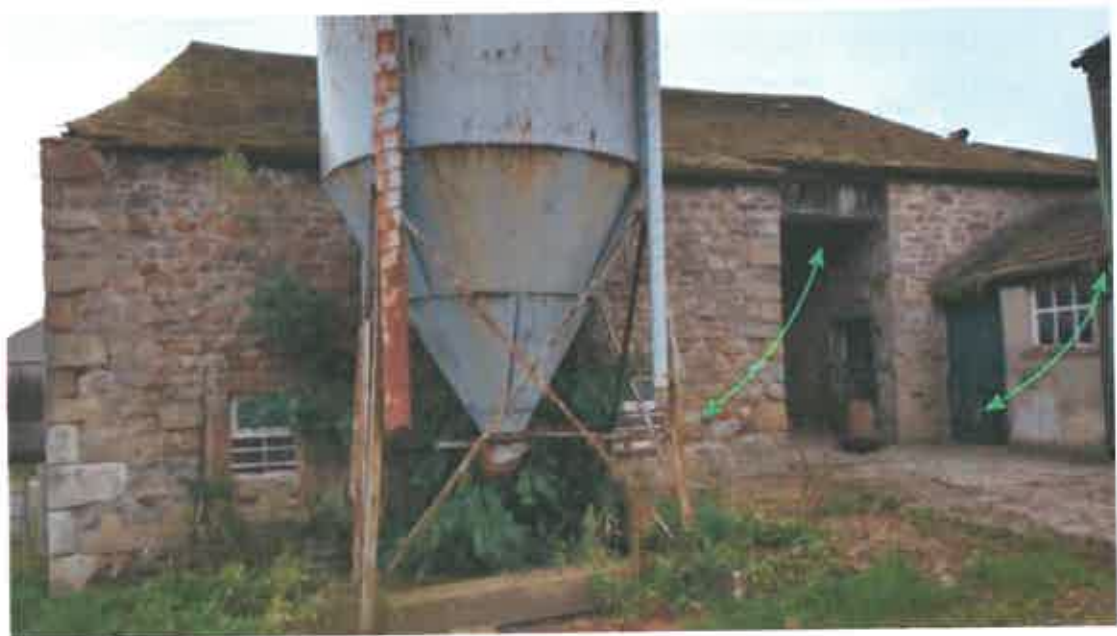
Plate 15: Roost entrance location on the western barn, eastern aspect. Also a single bat was seen entering/emerging from the eaves of the drainpipe on the eastern barn.

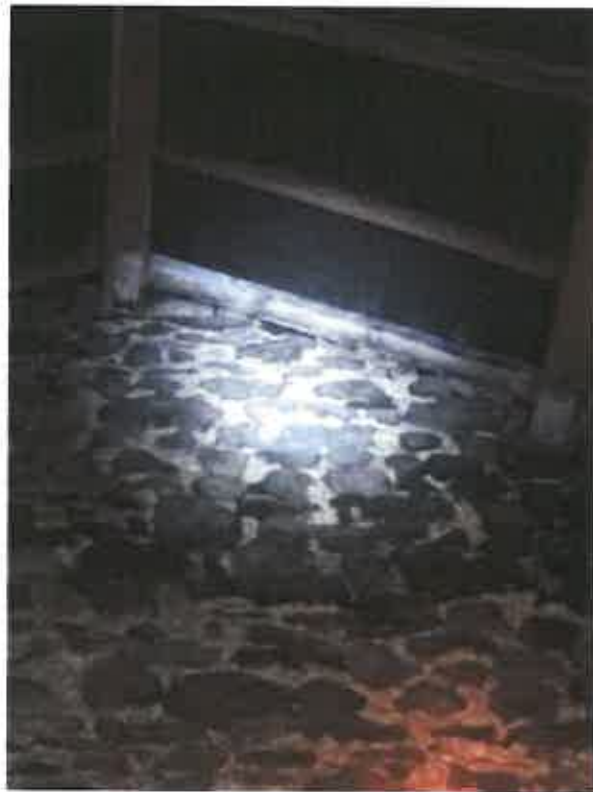
Plate 17: The western wall within the eastern section of the barn. Bats were seen using roosts atop the walls and around the purlins.

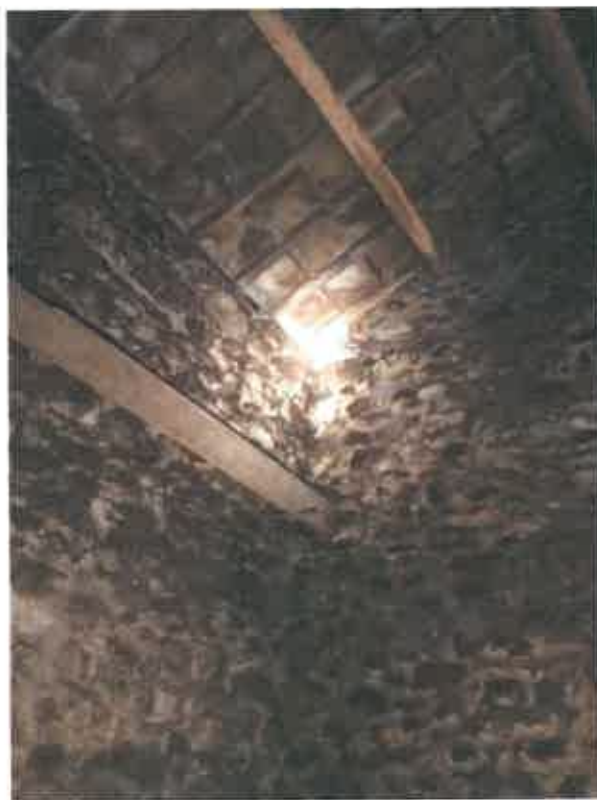
- 3.3.4 The specific roost locations within the barns were located with the aid of night vision cameras. Indeed, the night vision camera confirmed that the bats from within the eastern barn were exiting from the crevices depicted in Plate 17, above the collection of droppings found (see Plate 12). Roost locations within the western barn were also atop the walls, as shown in Plate 8 above and the below Plate 18.

Plate 18: Known roost locations within the western section of the barn.

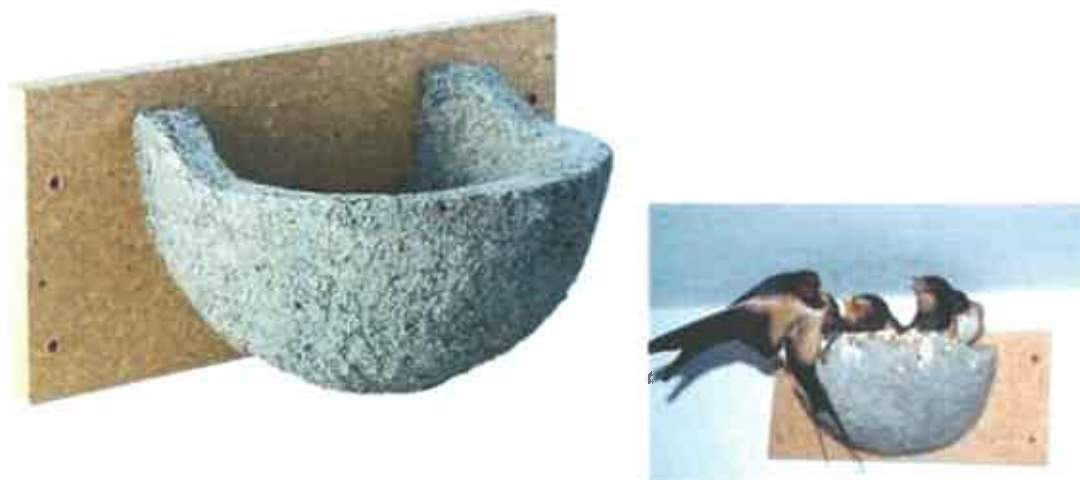
Plate 19: Illustrative examples of artificial swallow nesting boxes.

- To mitigate for loss of swallow nesting sites a key recommendation is that swallow nesting cups should be placed inside new or existing buildings on site. It is imperative that these are placed inside, or at the very least undercover in an area that is not exposed to the elements. These should be located at a height no less than 3m above the ground (see Plate 19). Swallow nests can be obtained from a number of sources including: http://www.gardengiftshop.co.uk/acatalog/Swallow-Nest-Box.html?utm_source=googlebase&utm_medium=feedmanager. Reason: This will ensure compliance with the Local Authority's duties under: Part 3 (40; 1) of The Natural Environment and Rural Communities Act 2006 and Section 11 (109 & 118) of the National Planning Policy Framework.

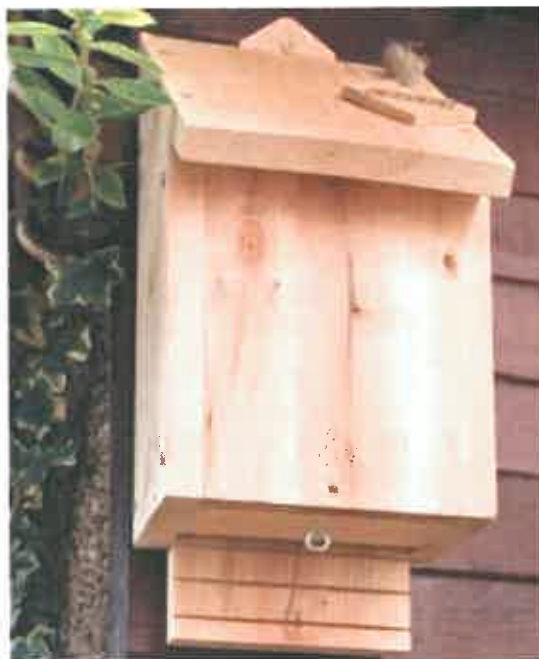
Plate 20: The tree mounted bat roost to be installed prior to any redevelopment works.

- **Prior to any works commencing on site, the new semi-permanent roosts should be introduced on site.** This will ensure that alternative roosting is available at the site prior to roost disturbance and reduce any low impacts during the period of time that the works are taking place. This should be in the form of at least 6 bat boxes (e.g. see Plate 20) to be placed near to the building. The location of these can be anywhere on site provided they are fixed to permanent structures. They should be placed high (ideally 4m above ground if possible) and facing a variety of aspects. South and south west are ideal for summer roosting bats, though one or two should be placed facing north in order to offer roosting potential for male/hibernating bats.

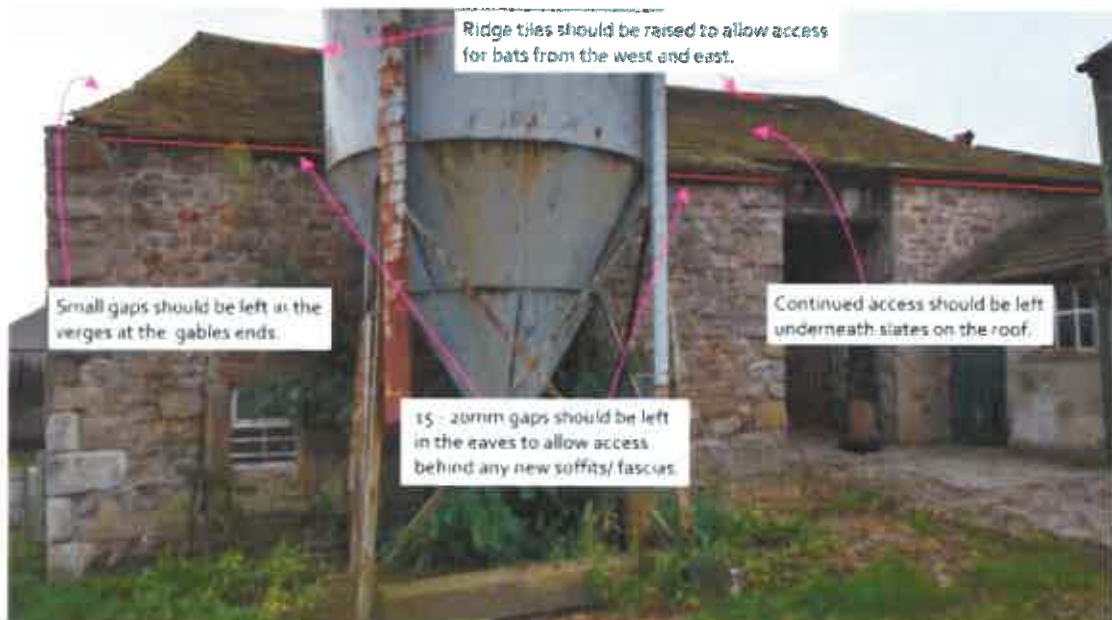
Plate 22: Compensation measures required for the western barn.

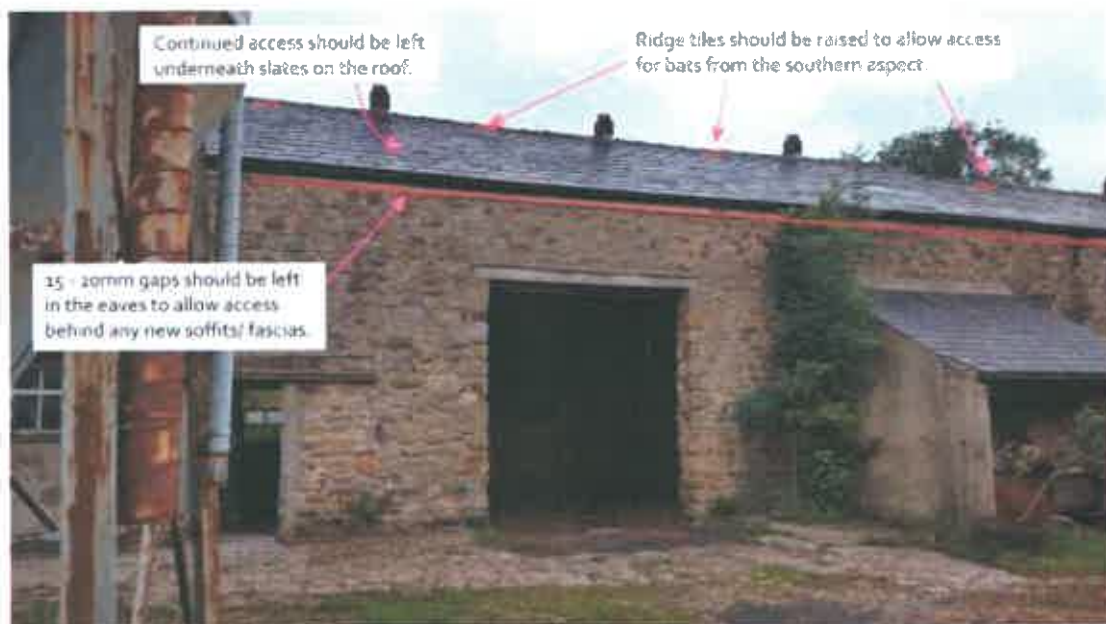
Plan 23: Compensation measure for the eastern barn.
