**BAT SURVEY AT - 22 KING STREET
WHALLEY**

DATE AND TIME OF VISIT
20th July 2016 3.30pm

Re roof a listed building. Remove the concrete tile, repair the structure and replace with slate.

The property is a terraced cottage dating from 1600's, it is currently uninhabited due to flood damage.

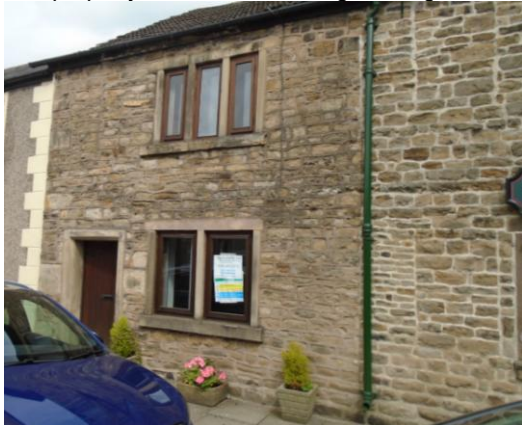
Front elevation to King street.

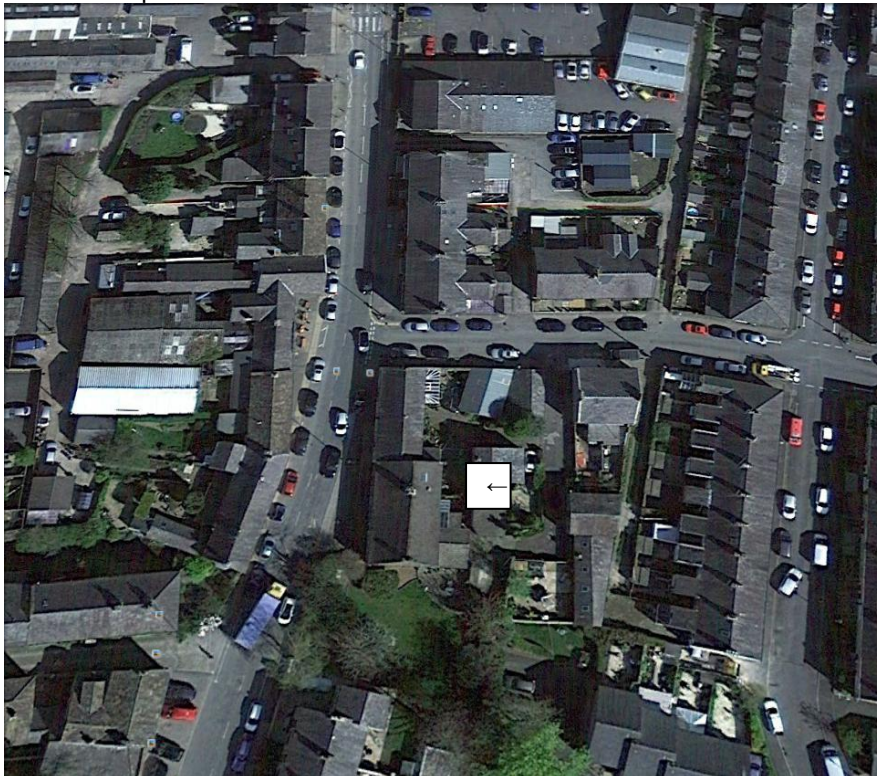
The front elevation of the house is located directly on King Street at the rear of the property there is a yard area and other properties of a similar type. There are no significant trees in the immediate locality however a small garden to the south has a few mature trees. Approx 80 m to the south there are wooded areas on the banks of the river Ribble, the river is located 130m to the south. The immediate locality of the house is considered to have sub optimal foraging or potential roost habitat, however the area approx 80m to the south would be considered optimal.

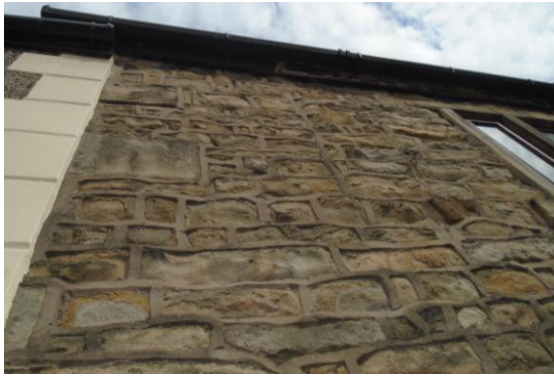
Front wall

The walls are solid stone. The front elevation has strap pointing. The rear and part gable has a partial render finish and the exposed stone is flush pointed.

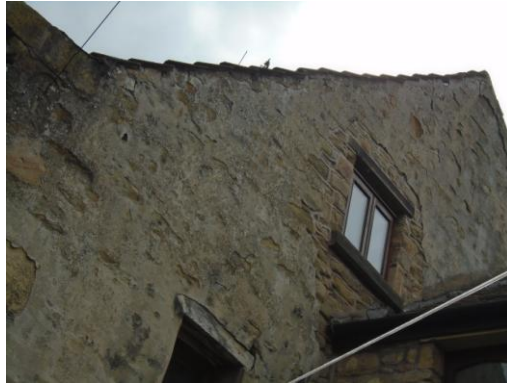
Gable adjacent to number 20

The walls have no access points.

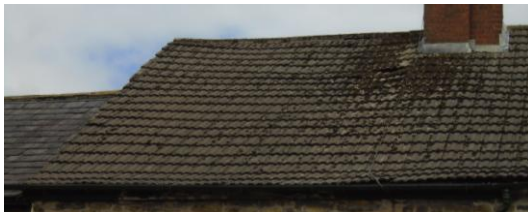
The roof is pitched it is higher than no. 20 but it is continuous with no. 24. The original slates have been replaced at some time by concrete profile tile. There is a brick chimney at the ridge.

Front roof pitch

The front roof pitch was mainly examined from the ground, there was some moss coverage just to the left of the chimney where there is a tile missing, a potential access point.

The roof was not accessible to bats until the slipped tile, it was however possible to confirm that bats have not used this potential access point. The repair and re slating of the roof of this property will not disturb or impact in any way the local bat population.

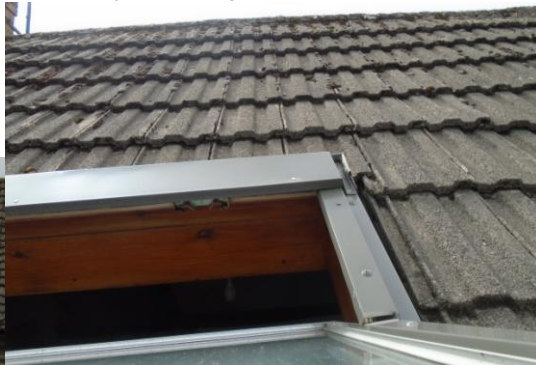
Rear roof pitch.

The rear pitch was examined closely via a roof window, all tiles tight fitting with no access points.

Previous evening surveys have had negative results on this section of King street however when approaching the trees adjacent to the river, activity has been recorded so the work provides an opportunity to enhance the roost potential in the area by incorporating of a couple of bat slates at high level in the rear roof pitch. See below.

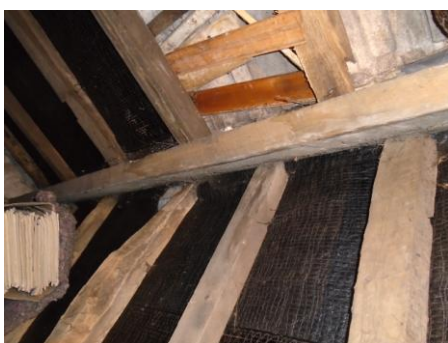
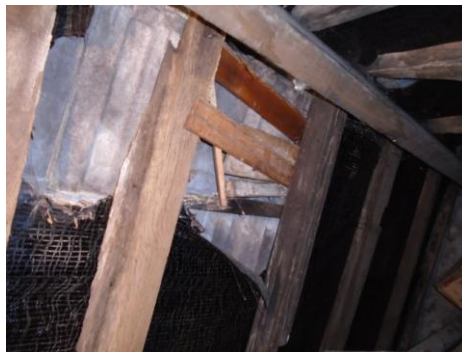
Much of the roof void is habitable space, with the rafters boarded out. The small void remaining under the ridge was viewed via a hatch, it was used for storage. The structure was timber rafters and purlins with an underlay beneath the battens. The area around the slipped tile was closely examined internally as the only potential access point. It had been temporarily patched and no signs of bat ingress could be found, the space was also free of any dropping or feeding evidence.
