**BAT SURVEY AT -**

**30 BEVERLEY DRIVE  
CLITHEROE**

**DATE AND TIME OF VISIT  
2<sup>nd</sup> Dec 2016**

**REFERENCE NO. 5195**

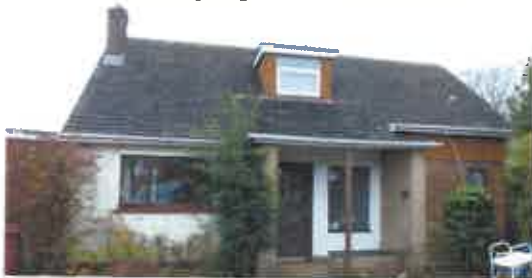
Front elevation

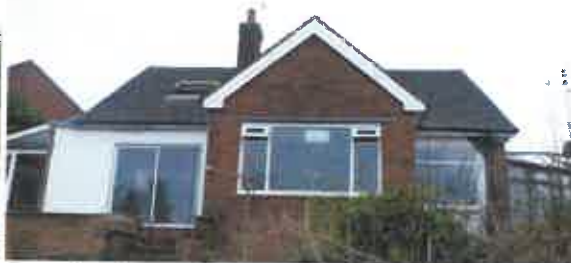
Rear elevation

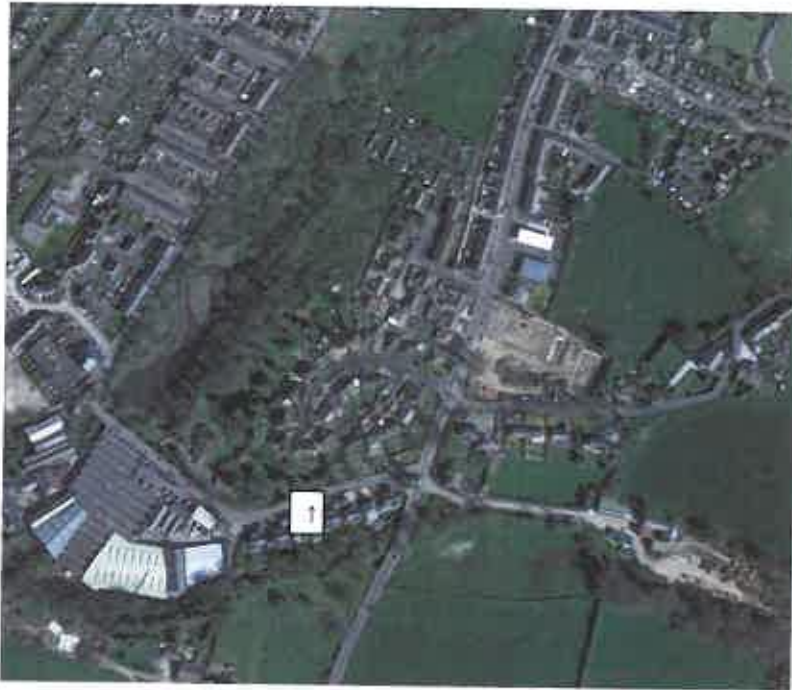
The house is located on a small housing estate on the southern edge of the settlement area of Clitheroe. The estate consists of houses which are of a similar type and age.

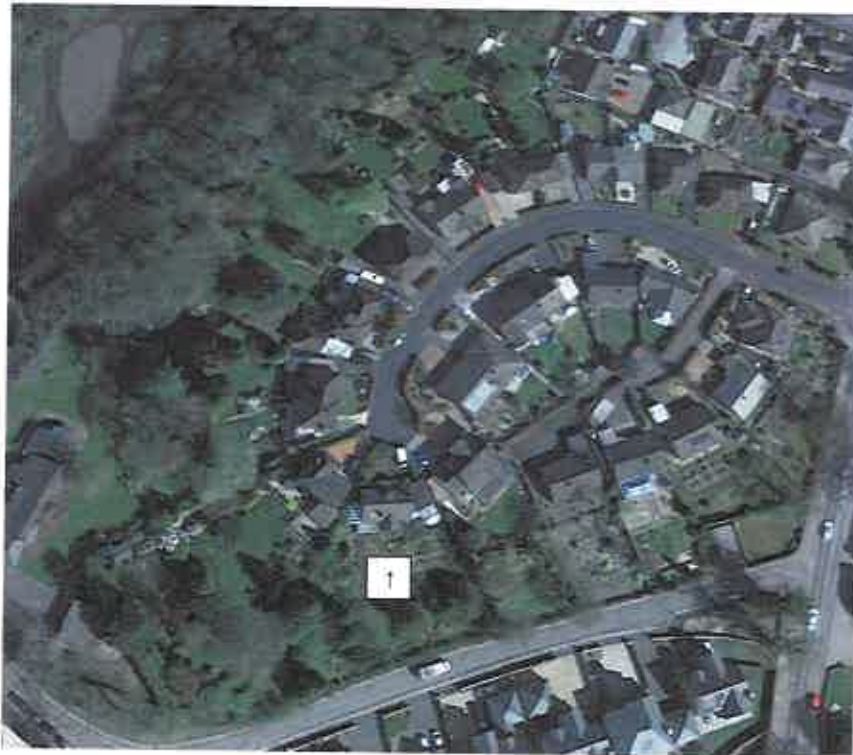
The house is located on an elevated large plot with the majority of the garden to the rear (south) which slopes steeply down to Primrose road which forms the rear boundary. The garden is clear of any planting except the side boundaries with adjacent gardens which contain domestic planting and shrubs. The main Whalley road is located 100m to the east, Primrose road is 32m to the south. Primrose mill lodge is an area of standing water 116m to the north west which is surrounded by mature trees and Pendleton brook water course runs east to west 90m to the south of the house. The brook is lined with trees which allows good connectivity (potential foraging / commute routes) to the pasture land and trees in the greater locality. Within 30m's of the house the foraging potential is sub optimal but it is well connected to optimal foraging potential in the greater area.

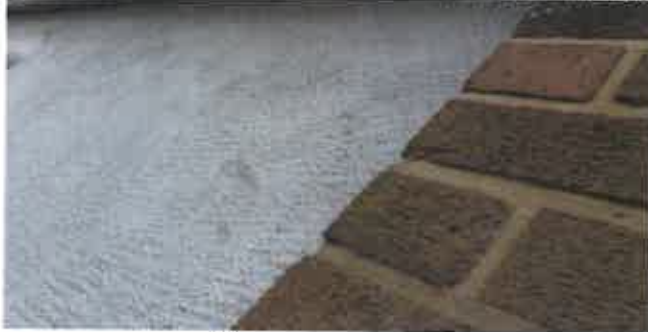
Render and brick walls

The walls are in good condition with no access points or cracks and crevices. The boards on the dormer are in good condition with no rot or access points. The boards are tight fitting against the tiles but with a slight gap at abutment with the lead to the front elevation.

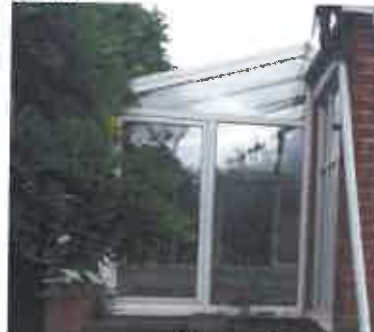
Conservatory

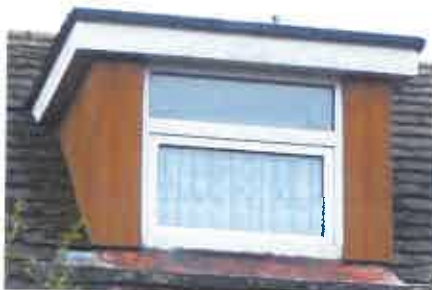
Dormer

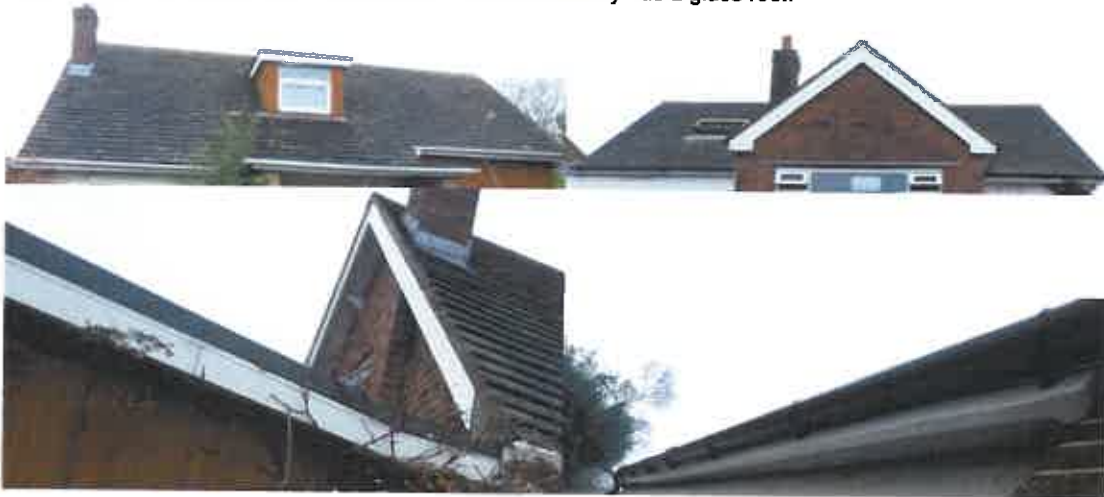
The roof is pitched tile with a gable and a roof window to the rear elevation and a small dormer to the front. There are upvc barge boards to the gables and a slight overhang at the eaves which is upvc boarded. The garage to the east side and the dormer has a flat felt roof. The conservatory has a glass roof.

The tiles are in reasonable condition and tight fitting with no gaps or slipped tiles. The lead flashings to the chimney, valley, dormer and roof window is in reasonable condition and tight fitting with no visible gaps suitable for bat use.

The roof window is open allowing free access.

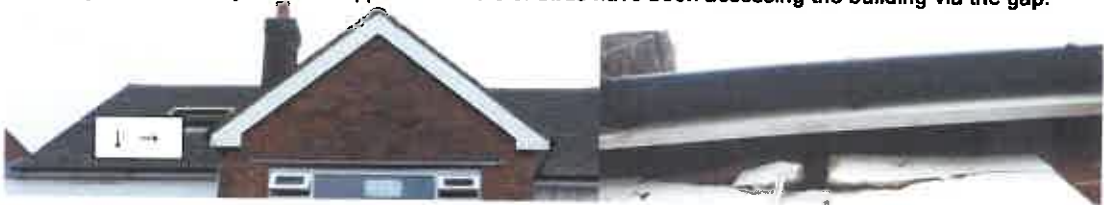
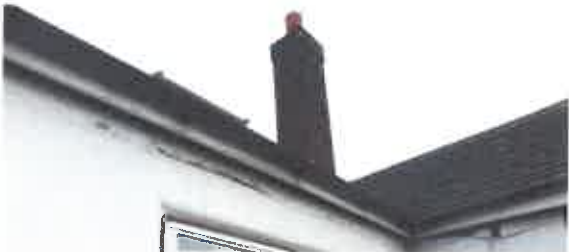
The eaves and barge board soffits are tight fitting with the exception of the eaves on the south elevation to the west of the gable outrigger which are open to the interior, see photographs below. The gaps were examined internally and externally it did not appear that bats or birds have been accessing the building via the gap.

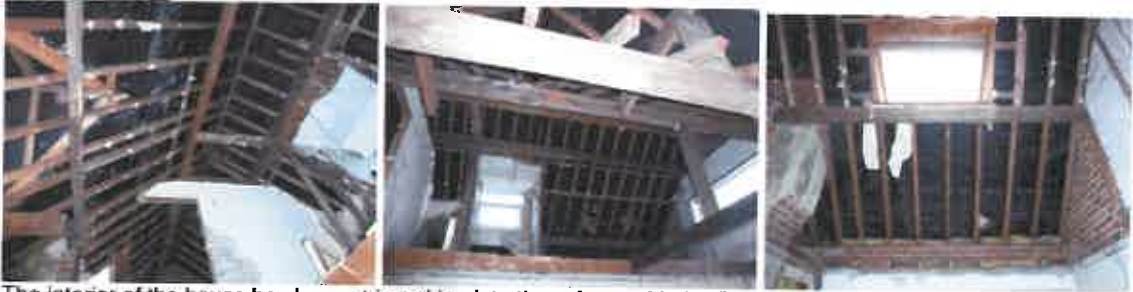
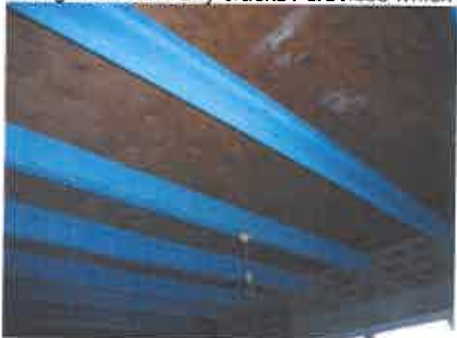
**ROOF SPACE**

The interior of the house has been stripped back to the rafters, with the floors and ceilings removed. The roof structure is timber trusses, purlins and rafters with felt underlay. The timbers are all in reasonable condition with no signs of rot or any cracks / crevices which bats could use.
