BAT SURVEY

AT
HIGHER BOYCES FARM
STONE GATE LANE
RIBCHESTER

REFERENCE NO. 4874

Proposed conversion of agricultural barn to two dwellings.

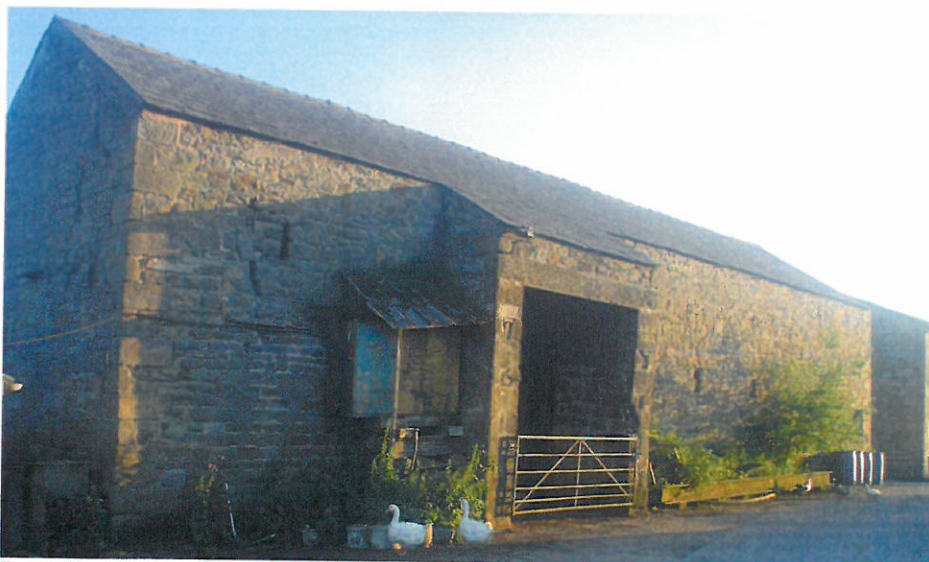
Front (north) elevation

A traditional detached agricultural barn possibly dating from 18th C with a later single storey rear outrigger and lean -to at the rear. Adjacent to the west is a small dwelling which was converted some years ago from a barn. The original Farm house is slightly remote from the barns to the east, it is under different ownership.

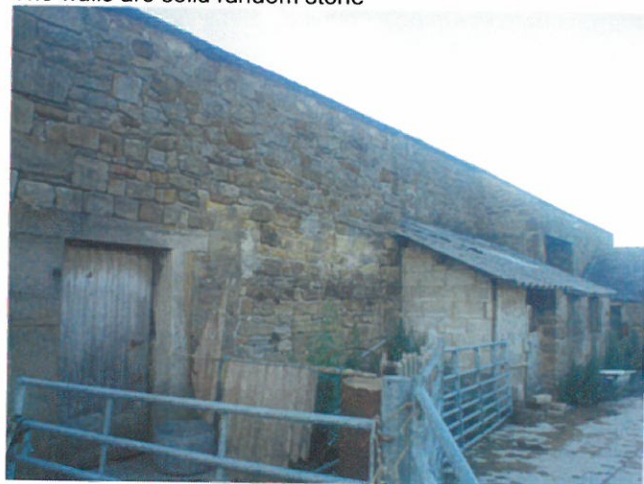
The walls are solid random stone

The barn walls are generally in good condition, however bats can access very small cracks and crevices of which there were numerous in this barn, the day light inspection of this building could not discount the possibility that bats could potentially roost in these crevices. The interior of the building was easily accessible via door, cart and vent openings.

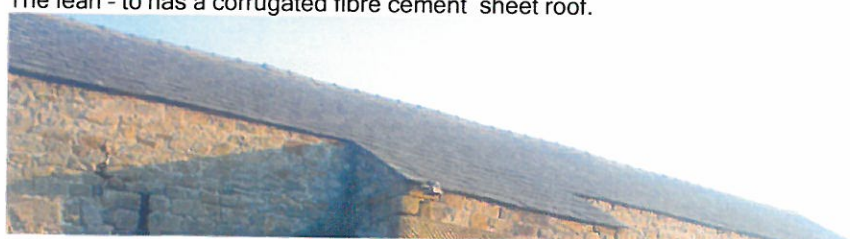
Front roof pitch

The main barn roof is a conventional pitched roof with cat slides to the rear projections, the rear outrigger has a pitched roof abutting the rear wall of the barn, both have a blue slate finish. The lean - to has a corrugated fibre cement sheet roof.

The roof is medium condition there are a number of loose / dislodged and missing slates and some with gaps between. All ridge tiles appear to be present however they appear to be in poor condition with some mortar missing. All these faults can potentially provide access points to the roof.

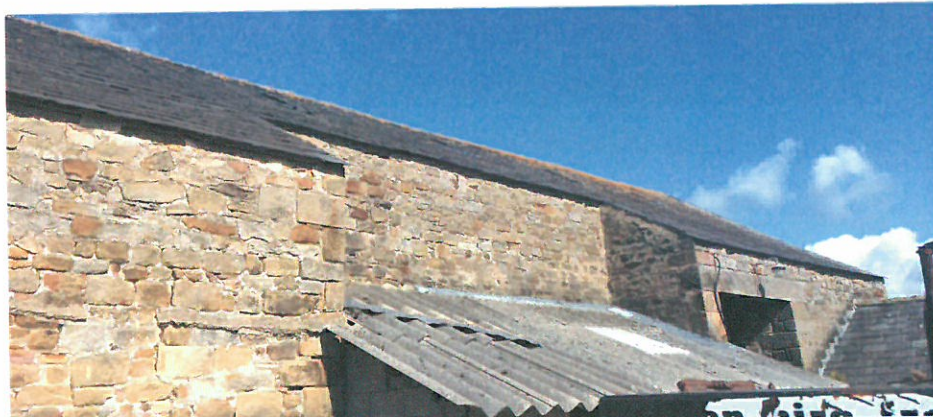
Rear main roof pitch, lean-to roof

←single storey roof

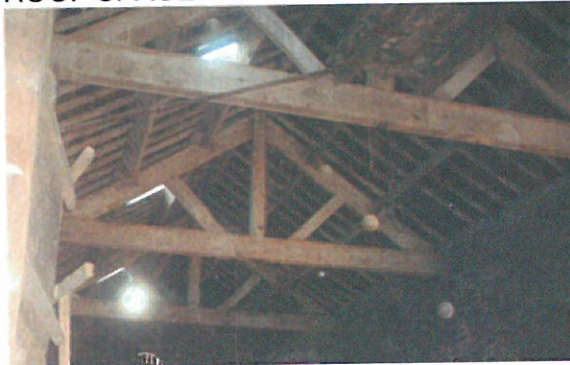
Main barn

The roof construction is timber trusses, purlins and battens. The timbers in the outrigger appeared to be in reasonable condition with no significant cracks or crevices. Some of the main roof trusses were showing signs of decay probably due to water ingress but they did not have any significant cracks or crevices. The building is generally cool and draughty.
